MARINE INVESTIGATION REPORT

M99M0062

GROUNDING

MOTOR POWERED SAILING VESSEL "BLUENOSE II"

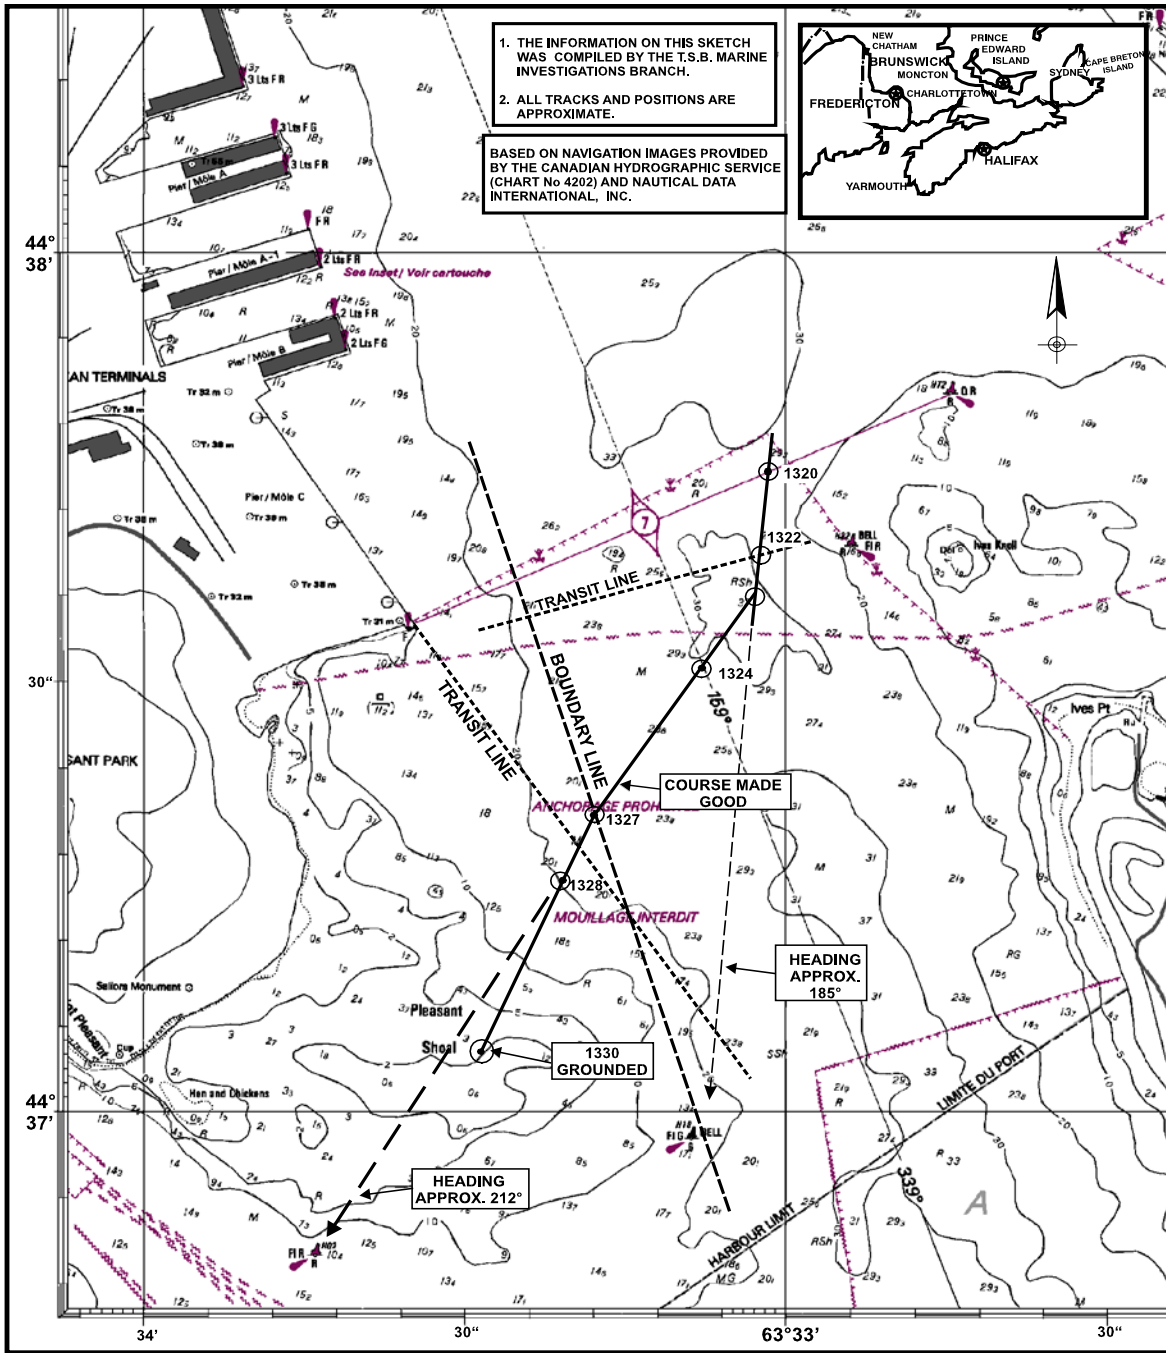
Appendix A - Sketch of the Occurrence Area

At 1323 the vessel was on a port tack and heading for the Hen and Chickens Buoy (Number HQ2; see sketch of area). The buoy was visible from the conning position and the master was estimating the vessel’s position by referencing the buoy and other visual clues. When it became apparent to him that the vessel’s course was taking her towards Pleasant Shoal, he ordered that the vessel be brought onto the starboard tack. He considered restarting the engines to assist in bringing the bow across the wind but was reluctant to do so in case the engineer was in the engine compartment in a potentially hazardous position. The vessel had begun tacking when she ran aground on Pleasant Shoal at about 1330.
