MARINE INVESTIGATION REPORT

M99W0078

STRIKING

TUG *SHEENA M* AND CHIP BARGE *RIVTOW 901*

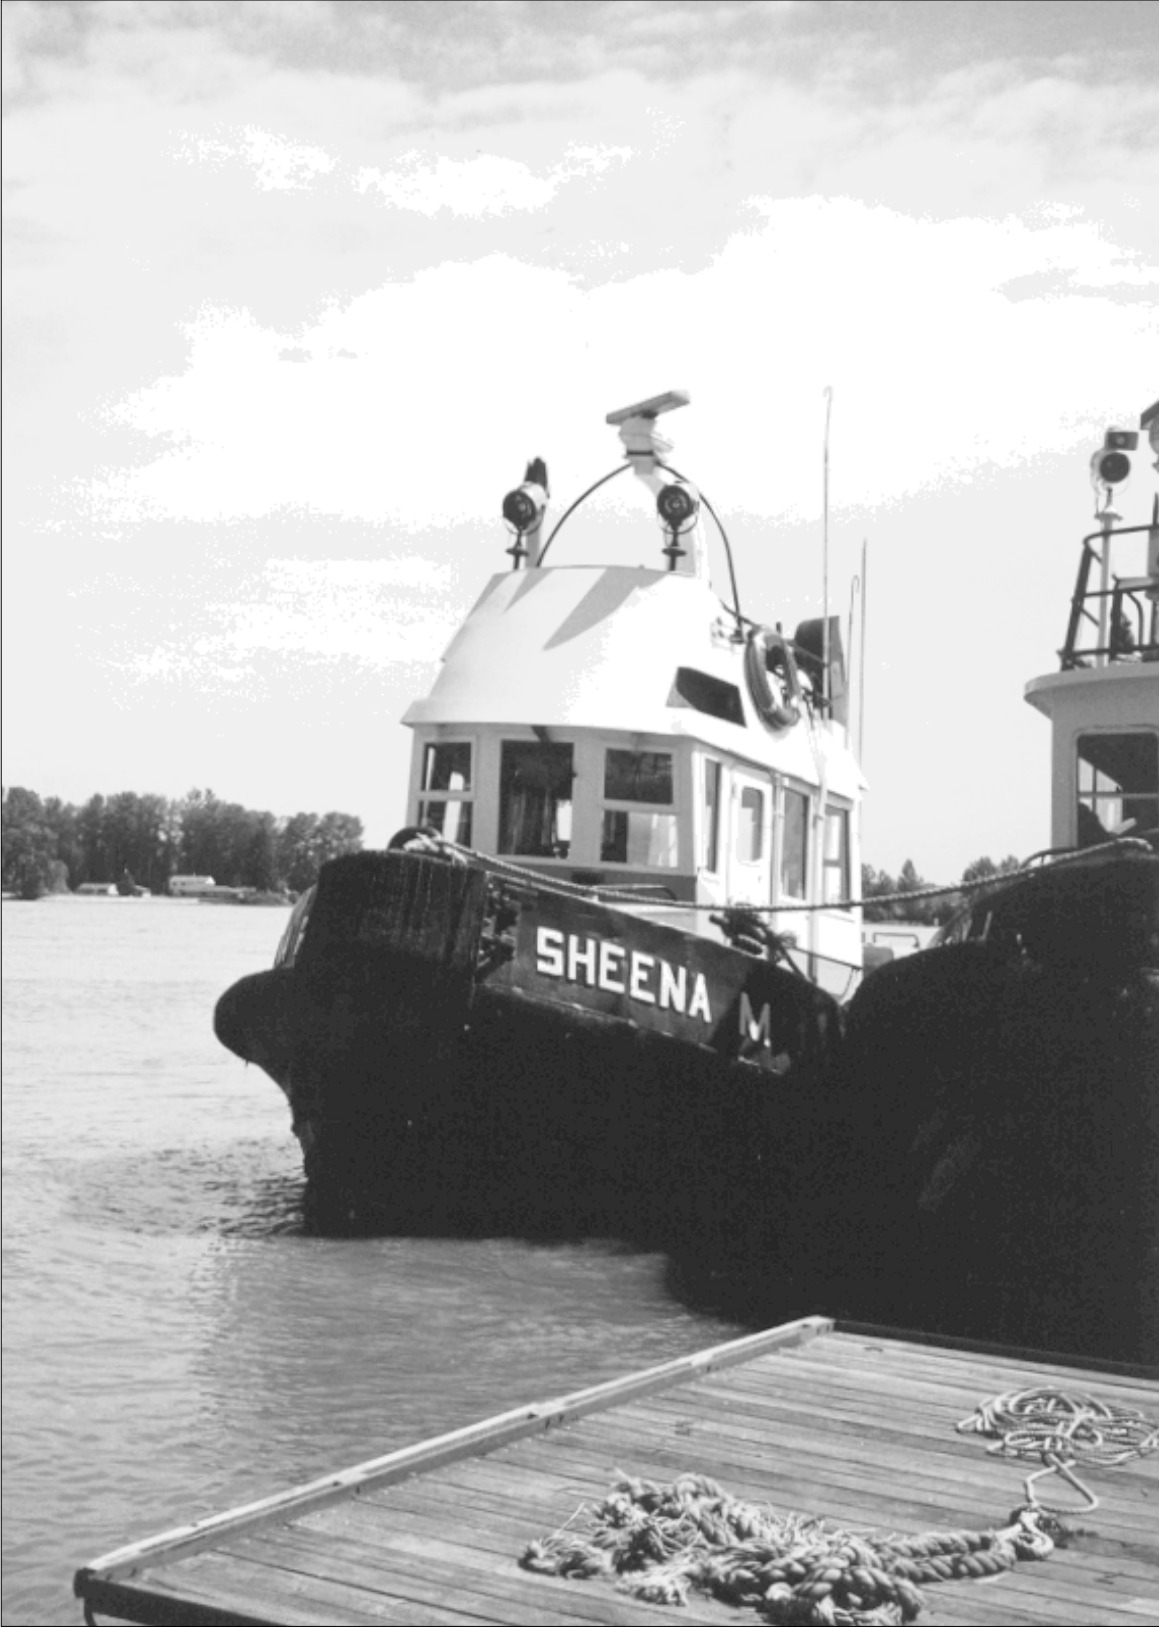
Damage to the tug was minimal. The low-voltage overhead cable spanning the draw was designed to provide an advertised clearance of 21 m above chart datum. This became dislodged when the bridge was struck resulting in a significant reduction of clearance. The tug's main mast, fitted with navigation lights and radio antennae, became fouled in this cable after the accident and was carried away (see Figure 2).

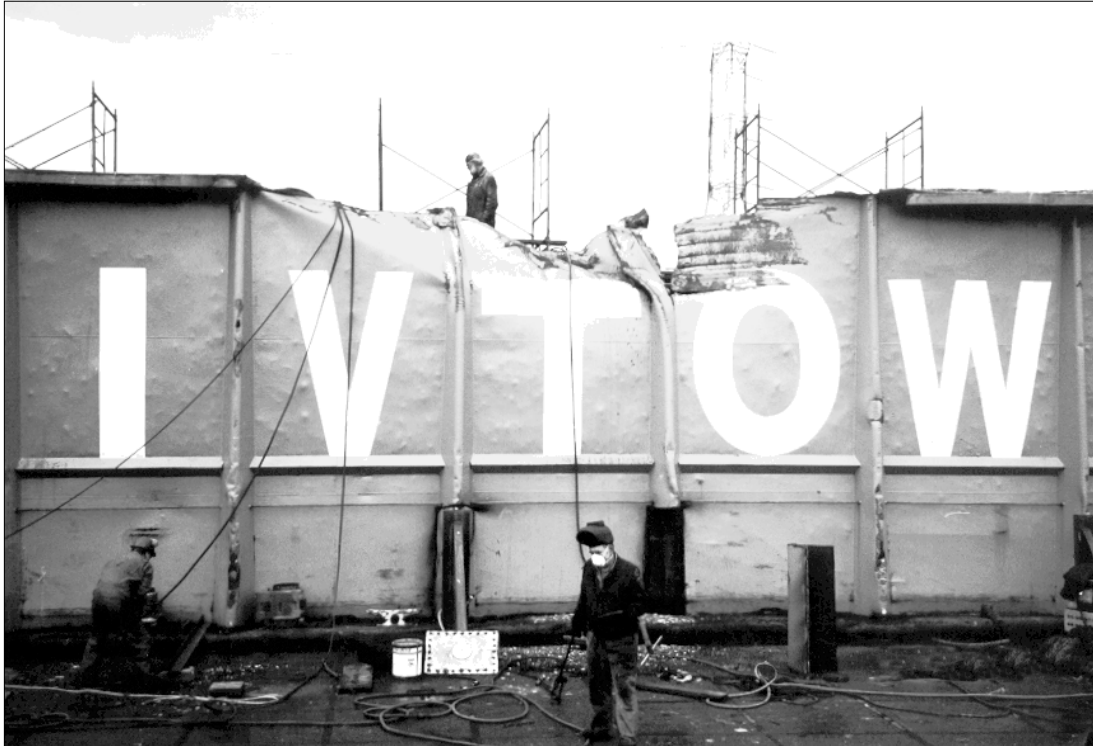
The most significant damage was to the upper edge of the steel box-wall on the starboard side which was fractured and set-in over a length of approximately 6 m at a point immediately forward of the barge's mid-length (see Figure 3). Lesser damage was sustained by the vertical stiffeners welded to the external face of the box-wall. These were damaged to varying degrees, ranging from paint scuffs to, in the case of one stiffener, sufficient deformation to require replacement. The barge's hull remained intact. Only a small amount of the wood chip cargo was spilled onto the bridge or into the river.

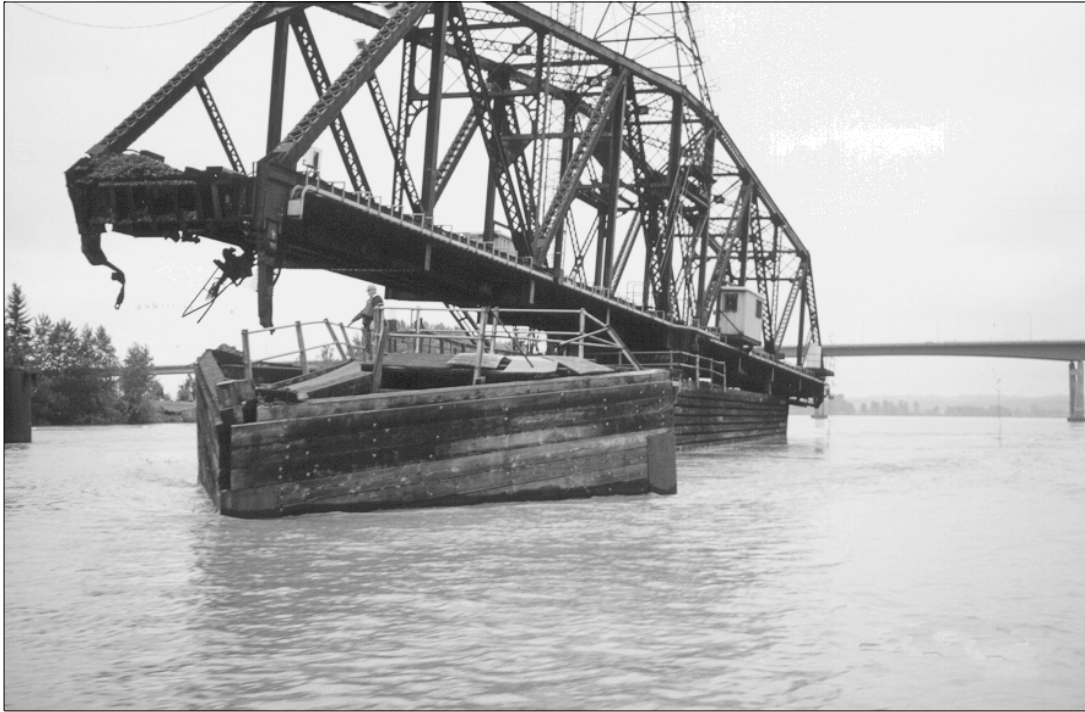
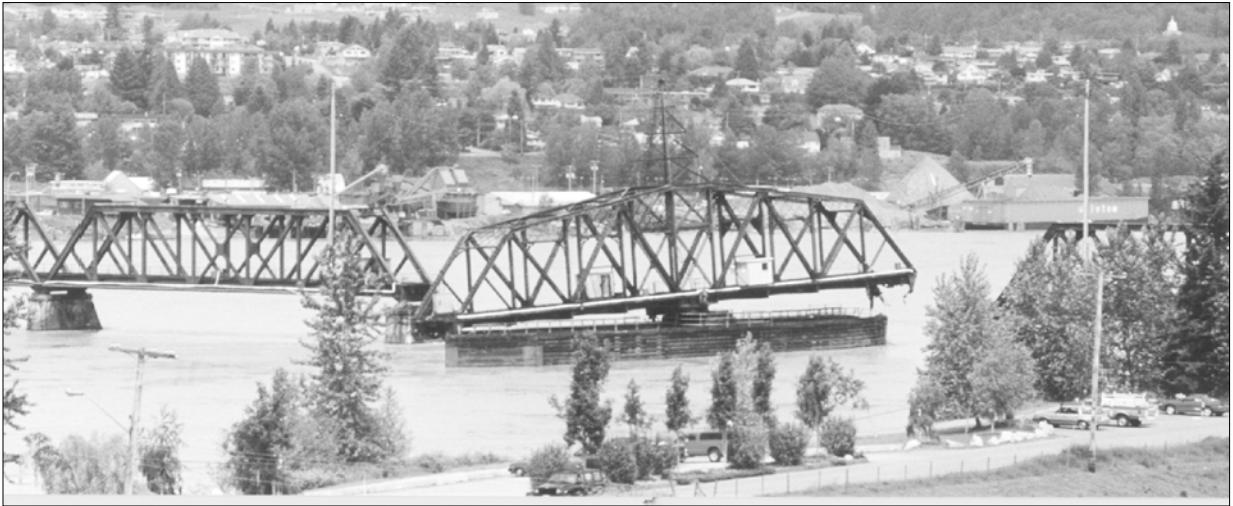
The upstream portion of the bridge protection pier was significantly damaged. As a result of the impact by the barge, the nose of the squared timber (upper) portions of the protection pier was deflected to the north. Without this protection, the swing span was dislodged from its pedestal by the barge impact and deflected approximately 4 m to the west.

Due to the height of the river (4.6 m above chart datum), at the time of the accident approximately 2 m of the upper squared timber portion of the protection pier was visible above the river surface. When the upper portion of the protection pier was struck by the barge, metal strapping and bolts, which connect with the wooden piles, distorted or sheared. Other bolts remained intact but were pulled bodily from position. The upper portion of the protection pier broke away from the pilings and was deflected to the north allowing the box-wall of the chip barge to make contact with the swing span of the railway bridge. The barge struck the swing span with a force sufficient to shift the span almost 4 m from its pedestal. Until it was stabilized several days after the accident, there was concern that the swing span might topple into the river.

Following the accident, the bridge was repaired and the upstream portions of its protection pier were repaired and enhanced. In the damaged section, wooden piles were replaced by a combination of steel pipes and “H” beams. The nose of the protection pier was extended approximately 10 m further upstream by the addition of a wooden-sheathed, triangular-shaped steel structure made from 915-mm diameter pipes driven into the river bed. CPR, in its four-year capital program, is budgeting for similar improvements to the downstream portions of the protection pier.
