PIPELINE INVESTIGATION REPORT

P09H0074

NATURAL GAS PIPELINE RUPTURE

**TRANSCANADA PIPELINE INC.
914-MILLIMETER-DIAMETER PIPELINE
LINE 2 - MLV 107-2 + 6.031 KM
NEAR ENGLEHART, ONTARIO
12 SEPTEMBER 2009**

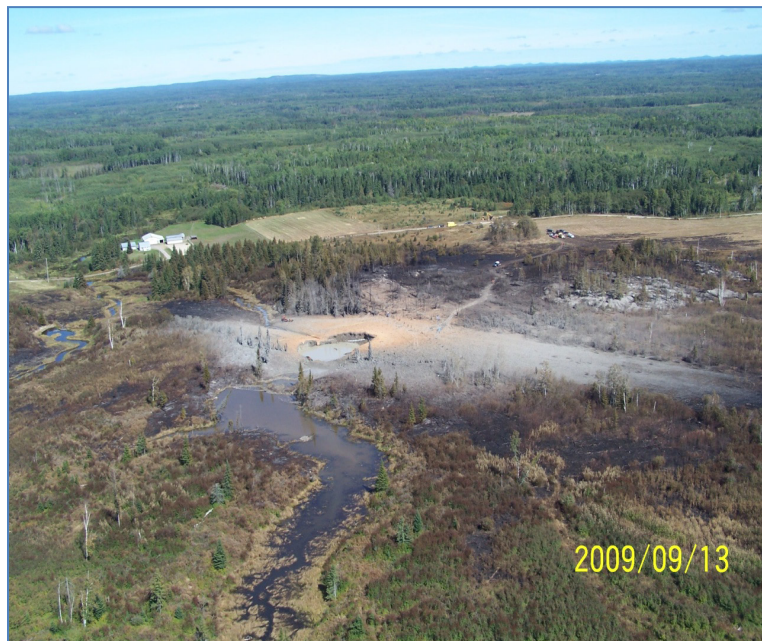
Photo 1 - Aerial Photo of the Englehart Occurrence Site

As a result of the rupture, two sections of pipe separated from the pipeline. A severely wrinkled pipe section was ejected during the explosion and was found approximately 150 m from the rupture location. The other section of pipe was found in the ditch to the south of the failed pipeline (see Photo 1).
