# PIPELINE INVESTIGATION REPORT

## P17H0011

### **Third-party damage to a crude oil pipeline**

Enbridge Pipelines Inc.

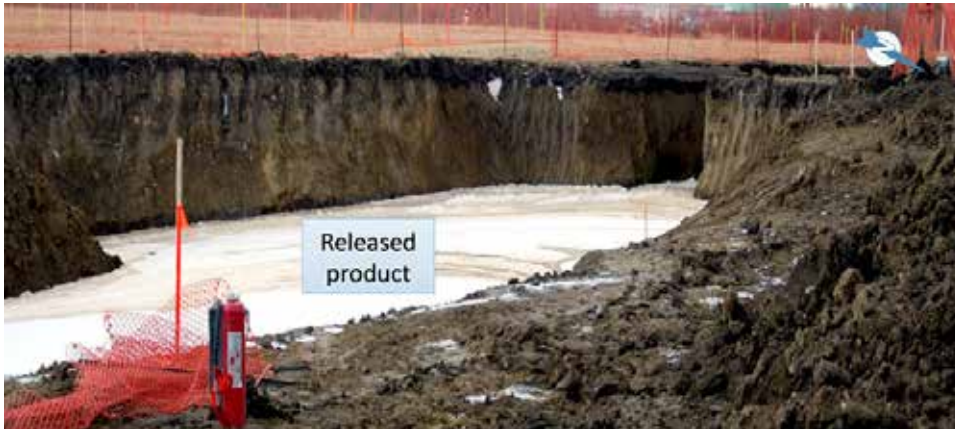
Figure 4. Existing excavation pit containing the released product

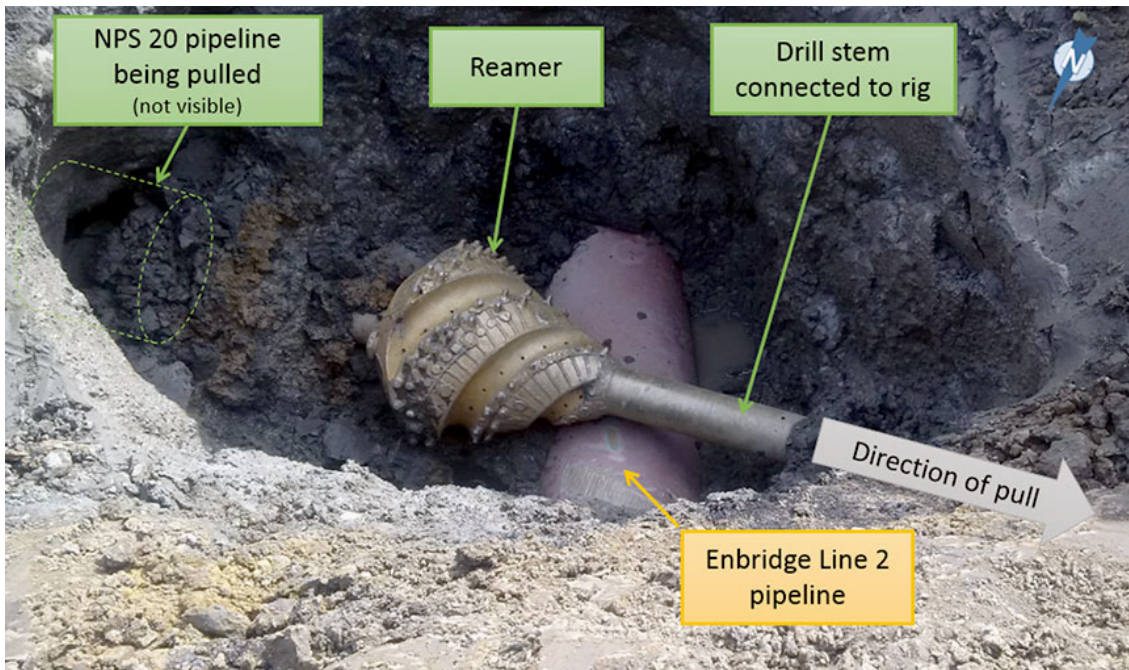
Figure 7. Reamer contacting the Enbridge Line 2 pipeline

At approximately 1505, when the reamer initiated the crossing of the Enbridge Line 2 pipeline, the drilling rig operator noted increased resistance. The operation was stopped. However, the reamer had already contacted the Enbridge Line 2 pipeline.

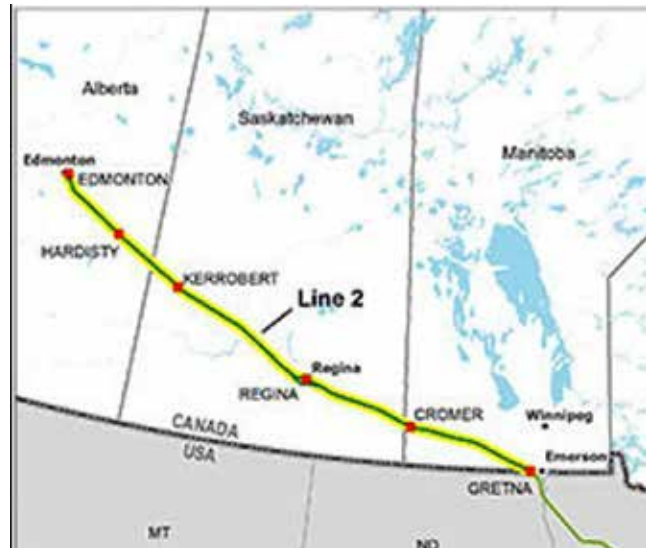
The segment of pipe involved in the occurrence had been installed in 2015 as part of a pipe replacement project. The pipe was manufactured from a Grade 483 Category I material, in accordance with the Canadian Standards Association (CSA) specification Z245.1-07.<sup>16</sup> The pipe had a nominal outer diameter of 24 inches and a wall thickness of 10.31 mm. The pipe was coated with a dual-layer fusion-bonded epoxy system.

Figure 9. Enbridge Line 2 pipeline

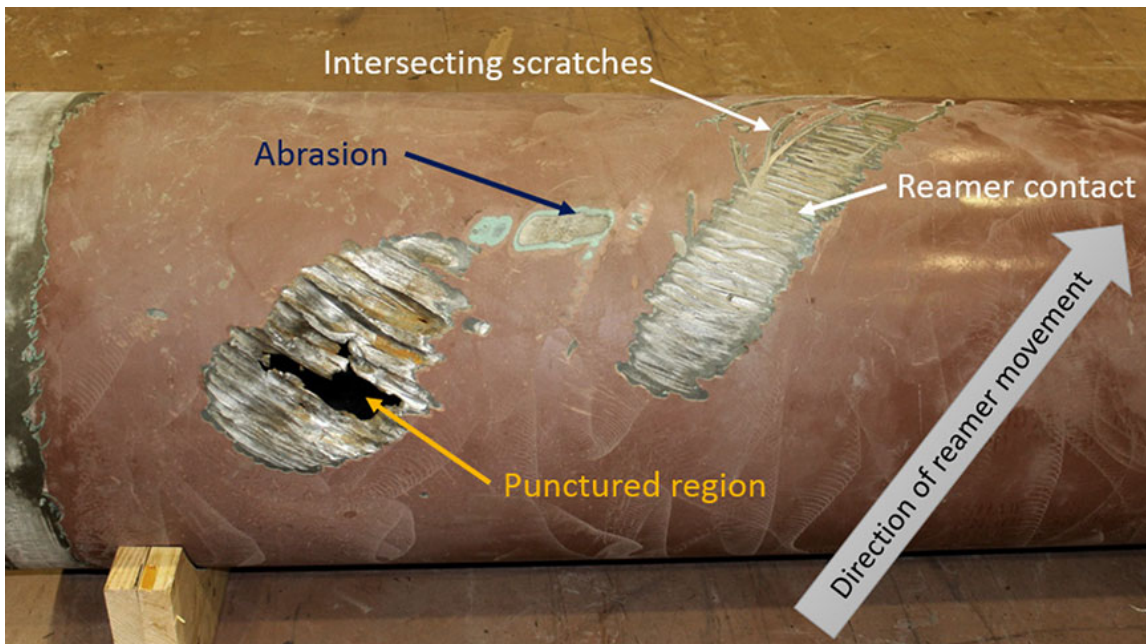
- The geometrical dimensions and metallurgical properties of the pipe met the specification requirements. The coating on the undamaged portion of the pipe was in good condition.
- On the damaged portion of the pipe, scratches and some abrasions were present. The scratch depths and widths were consistent with the size of reamer tooth tips<sup>17</sup> (Figure 10).
- The damage in the region of the reamer contact had no through-wall holes. The pattern and profile of the intersecting scratches indicated that the rotating reamer was moving toward the west, in the direction of the pull.

- Much deeper penetration of the reamer teeth into the pipe wall had occurred in the punctured region of the pipeline. Some local deformation (inward depression of the pipe wall) was present in this area. The pipe wall was perforated, with 1 larger hole and 2 smaller holes. The direction of the reamer movement was consistent with the region of the reamer contact.
- Several abrasion spots were present on the pipe. Some of these abrasion spots were through the coating into the pipe steel, while others were only within the coating thickness.
- No other flaws were found with the pipe.

Figure 10. Damaged area on Enbridge's Line 2 pipe

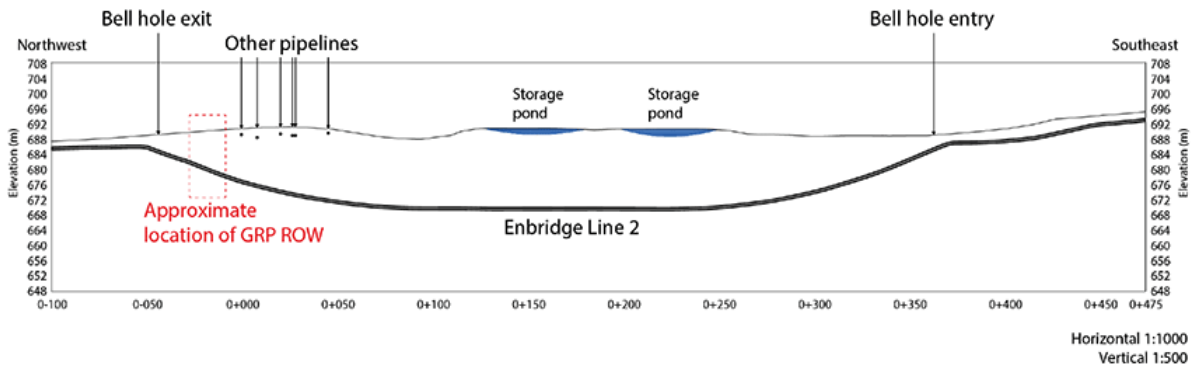
the depth of Line 2 at the NPS 36 crossing<sup>33</sup> (9.42 m) had been measured in the field. Also, when the Line 2 pipeline was daylighted at that location, field team members had noted that it appeared to be horizontal. Figure 11 illustrates the profile of Enbridge’s Line 2 pipeline in the vicinity of the GRP ROW.

Figure 11. Profile drawing illustrating the slope of Enbridge's Line 2 pipeline in the vicinity of the GRP ROW

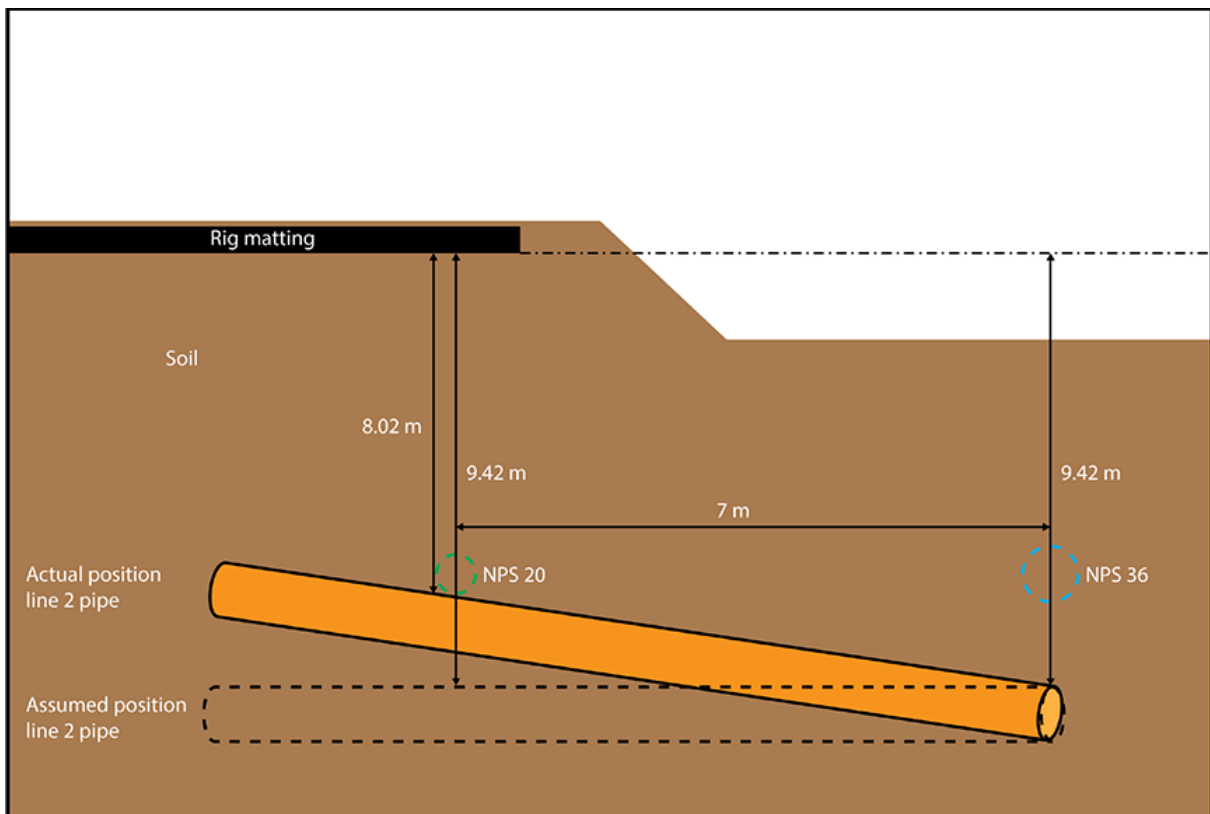
Figure 12 provides a side-cut view of the actual position of the Line 2 pipeline, compared with the assumed position based on the depth of cover at the NPS 36 crossing.

Figure 12. Side-cut view below ground showing the assumed position versus the actual position of the Line 2 pipeline (not to scale)

The Line 2 pipeline had not been daylighted at the NPS 20 crossing. The field engineer was aware that the depth of Line 2 at the NPS 36 crossing, 7 m from the NPS 20 crossing, had been measured in the field. No conflicting information indicated to the field engineer that the Line 2 pipeline would be in the drill path. Furthermore, several field team members had noted that when the Line 2 pipeline was daylighted at the NPS 36 crossing, it visually appeared to be horizontal. Therefore, the depth of cover measurement that had been taken for the adjacent NPS 36 pipeline was used for the NPS 20 crossing.
