# PIPELINE INVESTIGATION REPORT

## P17H0019

### Crude oil leak

Enbridge Pipelines Inc.  
Edmonton North Terminal  
Sherwood Park, Alberta  
20 March 2017

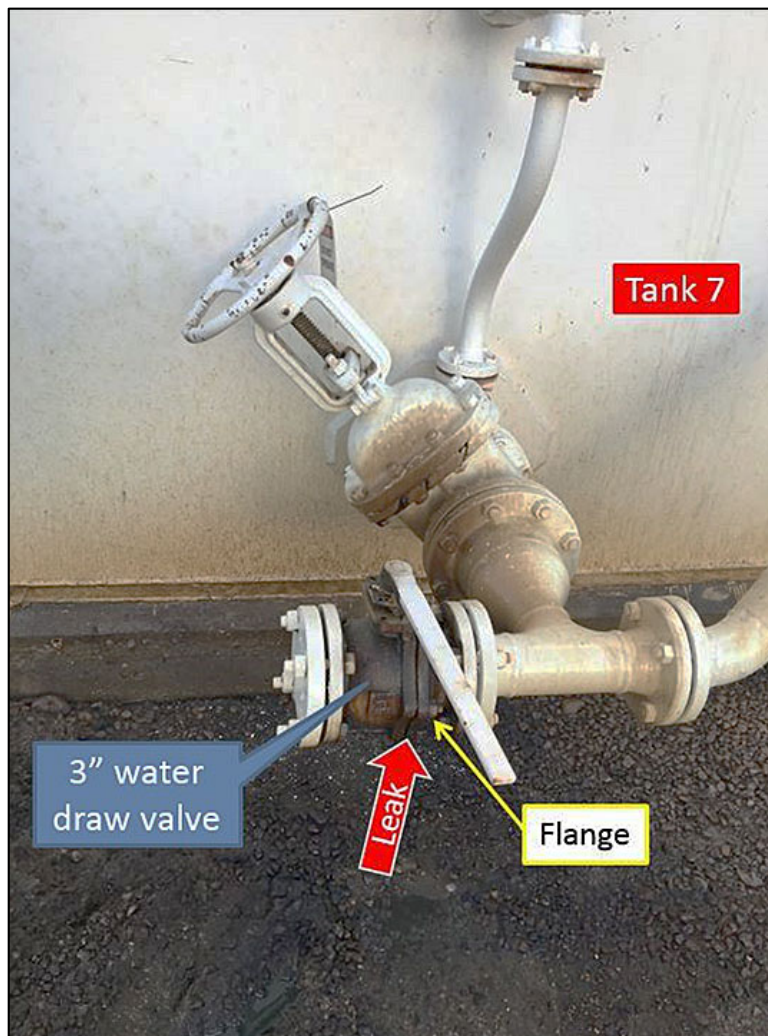
Figure 3. Location of leak

- A stream of product, approximately 6 mm in diameter, was observed to be escaping from the body flange of a 3-inch ball valve (water draw valve)<sup>3</sup> located at the bottom of Tank 7 (Figure 3).
- Approximately 10 cubic metres (m<sup>3</sup>) of product had leaked from the valve flange into the tank's secondary containment berm.

The leak occurred when crude oil was released from Tank 7 into its secondary containment berm through a flange joining the 2 halves of a 3-inch ball valve that is part of the tank's water draw system.

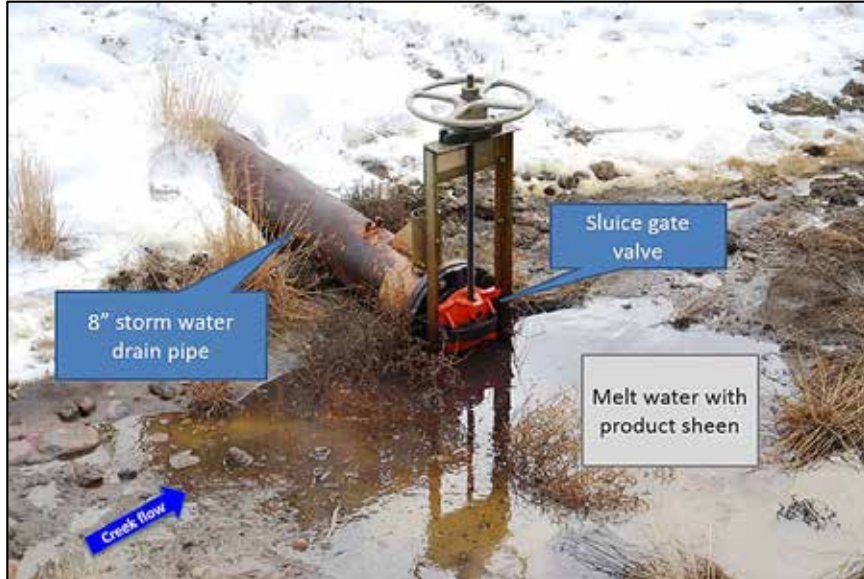
Figure 4. Storm water drain pipe with sluice gate valve

- Approximately 3 m<sup>3</sup> of the product contained by the berm had discharged into a creek by way of the berm's storm water drainage system, which consists of an 8-inch storm water drain pipe equipped with an 8-inch sluice gate valve (Figure 4).
- Product was observed to be flowing from the bottom of the sluice gate valve area.
- The storm water drain pipe was installed with its longitudinal seam weld located at the 6 o'clock position.
- It was not possible to determine conclusively the exact source of the leak, and there was no evidence of any product release from the drain pipe.

Some of the leaked product that was initially retained within the secondary containment berm was released into the creek from the berm's storm water sluice gate valve.

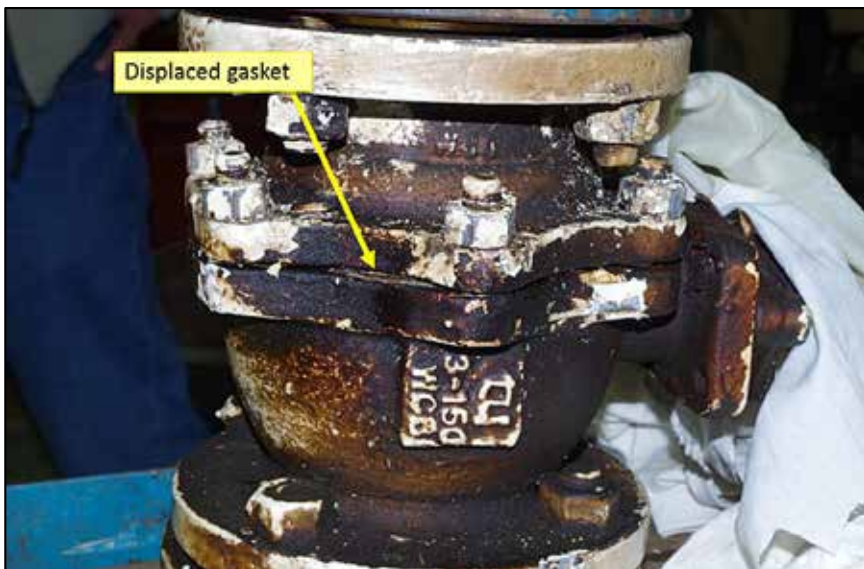
- A leak was present at the joint between the 2 valve body halves.
- A portion of the gasket between the body sections was displaced from its original position (Figure 9).

Figure 9. Displaced gasket (Source: Acuren Group Inc., with TSB annotations)

- The gap responsible for the leak was likely due to volume expansion of water contained within the valve cavity upon freezing.
- There was no indication of any flaw in the valve components or of incorrect valve assembly.

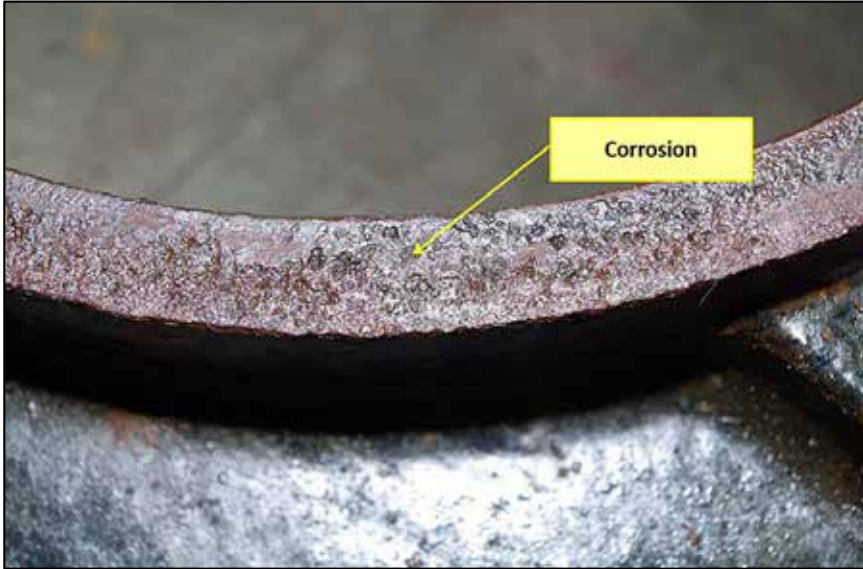
- The valve leaked slowly at low pressures when tested in the “as received” condition.

- Corrosion had occurred at the valve seat to the extent that it was not possible to achieve a liquid tight seal (Figure 10).

Figure 10. Corrosion at valve seat (Source: Acuren Group Inc., with TSB annotations)

The seat of the sluice gate valve, which was corroded, could not achieve a liquid tight seal. Furthermore, there were indications that the flange between the sluice gate valve and the drain pipe was permeable to water.

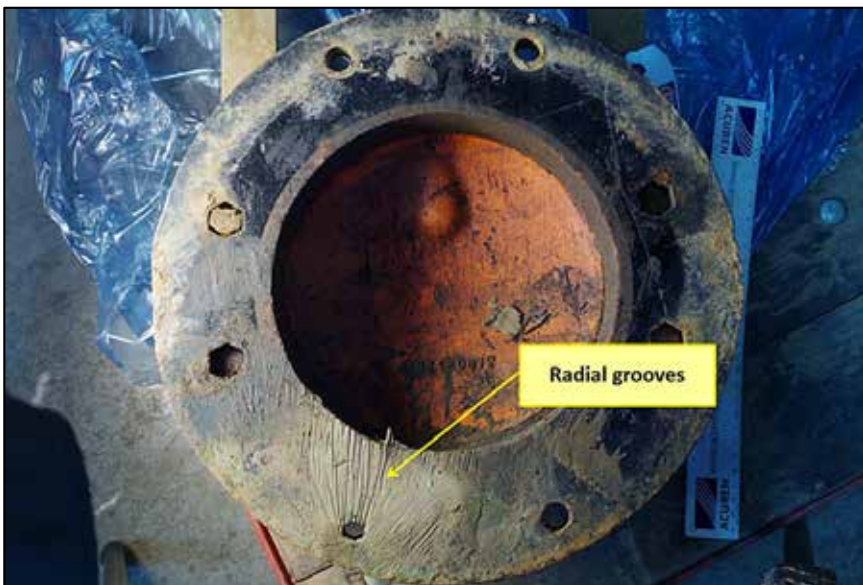
- Mud and dirt, which could have acted as a partial sealant, were present within the valve.
- The valve leaked at higher volumes after being disassembled and cleaned.
- The flange face of the valve, where it attaches to the drain pipe, was covered with a relatively smooth coating of mud. Radial grooves present in the mud coating indicate that water had likely flowed through this area (Figure 11).

Figure 11. Radial grooves on flange (Source: Acuren Group Inc., with TSB annotations)

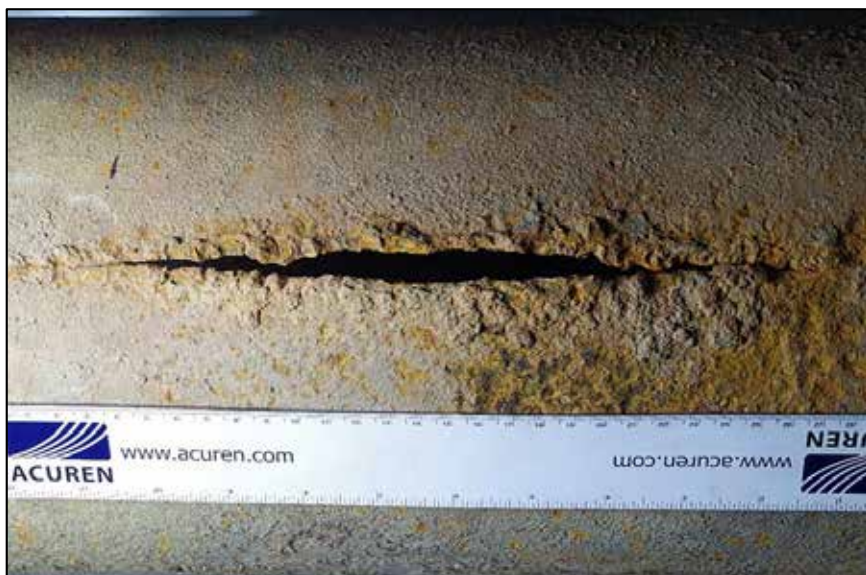
- The pipe was uncoated.
- The pipe had been manufactured using a manual longitudinal seam weld.
- The weld, which was of poor quality, had likely been made using an oxyacetylene welding process.
- There were 4 holes through the weld, the largest of which had a diameter of approximately 3 mm. The holes had been formed at the time the pipe was manufactured.
- A 258 mm-long split at the longitudinal seam weld was present. The split, which had likely occurred a number of years ago, had a maximum width of 12 mm (Figure 12).

Figure 12. Split at the longitudinal seam weld (Source: Acuren Group Inc.)

- The split was likely due to water freezing within the pipe.
- The pipe had suffered considerable wall loss due to oxygen corrosion in the presence of water. The corrosion likely occurred over a very long period of time.

Within the berm drain pipe, a 258 mm-long split in the pipe's longitudinal seam had occurred, likely due to freezing of water. Furthermore, the drain pipe was not liquid tight at the time of manufacturing due to the presence of a number of holes in its longitudinal seam weld. It could not be determined if this contributed to the leak.
