PIPELINE TRANSPORTATION SAFETY INVESTIGATION REPORT P22H0023

PIPELINE RUPTURE AND FIRE

NOVA Gas Transmission Ltd.
8-inch Simonette Lateral natural gas pipeline
Near Fox Creek, Alberta
07 April 2022

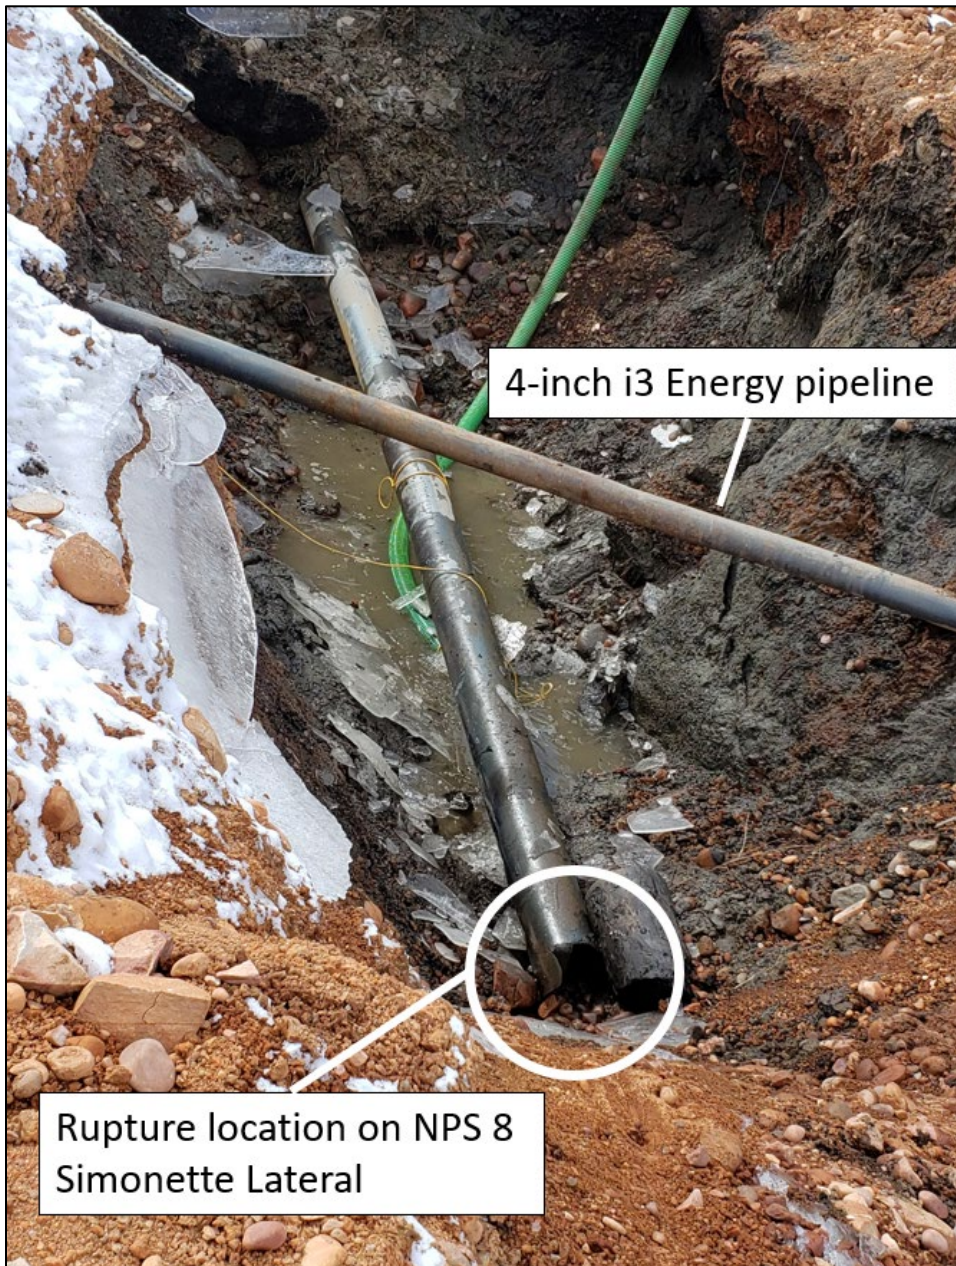
Figure 3. Crater and exposed pipelines after the occurrence (Source: TSB)

The NPS 8 Simonette Lateral was exposed at the bottom of the crater with its protective coating burned off. An out-of-service 4-inch pipeline, owned by i3 Energy Canada Ltd. (i3 Energy)¹⁰ was also exposed within the crater; it was about 2 m above the ruptured pipeline, at an approximate 60° angle (Figure 3).

The 4-inch i3 Energy pipeline did not rupture, but its coating was missing, having been directly exposed to the fire. The damaged section of this pipeline was subsequently replaced. A nearby production facility and other pipelines owned by i3 Energy were not damaged.

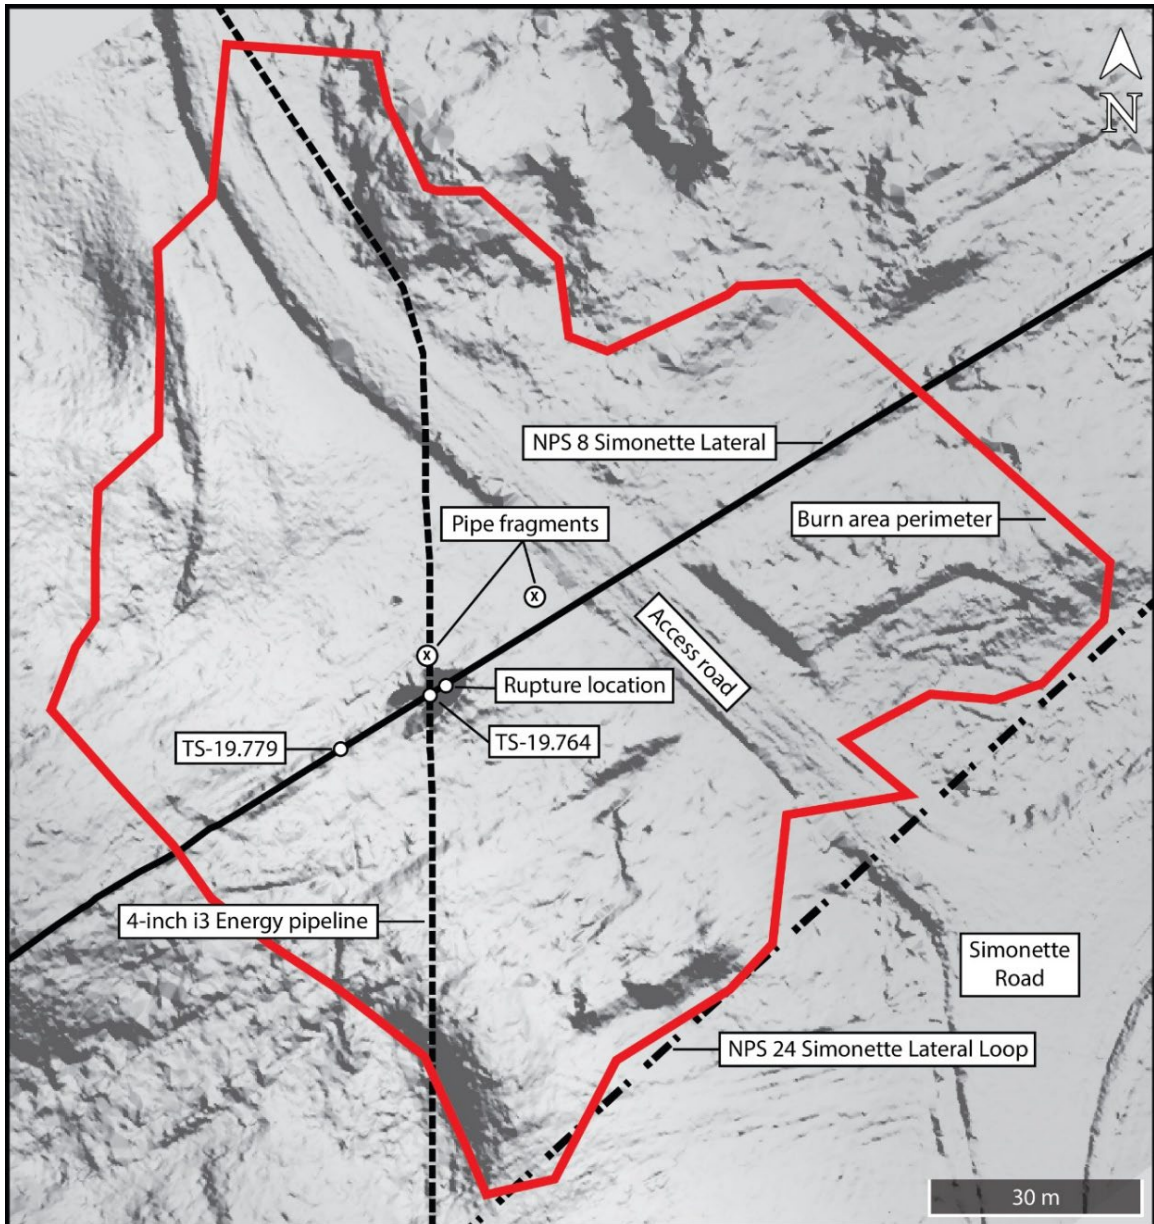
Figure 4. Survey of the occurrence area showing the main facilities within the burn area perimeter (Source: TSB)

In the vicinity of the rupture, test stations TS-19.764 and TS-19.779—above-ground terminals connected to the buried pipe for measuring cathodic protection (CP) potential—were damaged. System components from these test stations were also recovered for laboratory analysis.

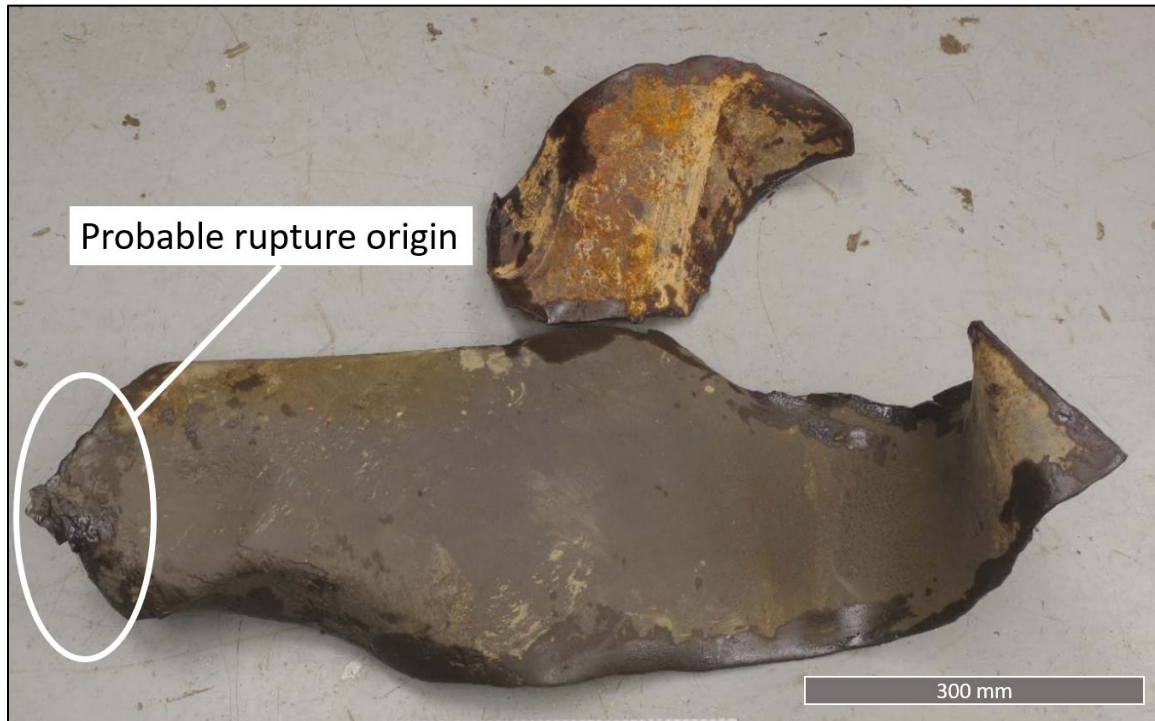
Figure 8. Ejected pieces of pipe (Source: Acuren Group Inc., with TSB annotations)

Examination of the ejected pieces of the pipe (Figure 8) found significant corrosion along one edge, identifying the probable location of the rupture origin. The probable rupture origin was located at the bottom of the pipe, approximately 3.5 m downstream of girth weld 1710. The edges of the ejected pieces showed features consistent with ductile fracture. No indication of prior cracking, brittle fracture, or any flaw such as stress corrosion cracking was observed. The minimum thickness measured at the probable rupture origin was 0.49 mm, an 88% reduction of the original wall thickness.

Mechanical testing found the tensile properties and composition of the pipe to meet both the specifications in effect at the time of construction¹⁴ and those in effect at the time of the occurrence.¹⁵ Based on the remaining pipe thickness along the rupture edge, the theoretical rupture pressure was estimated to be 4683 kPa.

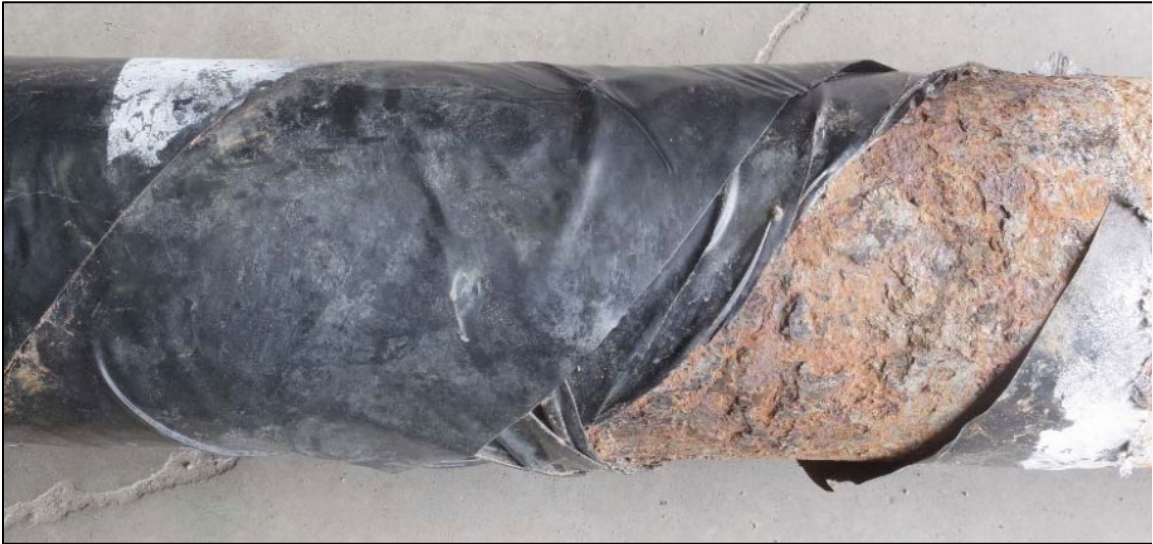
Figure 9. External pipe surface condition after the occurrence (Source: Acuren Group Inc.)

The areas of pipe exposed to the fire did not have any pipe coating remaining. The general condition of the remaining polyethylene tape coating was found to be very poor (Figure 9).

Laboratory examination found that the external field-applied polyethylene tape coating on the NPS 8 Simonette Lateral in the vicinity of the occurrence location had degraded, leaving 25-35% of the pipe surface exposed to the external soil environment. While the tape coating at the occurrence location could not be directly assessed, having been burned in the fire, it is likely that it was in a similarly poor condition in the time leading up to the rupture.

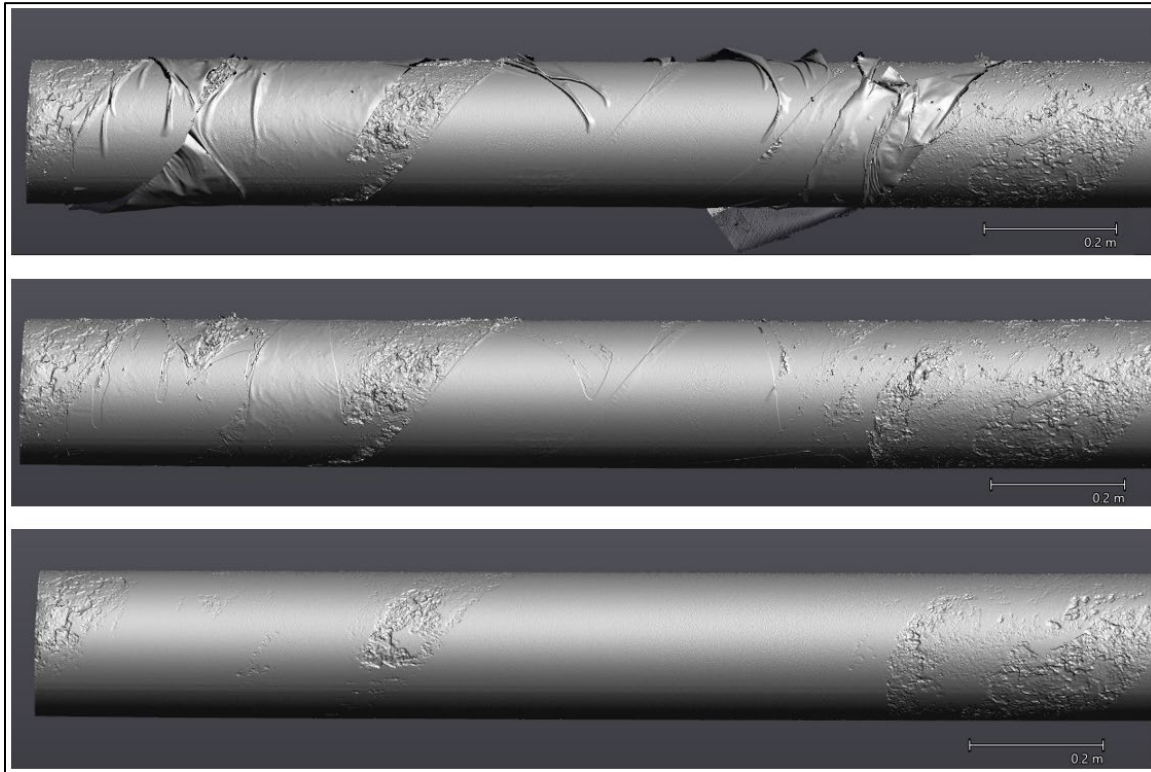
Figure 10. Example of 3-dimensional digital images of the pipe, as received (top), with disbonded coating removed (middle), and with all tape and pipe surface sandblasted (bottom) (Source: Acuren Group Inc.)

The images produced were analyzed to estimate the relative amount of disbonded coating and corroded surface area. The compiled results of the coating evaluation are presented in Table 2.

Pipe section	Tape holidays* (%)	Tape disbondment** (%)	Bonded tape*** (%)	Corroded surface (%)
1700-1	35	65	0	35
1700-2	30	50	20	30
1720	25	75	0	25
