RAILWAY INVESTIGATION REPORT
R00D0098

COLLISION AND DERAILMENT

VIA RAIL CANADA INC.
TRAIN NO. 603
MILE 119.35, LA TUQUE SUBDIVISION
LA TUQUE, QUEBEC
30 AUGUST 2000

Report Number R00D0098

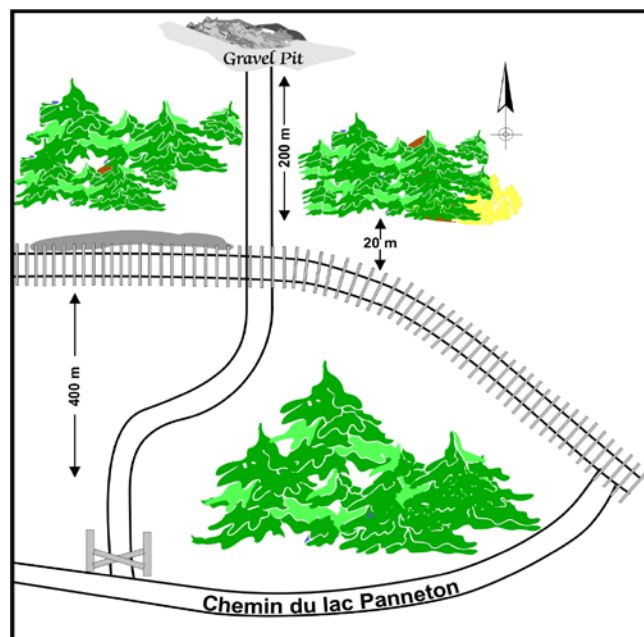
The road leading to the crossing is a restricted-access private road beginning at the Chemin du lac Panneton and ending at the gravel pit. It is a narrow winding road that runs for approximately 400 m before crossing the railway track (see Figure 1). On the north side of the track, the road is tangent with a descending grade followed by an ascending grade as far as the gravel pit. The land adjacent to the road is wooded to about 20 m from the railway track. Given the characteristics of the road, the loaded trucks travel at a speed of approximately 7 km/h; at that speed, a truck takes 11 seconds to travel the distance between the end of the woods and the crossing. Based on the number of trips made by the gravel trucks, the road traffic passing over this crossing is estimated at more than 80 heavy vehicles per day.

There were stop signs on both sides of the track about 2 m from the rails. They were movable and located at a height of 1.35 m, whereas the CN standard plan prescribed a height of between 1.8 m and 2.4 m. The sight-line to the east was approximately 180 m for a vehicle travelling south and approximately 120 m for a vehicle travelling north. The CN standard plan and the draft TC minimum sight-line guidelines indicated that the sight-line should be 230 m for a crossing where there were stop signs and the maximum train speed was 50 mph. In addition, as this was a private crossing, trains did not whistle because train crews were not required to follow CROR Rule 14(1)³ as for public crossings.

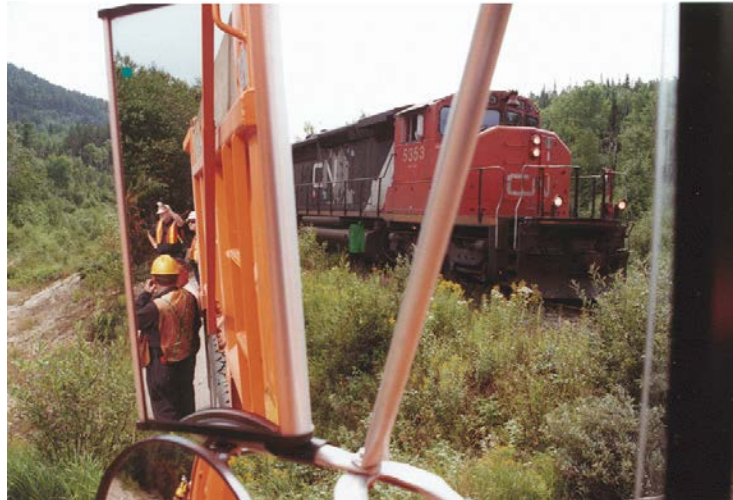
A simulation was conducted at the crossing on 01 September 2000. A truck of the same size but of a different model from the one involved in the collision was used. The dimensions and position of the exterior mirrors relative to the driver were similar. The simulation revealed that the left rearview mirror blocked the driver's view to the east (see Figure 2) when the truck was 8 m from the track (the distance specified in the TC sight-line guidelines); in these conditions, a freight train could be perceived only when it was 14 m from the crossing.

1. The truck driver's left rearview mirror created a blind spot that obstructed a large part of the field of view and may have prevented the driver from seeing the train approaching.
2. A quality control program ensuring compliance with established standards would provide an additional mechanism to ensure that some anomalies potentially having an impact on the safety of railway employees and the public are identified and corrected.
3. Reassessment of the risks based on the specific features of each crossing may prove necessary, because some crossings, even private crossings, have substantial seasonal traffic fluctuations that may affect safety.
