RAILWAY INVESTIGATION REPORT

R00H0004

MAIN TRACK DERAILMENT

OTTAWA VALLEY RAILWAY / RAILAMERICA INC.

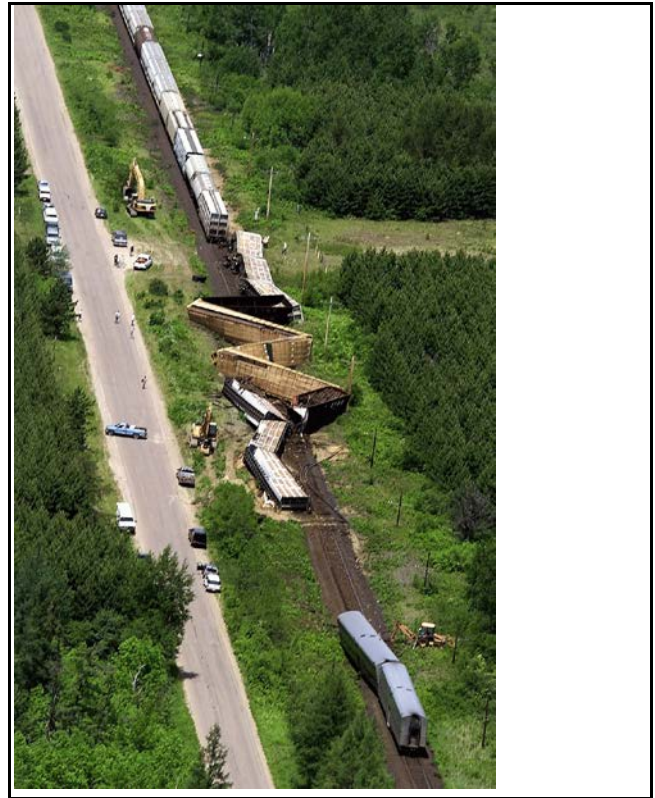
The train derailment area (see Figure 1) extended for approximately 850 feet. The two passenger cars, 8<sup>th</sup> and 9<sup>th</sup> behind the locomotive, were derailed in an upright position. The 10<sup>th</sup>, 11<sup>th</sup> and 12<sup>th</sup> cars, flat cars loaded with packaged lumber, were coupled together and lying on their sides to the south of the track. The 14<sup>th</sup>, 15<sup>th</sup> and 16<sup>th</sup> cars, centre beam flat cars loaded with lumber, and the 17<sup>th</sup> car, an empty hopper car, were upright and jack knifed on the right-of-way.

The 18<sup>th</sup>, 19<sup>th</sup> and 20<sup>th</sup> cars, also flat cars loaded with packaged lumber, were lying on their sides to the north of the track. The 13<sup>th</sup> car, an open top gondola car loaded with used railway ties, although upright, had the leading end of the car torn away. Two TCPL natural gas pipelines cross about 2 m underneath the railway where the 19<sup>th</sup> and 20<sup>th</sup> cars were lying on their sides. The top corners of the cars had penetrated the ground surface to an approximate depth of 75 cm.

The rails, crossties and roadbed at Mile 1.78 were substantially displaced both longitudinally and laterally. Wheel flange marks on the web of the rail indicated that the rail had rolled over and that loss of track gauge had occurred.

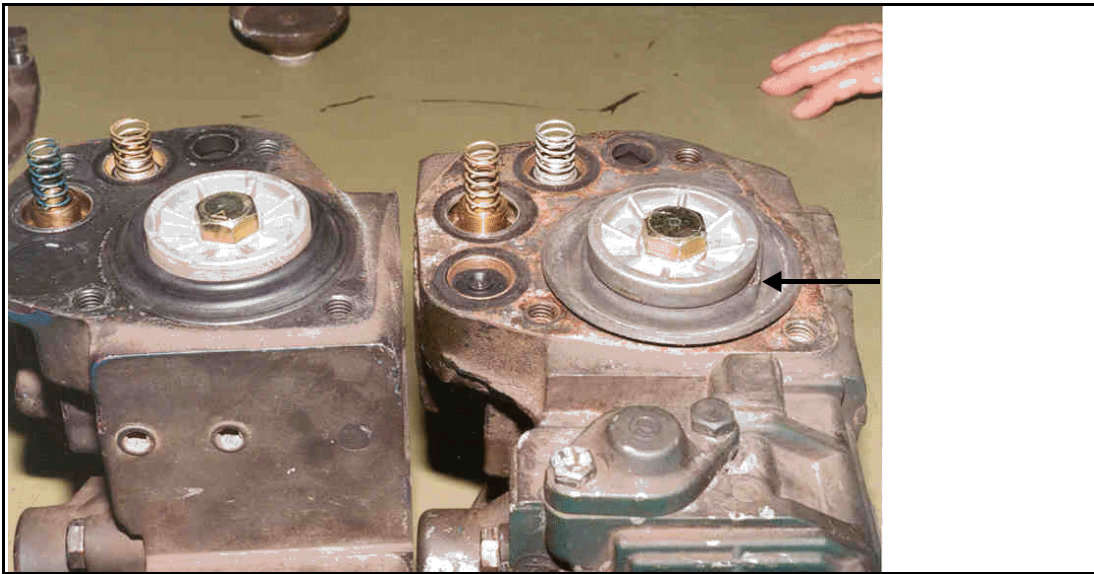
The 11<sup>th</sup> car, a centre beam flat car loaded with lumber, SRY 873090, was equipped with an air brake control valve that was comprised of a type DB-10 service valve portion and a type ABDW emergency valve portion. The service portion was damaged beyond serviceability in the derailment, which precluded testing. Post-recovery examination of the service portion revealed that there were no internal defects. The valve had been installed as a reconditioned valve in March 2000. The car passed the single car test requirements at that time. The TSB Engineering Laboratory had the ABDW emergency portion of this valve tested on an AAR-approved AB test rack at a certified air brake shop (report LP 028/01). In addition to having severe leakage problems, the emergency portion failed several requirements of the AAR-prescribed AB rack testing, including having repetitive UDEs. The diaphragm, which seals the emergency piston in its operating chamber,

was ruptured approximately one inch (see Figure 2). This rupture negated the buffering effect that the diaphragm is designed to have on minor pressure fluctuations and resulted in repeated UDEs.

QETE determined that all of the "in-service" diaphragms that were analyzed were permanently deformed in either a crimped or inverted position, reducing their buffering capability and making the valves prone to UDEs. In addition, there were a significant number of creases and cracks which could also lead to failure. Analysis of the diaphragm from the 11<sup>th</sup> car determined that the tear followed a crease in the rubber coating that resulted from long-term compressive strain on the inside surface of the curve in this area. This resulted in cold flow of the rubber, and a reduction in the effective thickness at this location, predisposing the diaphragm to failure.

ruptured diaphragm could then have been removed. The ruptured diaphragm sensitized the emergency portion to small fluctuations in bpp, such as that experienced when the dynamic brake was applied rapidly on the train.
