RAILWAY INVESTIGATION REPORT

R00V0206

COLLISION

13 DECEMBER 2000

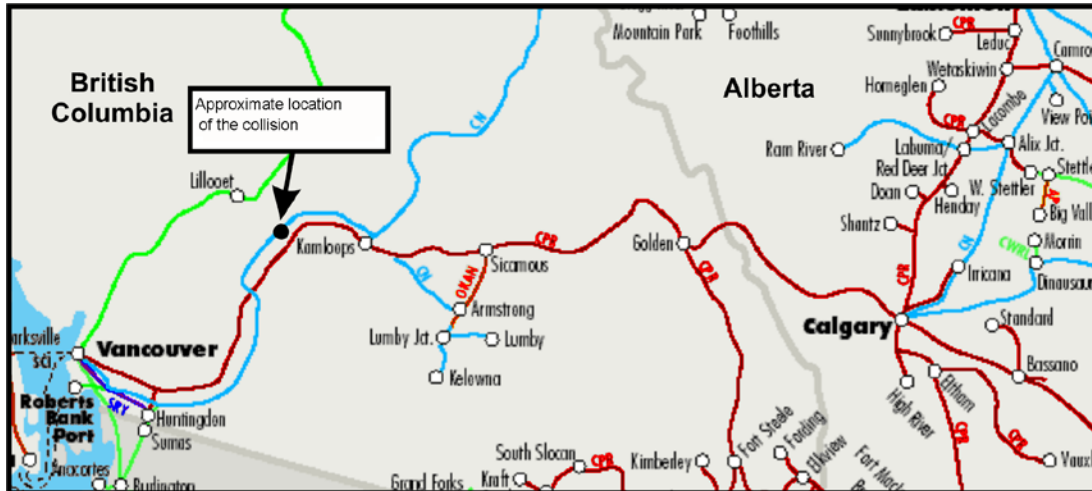
On 13 December 2000, at 0937 Pacific standard time (PST),¹ a Canadian National (CN) maintenance-of-way (MOW) crew received a track occupancy permit (TOP) from a rail traffic controller (RTC) to occupy the main track between Basque and Martel, British Columbia, on the CN Ashcroft Subdivision (Figure 1).

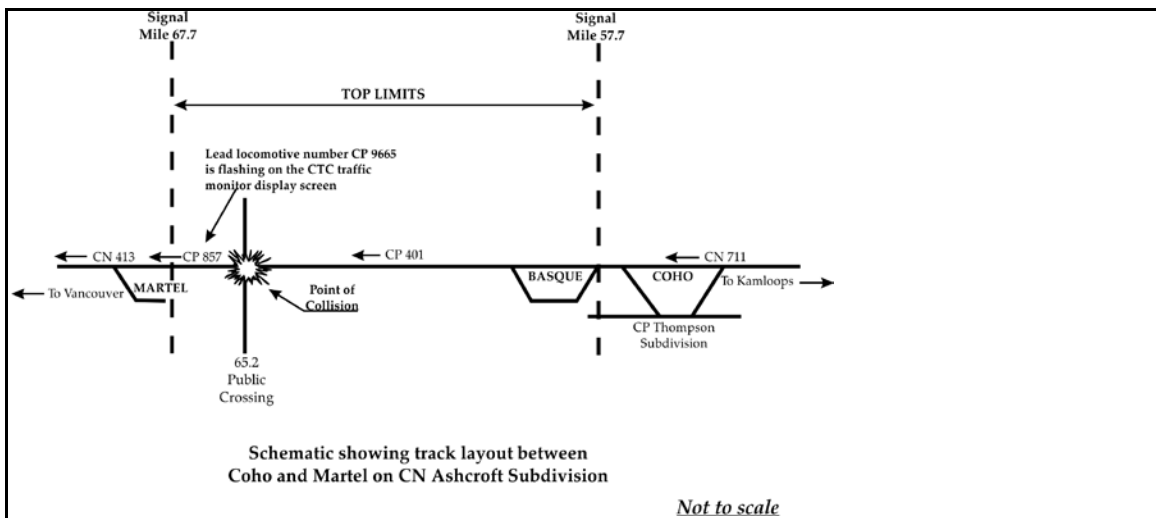
After a westward CPR train with lead locomotive No. CP 9665 (CP 857) cleared his location, the foreman reported the train's passing to the RTC at 1224. The RTC advised him that he could only have the main track for about 40 minutes, as another westward train (CN 711) would be approaching Coho at about 1310. The RTC then issued a TOP to the foreman to occupy the main track between Signal 577 at Basque and Signal 677 at Martel behind CP 9665 West (CP 857) that had left Mile 65.2 at 1224. The TOP also contained an instruction to call the RTC before 1310. The TOP was copied and repeated by the foreman and made complete by the RTC at 1227. All four MOW crew members, including the foreman, read and initialled the TOP, indicating that they understood its contents. Figure 2 depicts the area covered by the TOP limits.
