RAILWAY INVESTIGATION REPORT
R01H0005

DERAILMENT

OTTAWA VALLEY RAILWAY
TRAIN 301-043
MILE 85.0, NORTH BAY SUBDIVISION
BONFIELD, ONTARIO
12 MARCH 2001

Report Number R01H0005

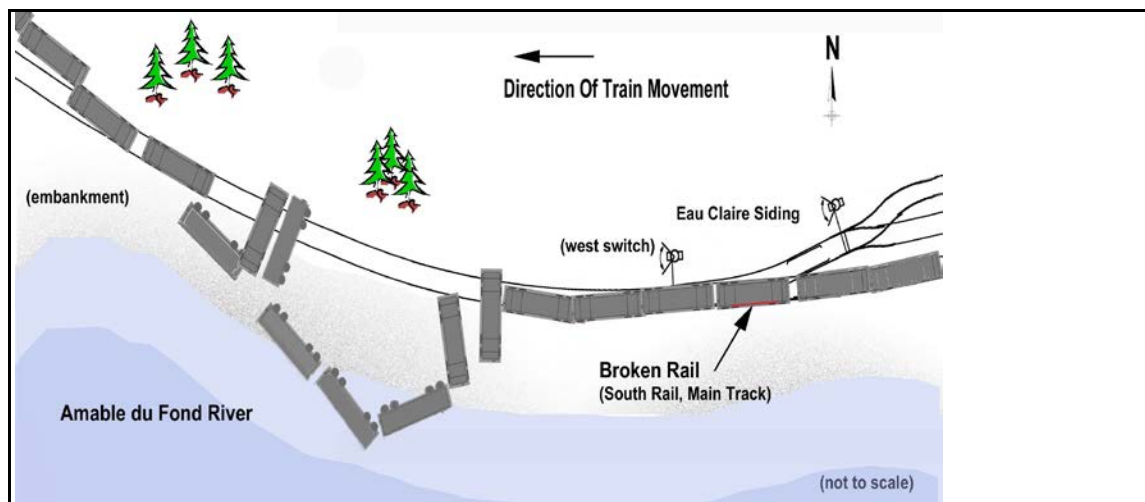
On 11 March 2001, train No. 301-043 (the train) departed Canadian Pacific Railway (CPR) Saint-Luc Yard (Montréal, Quebec) for Coniston, Ontario. At Smiths Falls, Ontario, the train was transferred to the Ottawa Valley Railway (OVR) and proceeded westward on the OVR North Bay Subdivision. At Mile 85.0, near Bonfield, Ontario, the train experienced a train-initiated emergency brake application. After conducting the necessary emergency procedures, the crew members determined that 14 cars (68th to 70th and 72nd to 82nd) had derailed. The derailed cars included one empty hopper car and three residue Class 111A tank cars (methanol, UN 1230) which rolled into the Amable du Fond River (see Figure 1). None of the cars was breached and no product was lost.

Approximately 500 feet (152 m) of track and a switch were destroyed. Two cars were destroyed and 11 cars sustained damage.

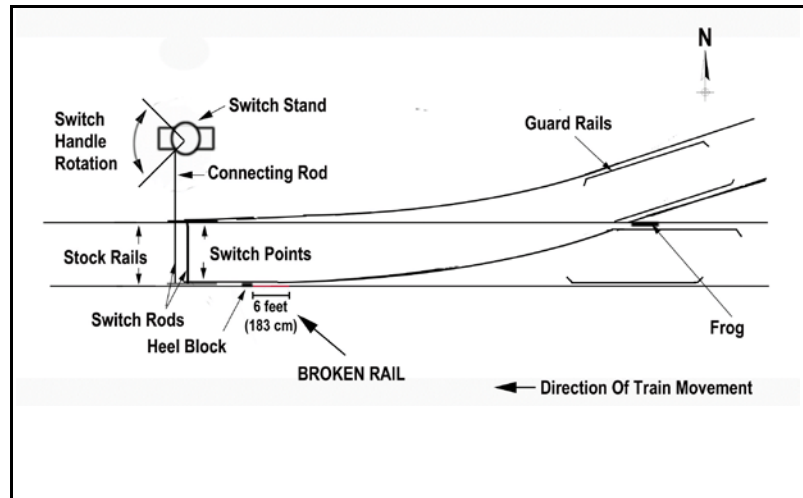
In the vicinity of the derailment, the track was adjacent to the Amable du Fond River and was oriented in an east-west direction. The derailment occurred in a 3-degree, 45-minute curve, near the west end switch of the Eau Claire siding (see Figure 2). The tie plates were secured with 8 spikes per tie in the turnout, and 10 spikes per tie in the rest of the curve. Several rail joints, within a short span, were present on the track east of the switch. The main track stock rail, on the west-end switch, was broken into many pieces over a distance of approximately 6 feet (183 cm). The break extended westward, from a bolt hole located 10 inches (25 cm) west of a rail joint, to the switch point heel block. The rail ends at the joint were battered and exhibited material flow.

The OVR relocated the Eau Claire turnout from its location in curved track onto tangent track.

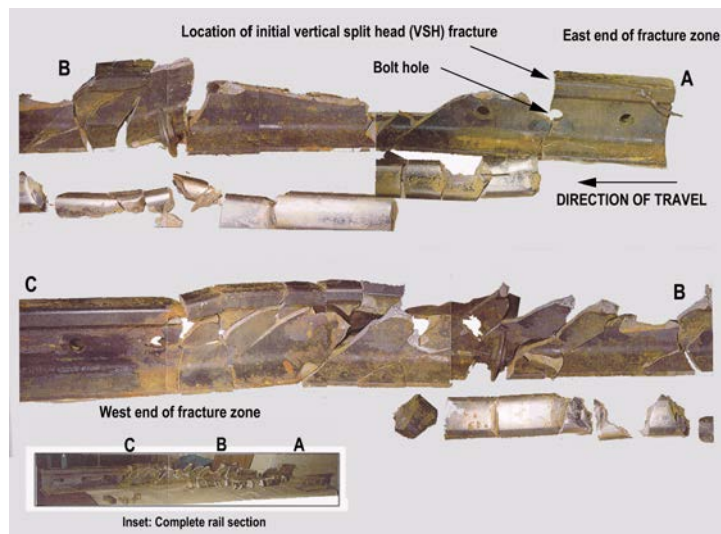
- The rail was made of chromium alloy.¹
- The ultimate tensile strength (UTS) of the rail averaged 165 000 psi, while its elongation was 9.0 per cent. The minimum rail properties specified by CPR are 155 000 psi for UTS and 9.0 per cent for elongation.
- The resistance of the rail to breakage, measured using Charpy impact testing, was 2 to 3 foot-pounds.
- The break occurred 10 inches (25 cm) from the rail joint, through a bolt hole (see Figure 3). The rail head had broken along the centre line consistent with a vertical split head (VSH) fracture.
- Chevron markings indicated that the fractures initiated from the top of the rail surface.
- No long-term cracking was observed, indicating that the VSH fracture was recent.

The rail head broke along the centre line, consistent with a VSH fracture initiated from the top of the rail surface. As the fracture was recent, it was not detected by the ultrasonic rail flaw detection test performed seven months prior to the derailment.

The Charpy impact test values and elongation results for the broken rail indicated a low fracture toughness and rail ductility. These results are consistent with other chromium alloy rail properties, and indicate that the ability of the rail to withstand high transient loads, particularly in cold weather, was limited. Therefore, it is likely that the stresses generated by the wheel R-1 impact load, combined with the tensile thermal stresses due to the low temperature, initiated the break in the main track rail.

The frequency of rail flaw detection on all main track rail has been increased to three times per year.

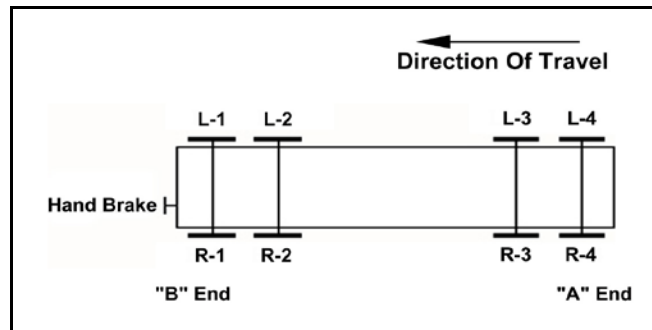
The wheels (see Figure 4) of the leading truck of car CPWX 601303 were examined and the following observations were made.

- All wheels exhibited built-up tread.
- The shells on wheel R-1 spread over a length of 5.75 inches (146 mm), a width of 1.6 inches (40 mm) and a depth of between 0.06 and 0.18 inches (1.6 and 4.5 mm). The shells on wheel L-2 spread over a length of 12 inches (300 mm), a width of 1.6 inches (40 mm) and a depth of between 0.056 and 0.16 inches (1.4 and 4.1 mm).
- The height of the wheel flange on wheels R-2 and L-2 was $1^{15}/_{16}$ inch (49.2 mm).
- Both wheel R-1 and wheel L-2 contained a flat spot $2\frac{1}{2}$ inches (63 mm) long.
- The maximum out-of-round measurements were 0.115 inches (2.9 mm) for wheel R-1, 0.013 inches (0.51 mm) for wheel R-2, and 0.185 inches (4.7 mm) for wheel L-2.

Out-of-round and flat spot measurements for wheels R-1 and L-2 reached or exceeded Association of American Railroads (AAR) limits.² The flange height on wheels R-2 and L-2 exceeded both Transport Canada (TC) and AAR limits. Relevant AAR and TC allowable limits for freight car wheels are contained in Appendix A.

All examined wheels from car CPWX 601303 had built-up tread; moreover, wheel R-1 had a flat spot and an out-of-round condition exceeding AAR measurement limits. Such conditions would have resulted in high impact loads adversely affecting the rail and equipment. Furthermore, the frozen ground and the presence of several joints within a short span of track increased the stiffness of the track structure and reduced its damping effect, causing the rail to absorb the full wheel impact loading.

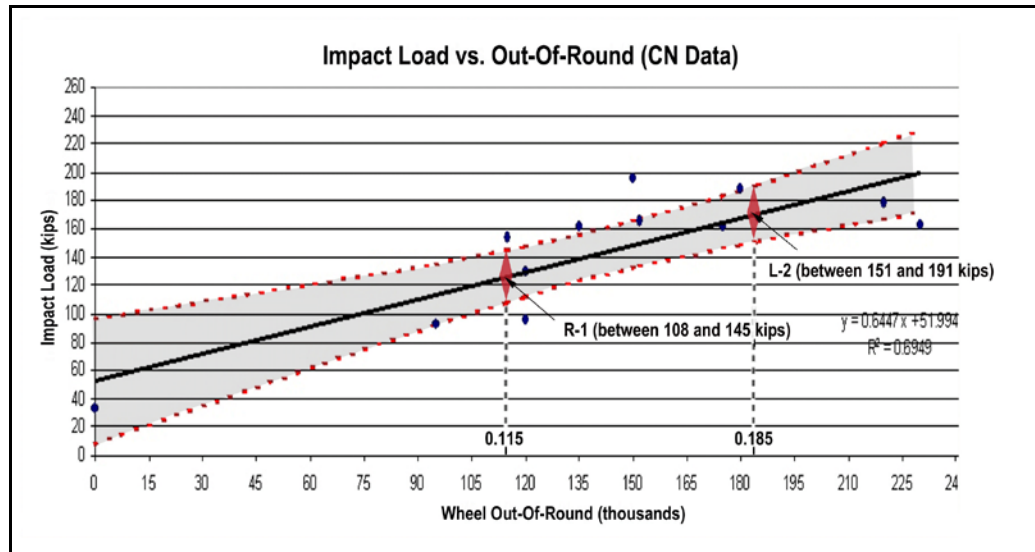
A 1994-1995 study established a correlation between WILD data and out-of-round wheel measurements. The impact loads generated by the wheels of car CPWX 601303 were interpolated using data from this study (see Figure 5). The interpolation shows that, when a 95 per cent confidence interval was used, the impact loads

would have been between 108 and 145 kips (108 000 and 145 000 pounds) for wheel R-1 (out-of-round value

0.115), and between 151 and 191 kips (151 000 and 191 000 pounds) for wheel L-2 (out-of-round value 0.185).

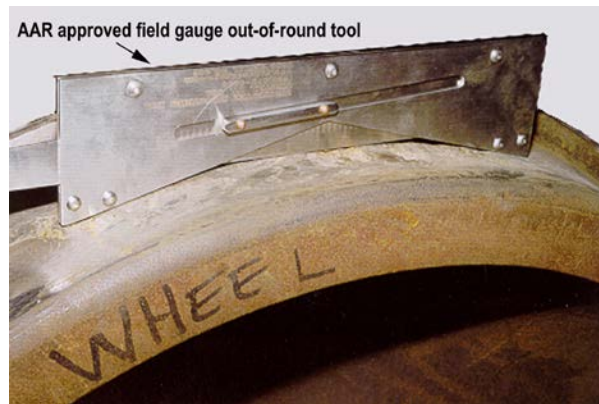
The purpose of safety inspections, performed by a certified car inspector, is to ensure that cars are deemed reasonably safe prior to allowing them to proceed down the track. During a safety inspection, each component of a car is examined and checked with measuring devices and gauges, when required. Defects such as shells or spalls can be identified visually; however, when they are healed (when metal flows into the spall cavities), they can only be identified by WILD systems. The detection of out-of-round wheels requires precise measurement at three locations using an out-of-round gauge (see Photo 1), or the use of WILD systems.
