RAILWAY INVESTIGATION REPORT

R02M0050

MAIN-TRACK DERAILMENT

MILFORD, NOVA SCOTIA

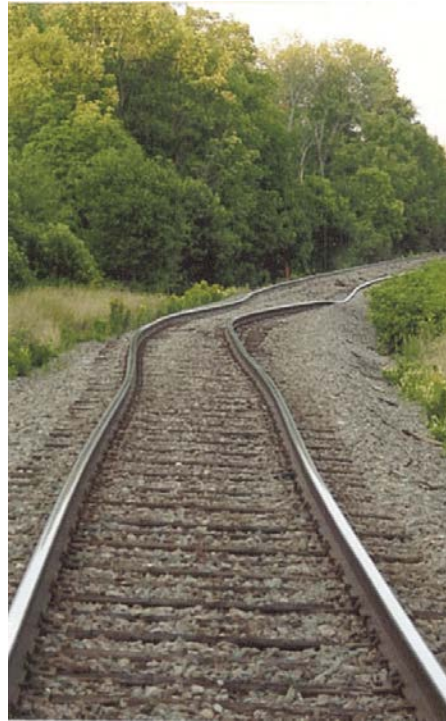
Canadian National (CN) freight train No. Q13711-13 (the train) departed Halifax, Nova Scotia, at approximately 1410 Atlantic daylight time,¹ travelling westward destined for Montréal, Quebec (see Figure 1). The operating crew consisted of one locomotive engineer and one conductor both located in the lead locomotive. They were qualified for their respective positions and met fitness and rest standards. As the locomotives passed Mile 42.60, a train-initiated emergency brake application occurred, bringing the train to a stop at Mile 42.90. After conducting the necessary emergency procedures, the train crew determined that seven container platforms on the last two five-pak container cars were derailed in an upright position on the right-of-way. There was approximately 2.85 miles of damaged track. A track buckle was noted at Mile 38.85 (see Photo 1).

The first derailed wheel marks were approximately 45 feet west of the initial indications of the lateral shift in the track structure (i.e. Mile 38.85). At that location, the track structure had shifted approximately 18 inches to the outside of the curve. There was no sign of any appreciable spike lift for the first 35 feet. Track destruction in the derailment zone precluded the identification of any signs of pre-derailment track conditions (e.g. rail creep). The train crew did not see or otherwise detect any problem with the track structure when the locomotives passed over that location.

- surveyed track geometry in the area;
- undercut the track to remove the excessive ballast conditions;
- removed some excessive superelevation; and
- distressed the rail.
