RAILWAY INVESTIGATION REPORT

R02V0057

MAIN-TRACK COLLISION AND DERAILMENT

CANADIAN PACIFIC RAILWAY

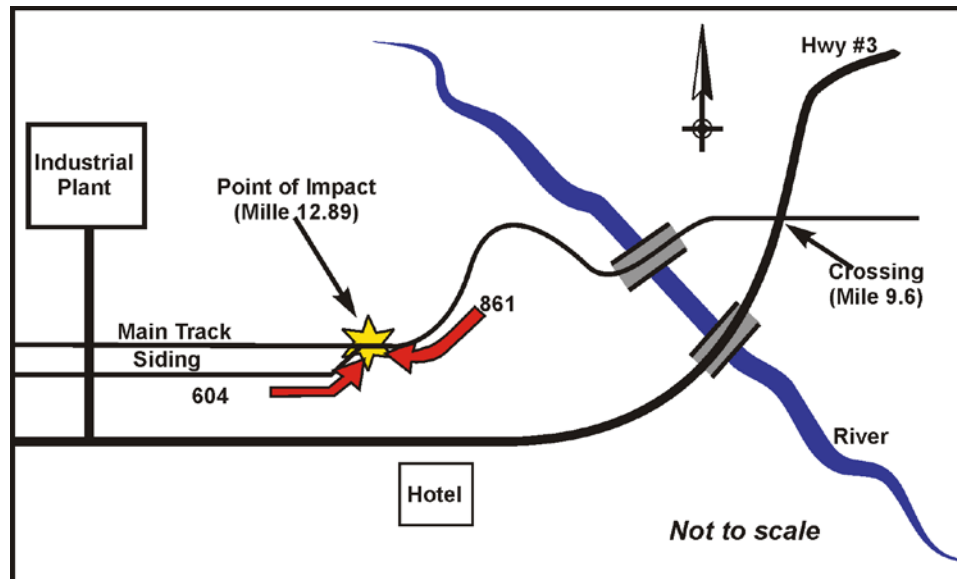
At approximately 0255, while proceeding westward at 20 miles per hour (mph), the crew of train 861 observed train 604 foul of the main track at the west end of the Natal siding and placed the train brakes in emergency. Train 861 side collided with train 604 at Mile 12.89 at a speed of about 14 mph. After striking train 604 and pushing it back 53 feet, train 861 came to a stop in approximately 100 feet. The conductor suffered minor injuries as a result of the collision. There was no one on train 604 at the time (see Figure 1 for a schematic of the collision area).

The train had been moved eastward about 121.5 feet and left just foul of trains travelling on the main track. The hand brakes remained applied on the 2 locomotives and the 12 lead cars during this movement. In the absence of a wayside signal system, the crew of train 861 had no advance warning that a train was foul of the main track.

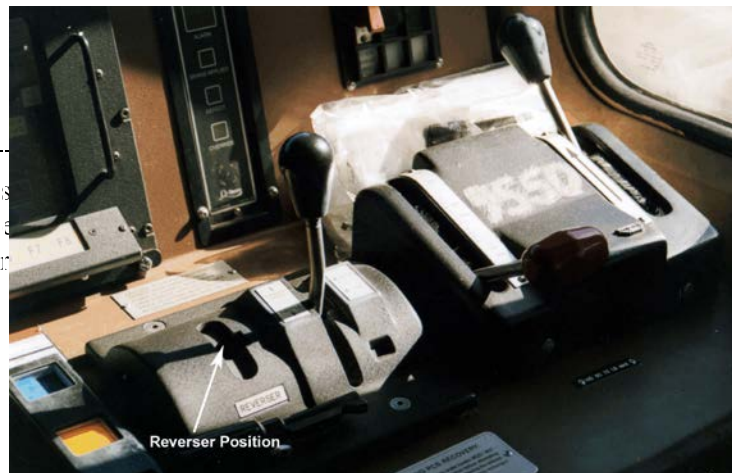
The reverser mechanism that controls the forward and reverse movement of locomotives is located inside the control stand. The locomotive control stand is an area upon which the air brake controls, reverser handle, throttle and dynamic braking control are mounted within convenient reach of the locomotive engineer. Air gauges and some control switches are also located on the control stand. Some control stands are oriented vertically beside the locomotive engineer, as opposed to the desktop orientation which locomotive CPR 9550 used.

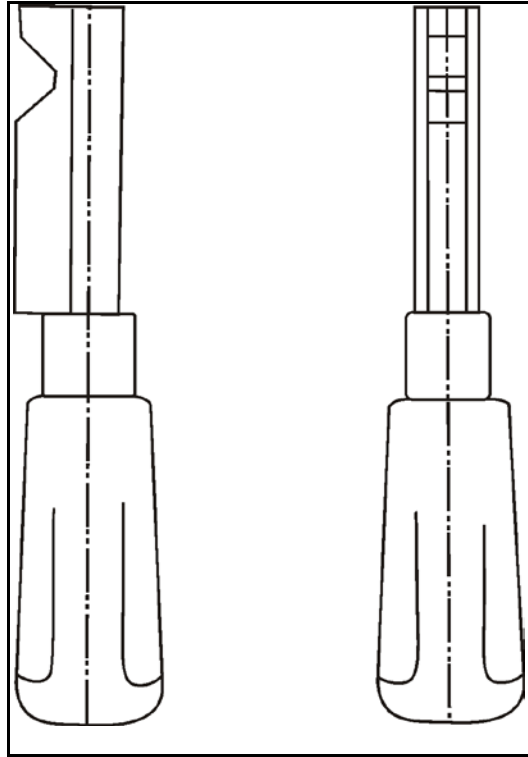
The handle, as indicated in Figure 2, is to have a round shape. It is designed to be the key to lock and unlock the reverser mechanism. The standard states:

The reverser handle must be inserted before the throttle handle may be moved out of "IDLE" or the dynamic brake handle may be moved out of the "OFF" position. When the reverser handle is removed, neither the throttle handle nor the dynamic brake handle may be moved out of the "IDLE" or dynamic brake "OFF" positions, respectively.

Because the reverser handle is to act as a form of key for locomotive operation, all Canadian railways require that it be removed from the control stand when the locomotive is left unattended. The reverser mechanism has an internal locking/release pin that is activated by insertion of the AAR standard handle, and intended to facilitate the key function. Informal interviews with a number of locomotive engineers indicated that, in extenuating circumstances, where a reverser handle had been forgotten, they had personally, or knew of someone who had, operated the train with a makeshift reverser handle.

Thirty-nine reverser mechanisms from General Motors and General Electric locomotives, which were manufactured since the 1950s, were examined under controlled conditions to determine if the reverser mechanisms could be activated with anything other than the standard reverser handle. Various items were inserted into the reverser control mechanism and the locking/release pin depressed in the same manner as a reverser handle. These items allowed the reverser mechanism on the control stand to be placed into either forward or reverse on 35 of 36 locomotives designed to use the AAR standard reverser handle. In addition, once the reverser mechanism was engaged with one of these items, the throttle and the dynamic brake on the majority of the locomotives tested could be operated in the normal fashion. On approximately half of the locomotives tested, after the foreign objects had been used to bypass the mechanism and were manipulated, the standard design reverser handle could be reinserted and operated in the normal fashion, without first having to manually return the locking/release pin to the normal position.
