RAILWAY INVESTIGATION REPORT
R03C0101

DERAILMENT

CANADIAN PACIFIC RAILWAY
TRAIN CP 269-21
MILE 10.75 MOYIE SUBDIVISION
NEAR CRANBROOK, BRITISH COLUMBIA
24 OCTOBER 2003

Report Number R03C0101

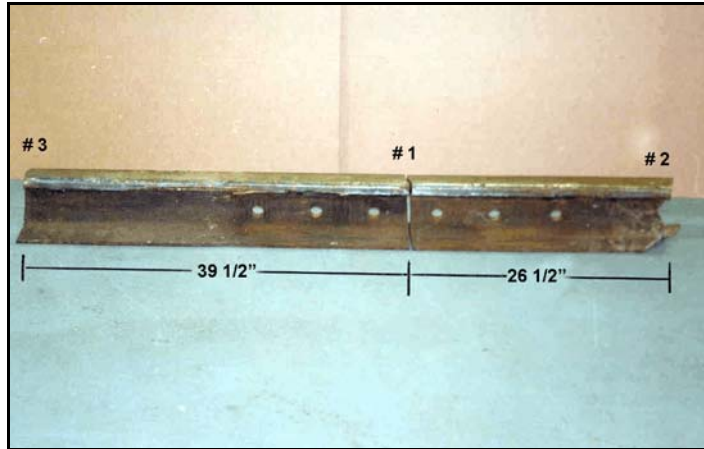
Two broken rails, totalling 67 inches in length and including a six-hole, fully bolted joint bar, were found in the ballast section on the high (north) side of the curve. The joint connected two pieces of rail, one 40 inches long on the west end and one 27 inches long on the east end. The joint connecting the broken rails had been installed as a temporary repair of a broken rail on 07 October 2003. CPR's policy regarding movement over broken rails specifies the conditions that permit train operations over broken rails and the actions to be taken in such situations. Although the joint bars were applied on the broken rail, a decision was taken by the track maintenance supervisor not to apply a temporary slow order of 10 mph or inspect each passing train as required by railway procedures.

The 67-inch section of rail was analyzed in CPR's Winnipeg Test Department with personnel from the TSB of Canada observing. The cause of the October 7 rail break was observed to be a 7/8-inch deep detail fracture due to shelling, which spread from the gauge corner of the rail.

Photo 1. # 1 – Original break secured by joint bars
2 - Secondary failure
3 – Point of derailment rail failure

Both ends of the 67-inch rail section, which contained the earlier break, also displayed transverse detailed fractures from shelling. The fracture at the east end had a visible defect that reached a depth of ½ inch, or about 5 per cent of the rail head’s cross-section. A brittle fracture originated from the boundary of the defect and spread through the remainder of the rail’s cross-section. Since there was no rail end batter, this fracture was identified as secondary, resulting from abnormal loading following the derailment.

The fracture surface at the west end of the 67-inch rail section displayed a defect that reached a depth of 1 ¾ inches. The majority of the fracture surface was polished, indicating that the failure occurred under load and that the fracture surfaces were subjected to subsequent dynamic loads. This fracture was determined to be the point of derailment (POD), since it extended from the gauge corner of the north (high) side rail and resulted in the rail’s failure. This failure subsequently led to the derailment.

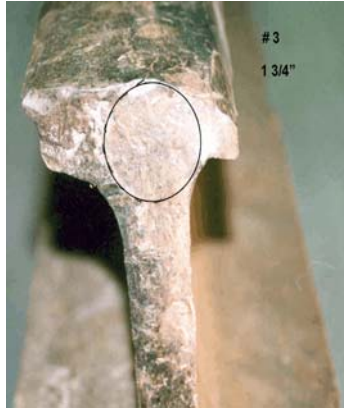
Photo 2. Transverse detail fracture

The shelling, cracking and checking on the gauge corner of the rail head indicated contact fatigue due to overstressing of the rail under traffic. As the rail wears with tonnage over the surface, the wheel/rail contact geometry creates excessive stresses that cause rail-surface plastic flow and surface fatigue (spalling,¹¹ shelling and head checks). This also increases the internal stresses in the rail, which gives rise to transverse defects within the rail head. An examination of the derailment rail revealed that the train derailed due to a pre-existing transverse detail fracture defect in the north (high) side rail of the 6° left-hand curve. The detail fracture defect resulted from shelling that started at the gauge corner and spread transversely 1 3/4 inches into the rail head.

1. The train derailed when the high rail in the curve broke due to a transverse detail fracture defect.
2. The detail fracture defect resulted from shelling that started at the gauge corner and spread transversely 1 3/4 inches into the rail head.
3. The lack of rail grinding programs on the Moyie Subdivision allowed rail-surface and sub-surface defects to grow, and the absence of a smooth, clean rail surface then limited the effectiveness of ultrasonic testing in detecting internal defects.

3. CPR has implemented an annual rail grinding program on the Moyie Subdivision.

5. Following the incident, ultrasonic rail testing on the Moyie Subdivision was increased to three times each year, and in 2005, CPR will increase the frequency to four tests each year. New "B-Scan" technology will be used that will improve the ability to detect a larger number of smaller rail defects. Any rail test reliability parameters that may have dropped below CPR specifications due to rail surface conditions will be recorded in a database. This information will be incorporated into the rail grinding plan for these locations.

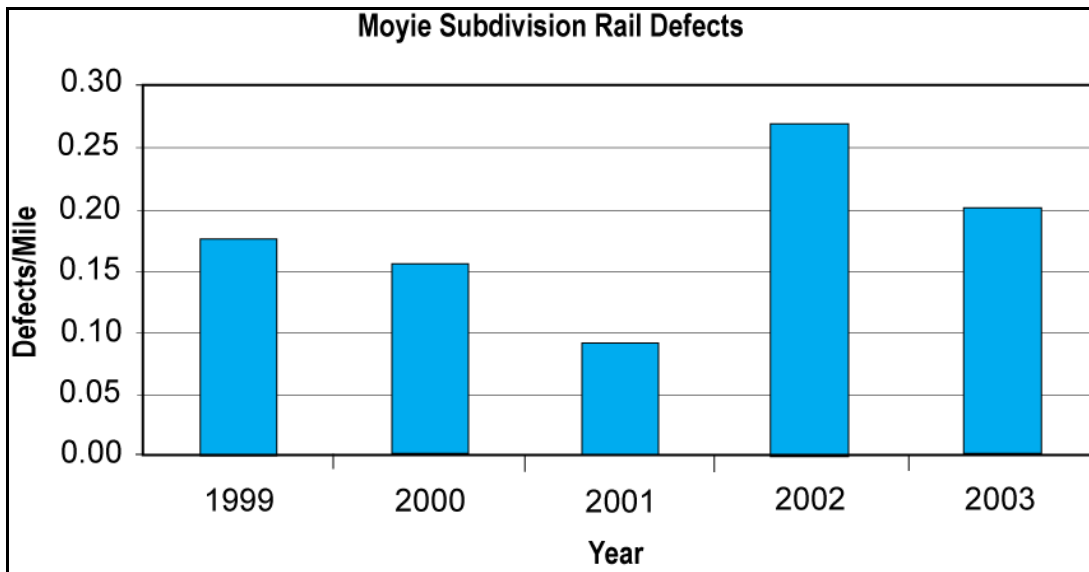
CP's rail flaw detection car had tested the Moyie Subdivision three times a year since 1999. For the years between 1999 and 2003, total annual rail defects identified were 25, 22, 13, 38 and 30, respectively. Defects per mile tripled between 2001 and 2002, with a slight decrease in 2003. The most recent ultrasonic test over this territory took place 35 days prior to the accident, on 19 September 2003; no defects were noted in the area of the derailment. In the area of the POD, the rail flaw detector car showed an intermittent response typical of a rail head surface condition. No further action was required of the rail test operator and none was taken. The chart below shows the five-year rail-defect history for the Moyie Subdivision.
