**RAILWAY INVESTIGATION REPORT**  
**R03V0019**

**DERAILMENT AND COLLISION**

**CANADIAN PACIFIC RAILWAY**  
**TRAIN 771-009**

**MILE 116.95, CASCADE SUBDIVISION**  
**PORT MOODY, BRITISH COLUMBIA**

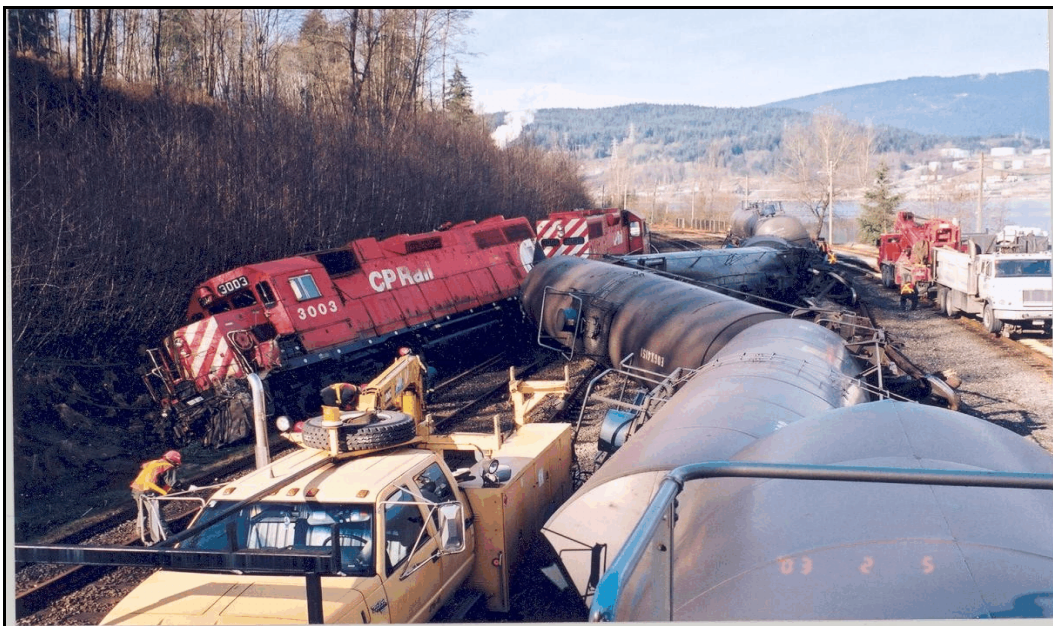
The north rail had subsided and created a reverse cross-level condition. This track condition resulted in a weight shift of rail cars as each wheel passed over the soft track, with the gauge progressively widening under the loads. The track gauge measured at the POD under static conditions was 58 1/4 inches (1 3/4 inches wide). Markings on the rail and ties indicated that the car travelled with the one wheel in a derailed state for approximately 900 feet, at which time the car dug into the subgrade causing two cars to jackknife to the south across the north and south main tracks.

**Photo 1.** View of accident site

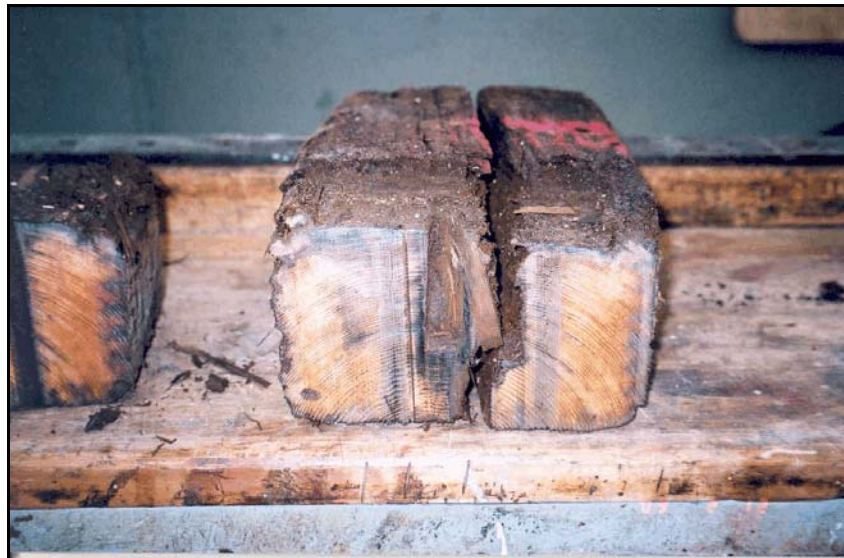
The 100-pound rail in the area of the derailment consisted of 39 feet of partly worn 100-pound RE-HF<sup>2</sup> rail manufactured by Algoma and rolled in 1943. The vertical head wear on the north rail was between 1/8 and 3/8 inch, and the vertical head wear on the south rail was between 1/8 and 3/16 inch. The flange wear was negligible. The rails were connected by 24-inch joint bars. Tie plates were 100-pound single-shouldered. Approximately 1 per cent of the plates were either bent or broken at the gauge side shoulder and were corroded from the combination of sulphur and sea air. The rail was fastened to No. 1 treated track ties with two track spikes on the gauge side and one spike on the field side at each plate. Examination of the track ties in the area of the soft track indicated that the ties were in poor condition, with tie plates cut into the field side as a result of the weight shift of the loaded rail cars (see Photos 2 and 3). Deformation in the spike holes indicated that there was lateral movement and the deteriorated ties could not hold the gauge within accepted tolerances.

**Photo 2.** Defective tie condition, track G-5

The condition of the ties and fastenings clearly indicated that the integrity of the track structure of track G-5 had been compromised. This condition rendered the track gauge susceptible to widening under the load of a passing train.

- A total of 450 ties were changed out on track G-5.
- Track G-5 was re-surfaced.
- A monthly inspection of the drainage adjacent to the Pacific Coast Terminals ship loader has been established.
- A local job aid, in the form of an inspection checklist, has been developed for all "other than main tracks" on the Vancouver Service Area.

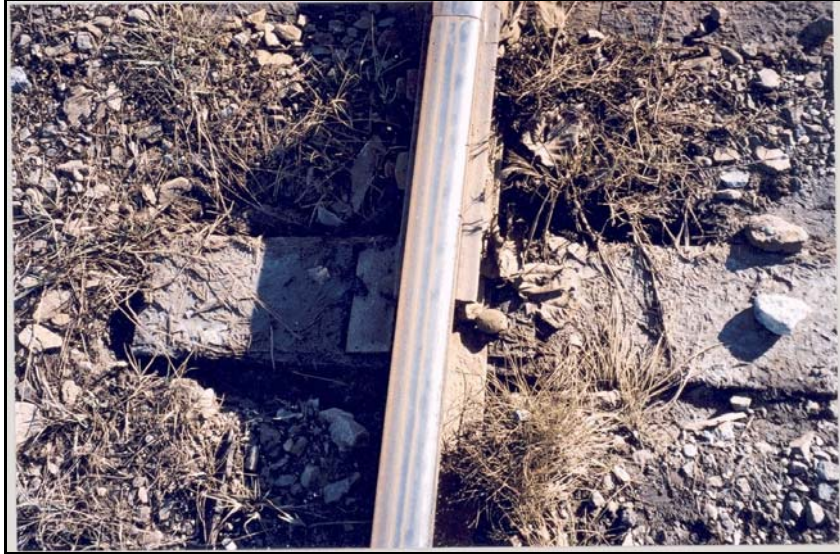
**Photo 3.** Fouled ballast on track G-5 in the vicinity of the derailment site

Rail anchors were in place at every third tie in the jointed section of track and every second tie on the CWR portion of track. The ballast consisted of crushed limestone and was fouled with fines (see Photo 3).
