RAILWAY INVESTIGATION REPORT

R03V0083

MAIN-TRACK DERAILMENT

CANADIAN NATIONAL

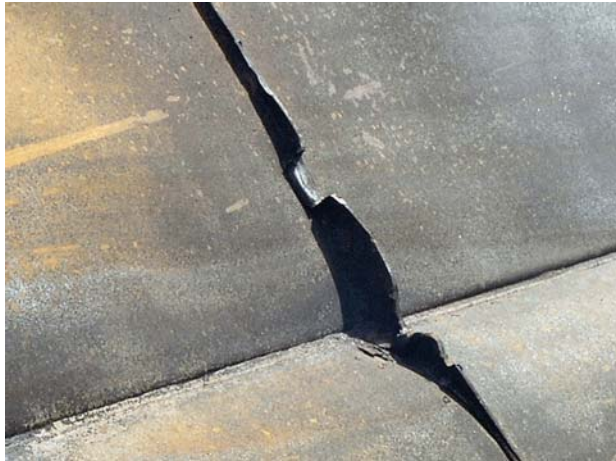
Marks on the left side of the lead truck of the lead locomotive showed the imprint of a rail head. There were marks on the bottom of the locomotive's pilot (snow plough) possibly caused by contact with the base of the north running rail. There were also rail head marks on the front end and on the front baffle plates on the underside of the fuel tank (see Photo 2). Abrasion marks were found on three traction motor gear casings on the leading truck. There were minor marks on the trailing traction motor gear case cover on the south side of the trailing truck of the lead locomotive. The minimum clearance between the top of the rail and the underside of the locomotive fuel tanks and traction motor gear casings for this type of locomotive is 6.25 inches.

Photo 2. Rail head marks on the baffle plate on the underside of the fuel tank
