## **RAILWAY INVESTIGATION REPORT**

**R04C0110**

### **CROSSING ACCIDENT**

**NEAR BLACKIE, ALBERTA**

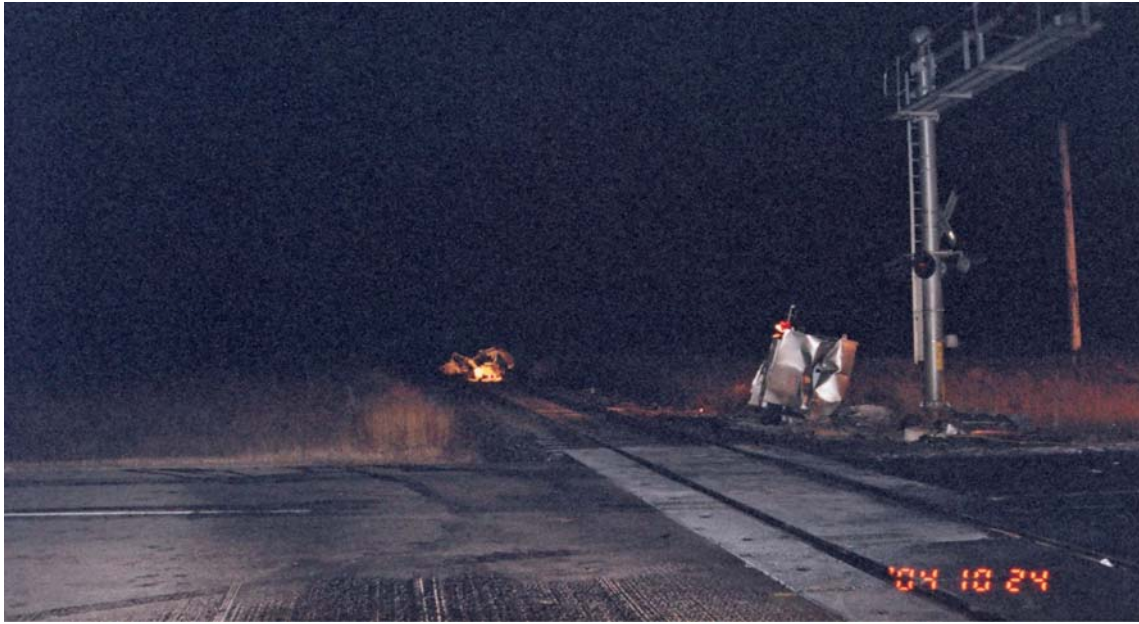
**Photo 1.** Looking south at the damaged signal bungalow and the tractor cab

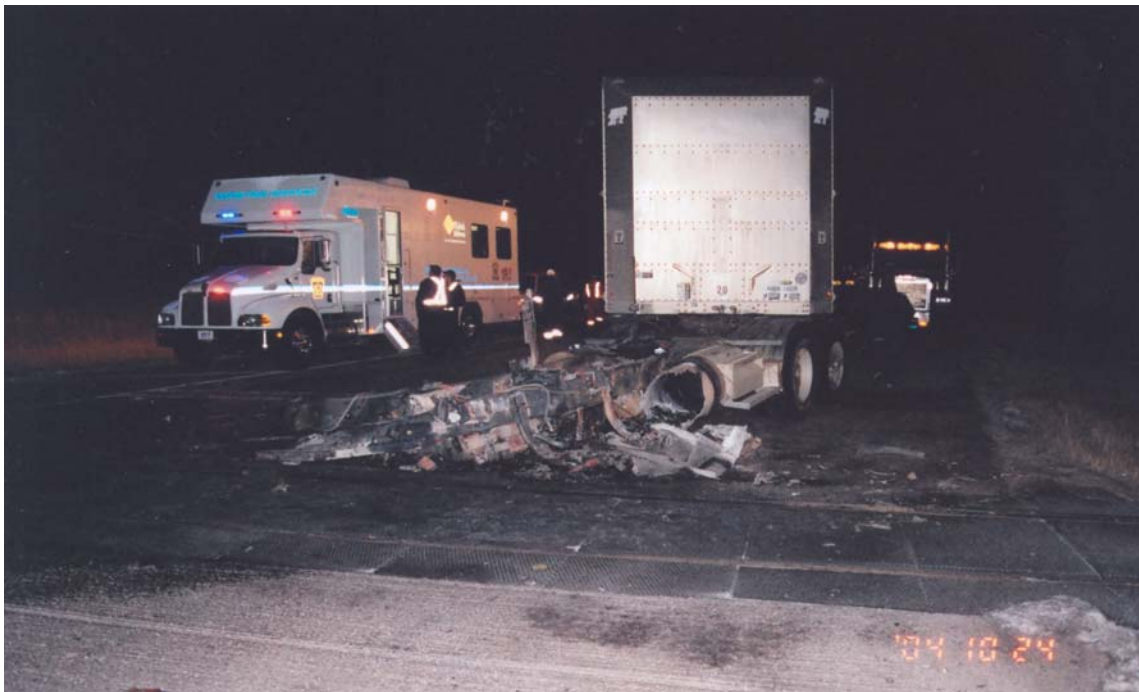
**Photo 2.** Looking west at the Highway 23 crossing, and the trailer and damaged tractor
