## RAILWAY INVESTIGATION REPORT

R04W0035

### YARD DERAILMENT

CANADIAN NATIONAL  
SYMINGTON YARD ASSIGNMENT YATS-02-17  
MILE 145.20 SPRAGUE SUBDIVISION  
WINNIPEG, MANITOBA  
17 FEBRUARY 2004

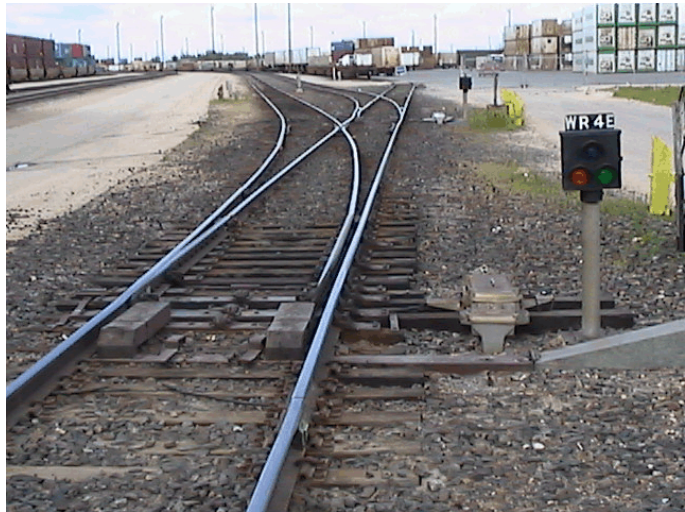
**Photo 1.** View looking westward into classification tracks at switch WR4E, Symington Yard (TSB photo) Switch aligned for movement into track WI03.

Belpack operator observed the adjacent track (WI03) to be clear. He brought the movement to a controlled stop on the switching lead track, just east of electric power switch WR4E (see Photo 1).

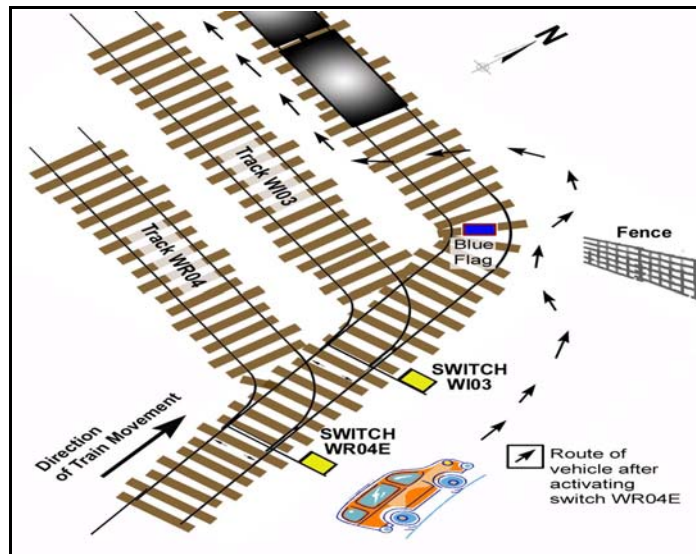
Figure 1. Symington Yard, West Receiving Tracks.

With the movement stopped, the vehicle drove eastward along the north roadway, then turned westward to stop alongside switch WR4E. The Belpack operator exited the vehicle and walked in front of it to switch WR4E. He pushed the button on the side of the switch stand to engage the power switch to line it for track WI03. The Belpack operator observed the switch points line for the intended route and believed that he had seen a green switch target light. The Belpack operator returned to the vehicle, waited briefly, and was then driven westward alongside track WI03, approximately 400 feet ahead of the movement (see Figure 1).

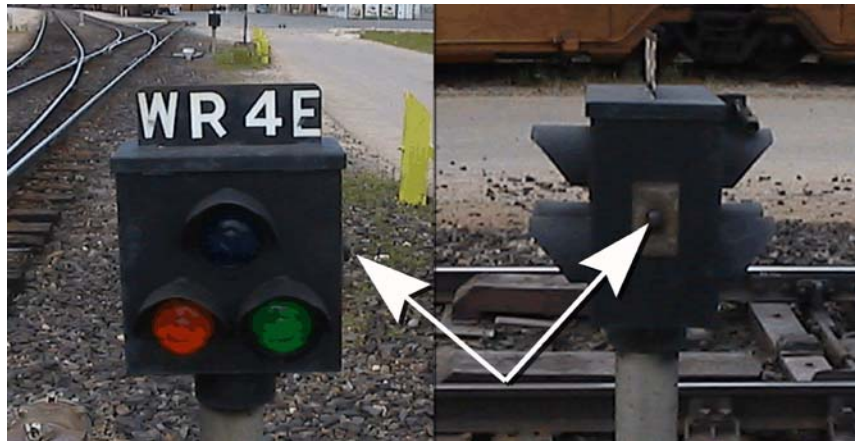
- 1124 - Switch WR4E was manually activated by push button to line it in the reverse position for track WR04. The yellow light of the switch target was illuminated indicating that the switch was in correspondence and locked for that route.
- 1141 - An eastward movement out of track WR04 was initiated. The movement reached a maximum speed of 15 mph.
- 1146 - The movement stopped just east of switch WR4E.
- 1148 - Switch WR4E was manually activated by push button to line it for track WI03 (see Photo 2). The switch target lights did not illuminate, indicating that the switch had not locked and that the switch was positioned at some point in mid-throw.

**Photo 2.** Two views of switch WR4E (left: looking west, right: looking south). Arrows indicate the location of the manual activation button. Switch target lights are not visible when standing to the north side of the switch, looking south.

The target lights are designed to be viewed from the point of an approaching movement. As such, each light is covered by a sun shade and located below the eye level of a standing switch operator. This design limits the ability of an operator standing beside the switch stand to observe the target light without stepping in front of the switch box.
