RAILWAY INVESTIGATION REPORT
R05C0049

ROLLING STOCK DAMAGE

CANADIAN PACIFIC RAILWAY

CAR NATX 77085

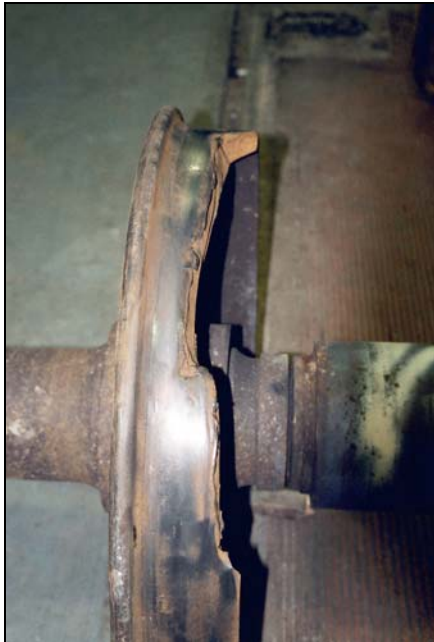
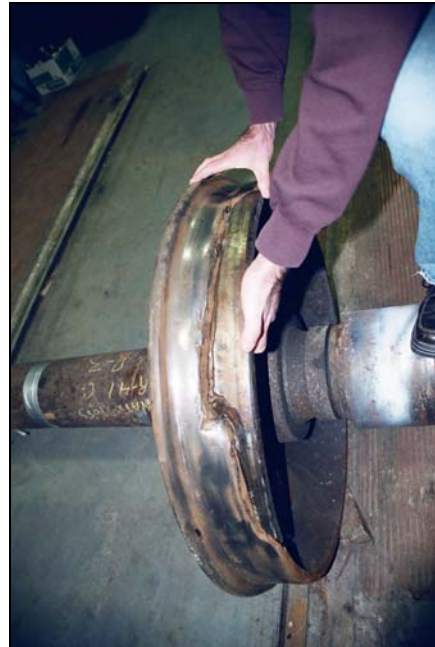
On 17 March 2005, CPR's test department, along with TSB investigators, examined the section of wheel and determined that it was a section of wheel tread measuring 27 inches long and 2 ½ inches at its widest point from the front face of the rim. A visual examination confirmed that the section of wheel tread mated with the reported R3 wheel on car NATX 77085 (see photos 1 and 2).

Photo 1. Matched rim section broken wheel

Photo 2. Broken wheel from car NATX 77085

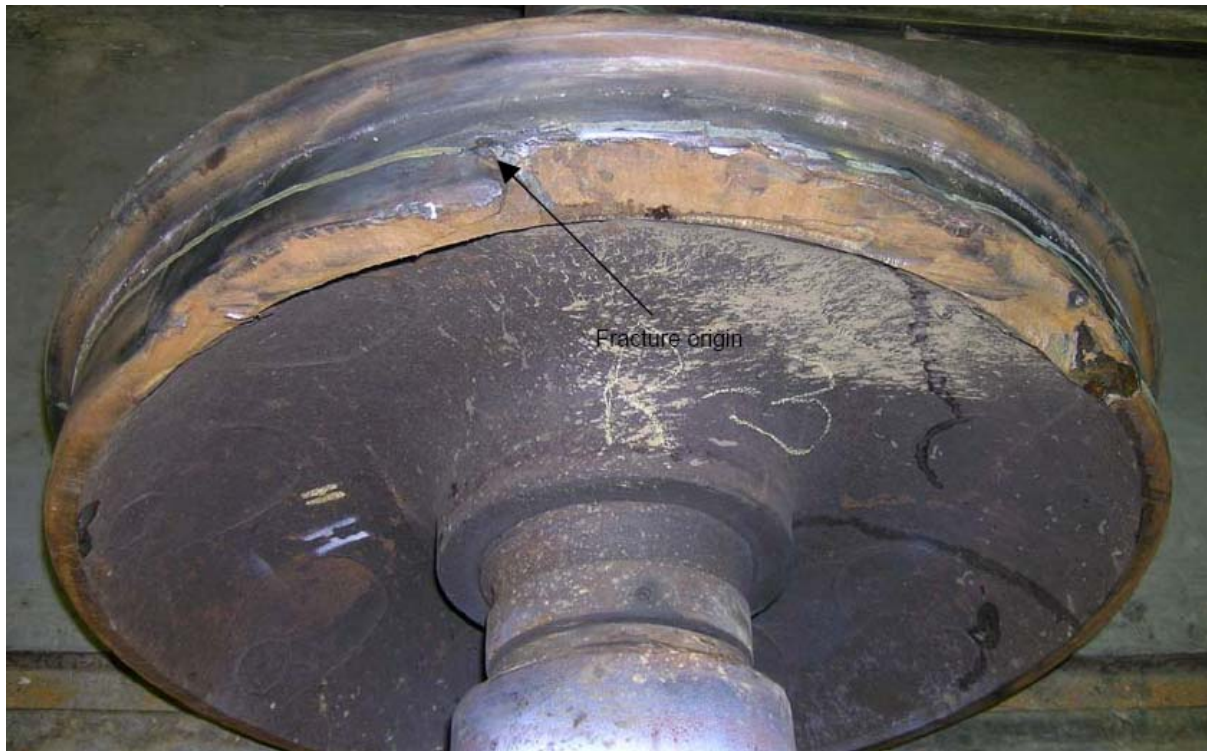
The inspection also noted a shell along the edge of the fracture, approximately in the middle of the tread surface. The shell measured approximately two inches in diameter, which was condemnable according to the Association of American Railroads (AAR) dimensional standards.²

Shelling on the running surface of wheels is a fatigue failure of the tread due to the repeated overstressing by high rolling contact fatigue.³ The sources of rolling contact fatigue can include heavy braking and heavy tractive effort on locomotives. Although the source of the shelling was not identifiable in this occurrence, the fracture initiated from the bottom of the shell and propagated in opposite directions perpendicular to the tread surface to an overall length of 27 inches until the piece separated from the wheel (see photos 3, 4 and 5).

Photo 3. Broken R3 wheel from car NATX 77085

1. Shelling on the R3 wheel of car NATX 77085 initiated a fracture that propagated in opposite directions perpendicular to the tread surface until the piece separated from the wheel.
2. Despite numerous opportunities to identify the defective wheel through the required manual inspections, the broken wheel was not identified until six days later.
3. Canadian Pacific Railway's (CPR) internal communication processes failed to alert field employees of the situation and did not result in a general heightened vigilance with respect to the hazard posed by the continuing operation of the defective car.

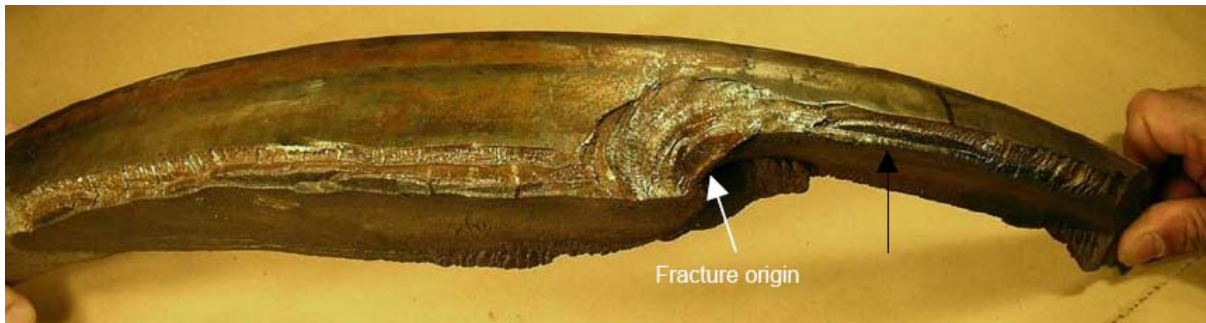
Photo 4. Recovered rim section

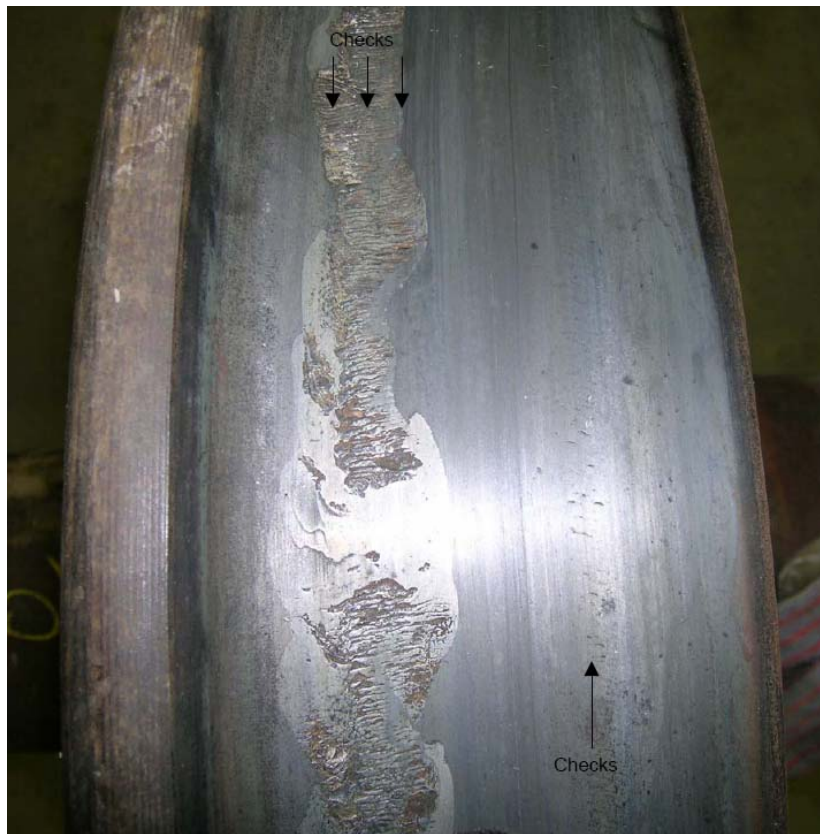
Photo 5. R3 wheel from car NATX 77085 – close-up of tread surface with two circumferential bands of heat checks
