RAILWAY INVESTIGATION REPORT
R05H0013

MAIN-TRACK DERAILMENT

CANADIAN NATIONAL
FREIGHT TRAIN U-78631-04
MILE 113.35, KINGSTON SUBDIVISION
PRESCOTT, ONTARIO
04 JULY 2005

Report Number R05H0013

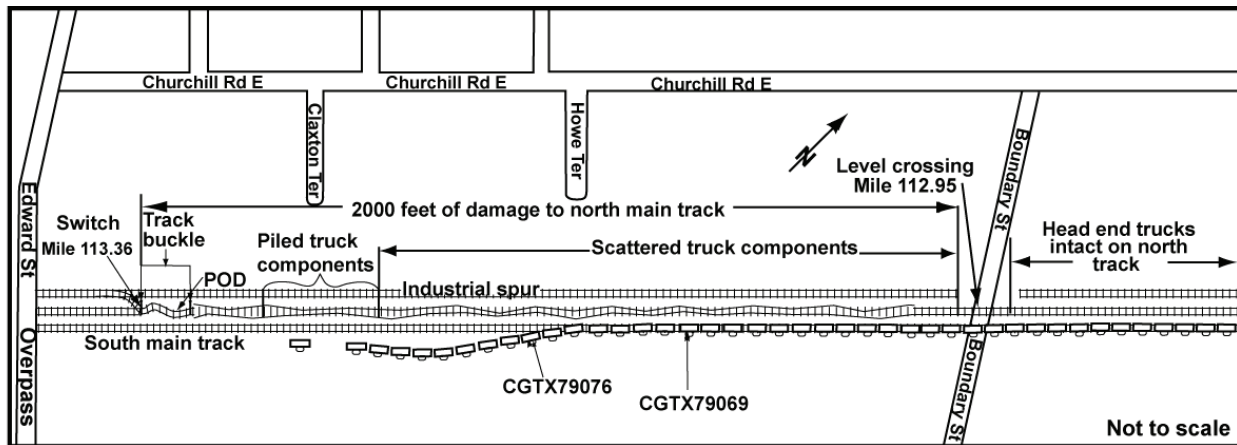
Figure 2. Derailment area diagram

The derailment zone extended between the turnout at Mile 113.36 and the crossing at Mile 112.95 (see Figure 2).

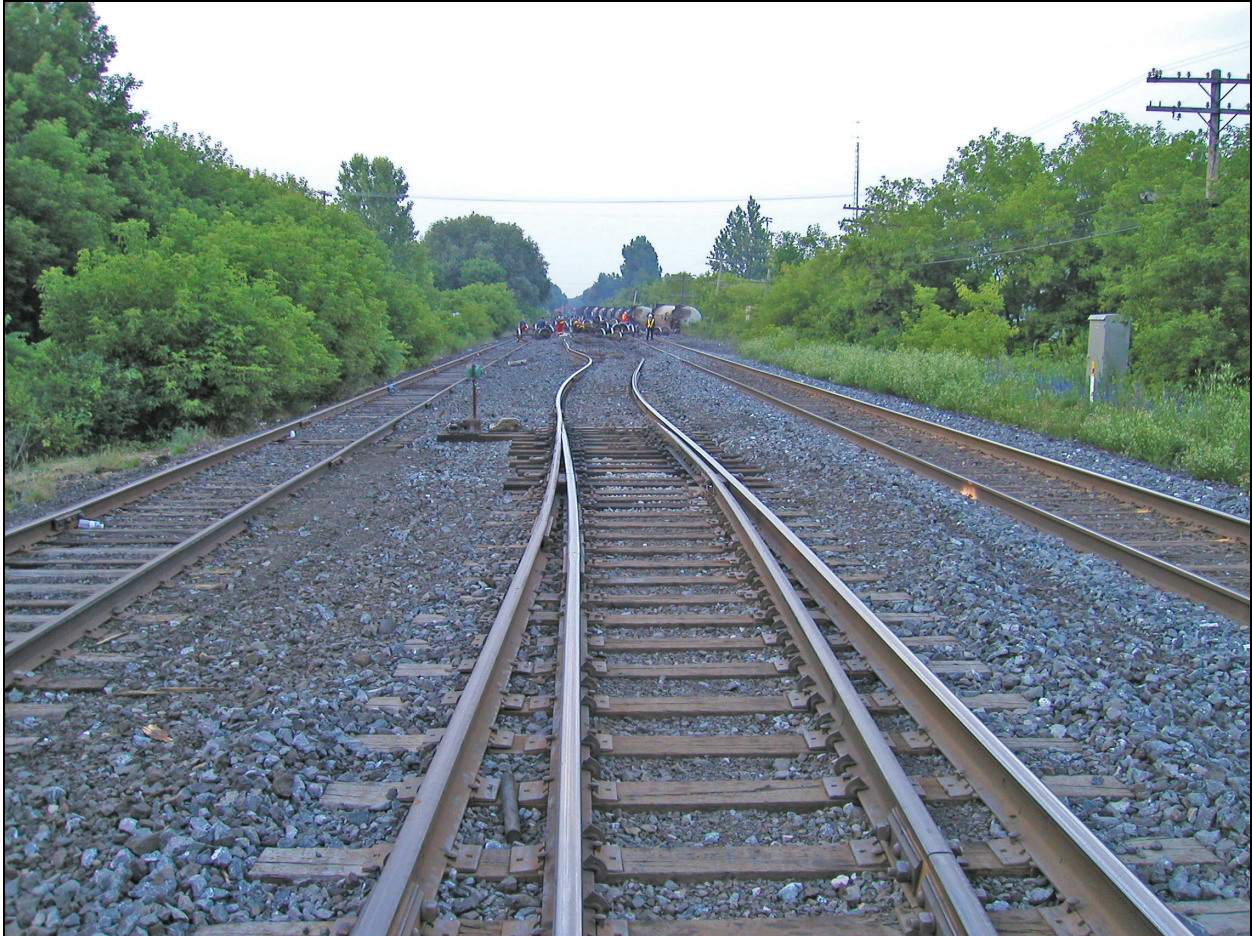
In the vicinity of the turnout, the track had shifted laterally up to 24 inches. The shift began 24 feet west of the switch point and extended eastward in an “S” shape for 133 feet (see Photo 1). A mark was observed on the top of the south rail, approximately 60 feet east of the switch point. Two feet from the mark and extending eastward for 30 feet, the gauge-side spikes and the rail anchors exhibited impact marks. Damage to the track structure extended for approximately 2000 feet, up to the public crossing.

Photo 1. Derailment zone showing the track buckle

The first wheel marks were observed on the rail head, spikes and anchors in the zone where a lateral deviation of the track was observed, ahead of the train. The lateral deviation, the S-shaped curve of the destroyed track, and the high ambient temperature on the day of the derailment suggest that the track was experiencing high compressive stresses, which led to track buckling.

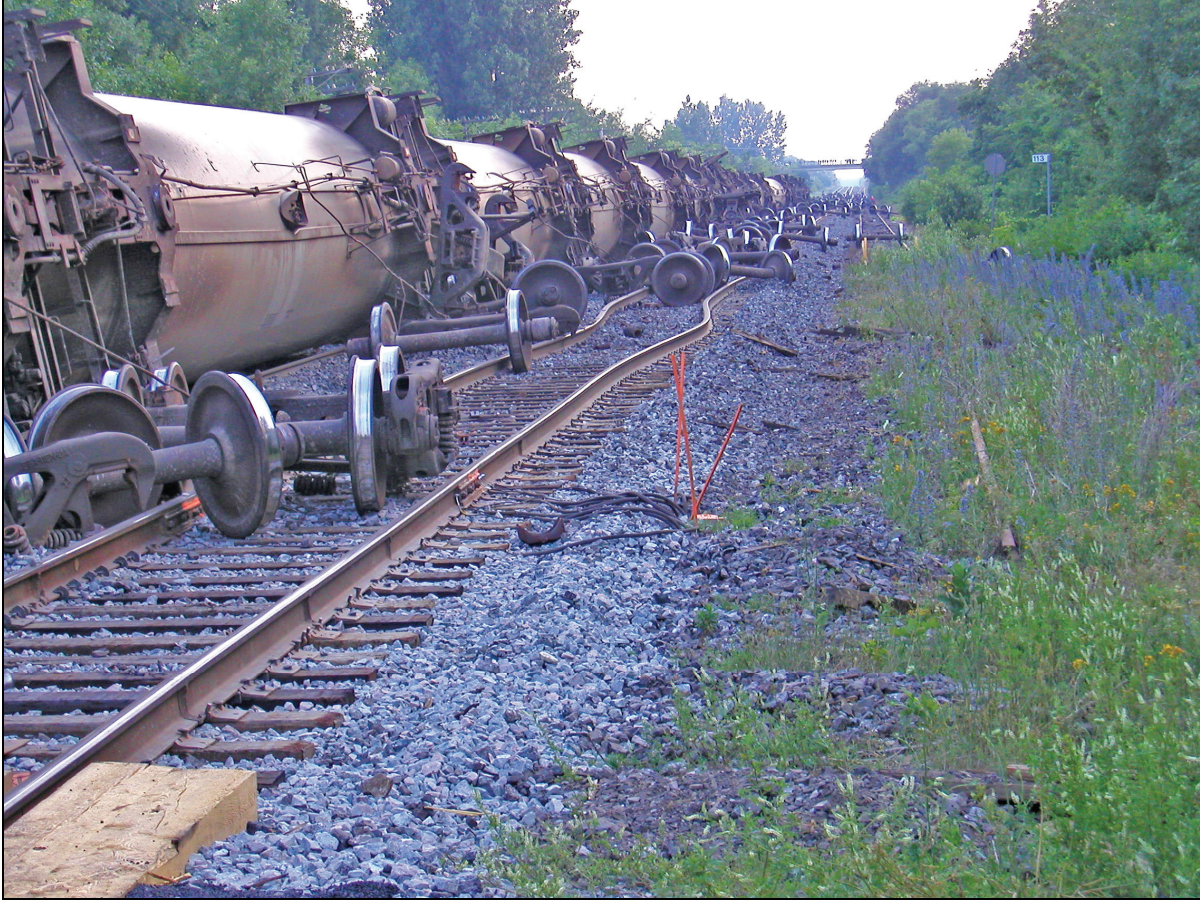
All derailed cars came to rest on their side. The last car of the train, which had uncoupled, came to rest at Mile 113.28, and the other 50 cars remained coupled to the locomotives. The 1st to the 21st cars (from the locomotives) were located east of the crossing, fouling the south track, while their trucks remained intact on the rails on the north track. The 22nd to the 39th cars were also lying on the south main track, but their truck components were scattered over the north portion of the right-of-way (see Photo 2). The remaining cars came to rest skewed south of the tracks, while most of their truck components were piled up about 250 feet east of the switch point.

Photo 2. Derailment site looking westward from the crossing
