RAILWAY INVESTIGATION REPORT
R06D0044

PEDESTRIAN ACCIDENT

AGENCE MÉTROPOLITAINE DE TRANSPORT
COMMUTER TRAIN 928
MILE 13.40, DEUX-MONTAGNES SUBDIVISION
ROXBORO-PIERREFONDS, QUEBEC
22 NOVEMBER 2006

Report Number R06D0044

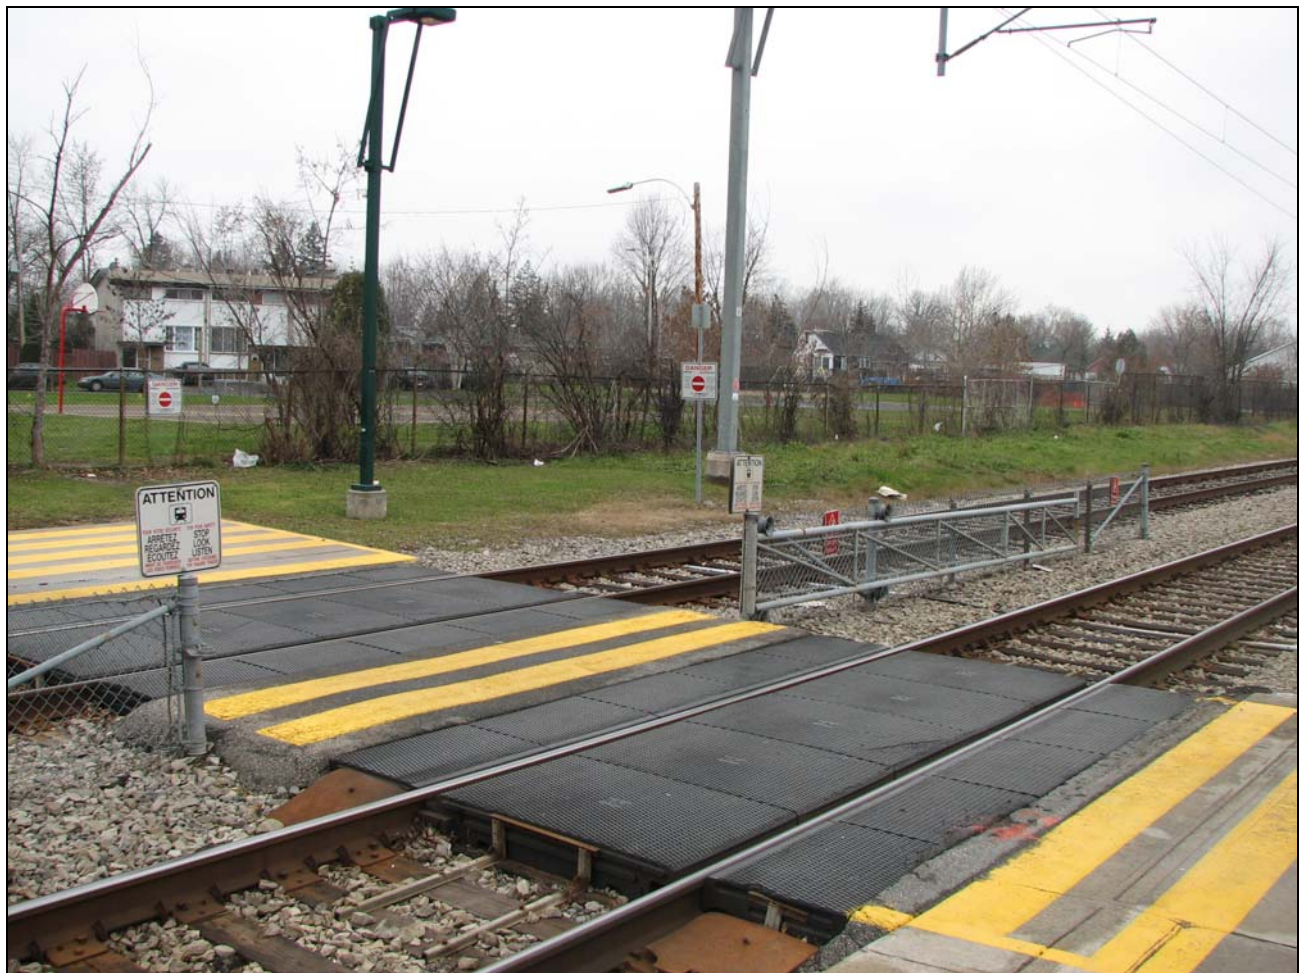
coming in. From the north end of the east platform, the view northward is partly obstructed by signs displaying information and restrictions and by the poles supporting surveillance devices, lights, and power lines. Rail Safety Information letter 06/06 on this matter was sent to Transport Canada on 11 December 2006.

There is a platform link at each end of the platforms, allowing commuters to move between the station's east and west platforms. The platform links cross the main track and siding at right angles. They are considered unrestricted access private crossings. They consist of rubber sheeting designed for road crossings (see Photo 1). They measure 22.5 feet long by 15 feet wide. There are no automatic protection devices to warn that a train is coming or to prevent commuters from crossing the tracks when a train is coming. Two signs are posted on the fence between the tracks, warning commuters to use caution when crossing the tracks.

Photo 1. Platform link at the north end of the Roxboro-Pierrefonds Station

The TSB sent Rail Safety Information letter 06/06 to Transport Canada on 11 December 2006 concerning the partial obstruction of the sightline from the east platform. In March 2007, Transport Canada confirmed that the railway relocated one sign to clear the sightline.
