**RAILWAY INVESTIGATION REPORT
R07M0017**

MAIN-TRACK DERAILMENT

**CANADIAN NATIONAL RAILWAY
FREIGHT TRAIN M-30711-02
MILE 123.5, NAPADOGAN SUBDIVISION
JUNIPER, NEW BRUNSWICK
03 MARCH 2007**

Report Number R07M0017

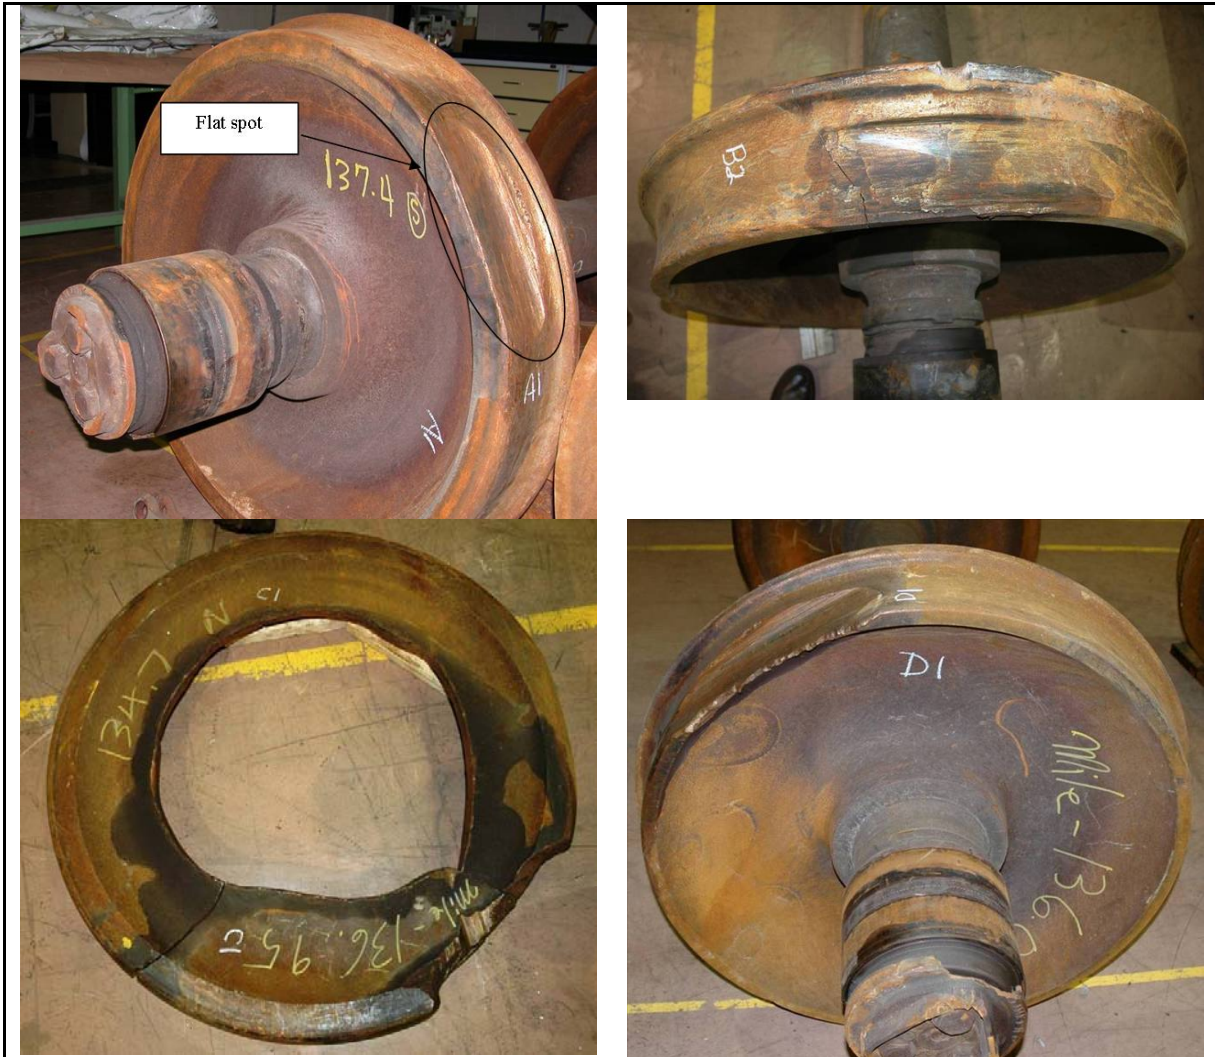
A review of the car's repair history did not indicate any unusual problems with its brake equipment or related running gear. The four damaged wheel sets from this car had large flat spots ranging from 12 to 16 inches in length and had sustained damage to the extent that the wheel plates and wheel rims were fractured (see Figure 2 and Appendix B for details). The wheel sets, broken fragments, brake control valves, handbrake, slack adjuster, and the retainer valve were sent to the TSB Engineering Laboratory for examination (Report LP 046/2007, *Examination of Wheel and Brake Components*. This report is available from the TSB upon request).

Figure 2. Four damaged wheel sets located at derailment site from car CRDX 7735.

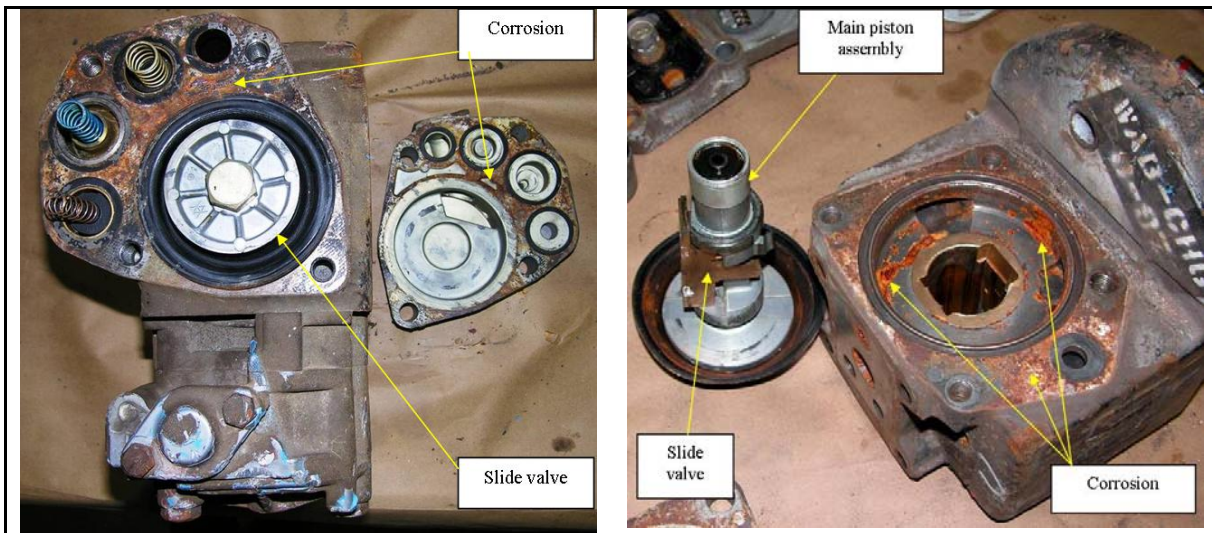
The examination of the wheels, handbrake, slack adjuster, and retainer valve did not reveal any pre-existing conditions that contributed to the accident. However, the brake control valves did not pass all bench tests. Testing of the service portion could not be completed because the slide valve was stuck. Localized corrosion was noted on some of the internal components from the emergency and service brake valve assemblies (see Figure 3). It was noted that lower air pressures could make a slide valve more prone to a sticking condition. The report stated that

Figure 3. Corrosion noted on internal parts of brake valve components.

The failure of the service portion to pass bench tests due to a stuck slide valve was a condition that could cause an air brake system to not properly release. Corrosion noted on some of the internal components indicated that there was moisture present within the valve's internal mechanisms for this corrosion to occur. As the train stop at Juniper was made using a moderate application of the brakes (brake pipe reduction of 17 pounds per square inch), it is also possible that any minor corrosion on the slide valve would have made it more prone to stick. Although the cause of the stuck slide valve could not be positively identified, the signs of large slid-flat defects on four wheels are indicative of a malfunctioning of the car's air brakes. The examination and testing of the air brake control valves indicated that the service portion's slide valve stuck, thus preventing the brakes from properly releasing on covered hopper car CRDX 735 during the train stop at Juniper.
