RAILWAY INVESTIGATION REPORT
R08V0270

NON-MAIN-TRACK TRAIN RUNAWAY AND COLLISION

KETTLE FALLS INTERNATIONAL RAILWAY
WANETA TURN ASSIGNMENT
MILE 141.20, KETTLE FALLS SUBDIVISION
WANETA, BRITISH COLUMBIA
29 DECEMBER 2008

Report Number R08V0270

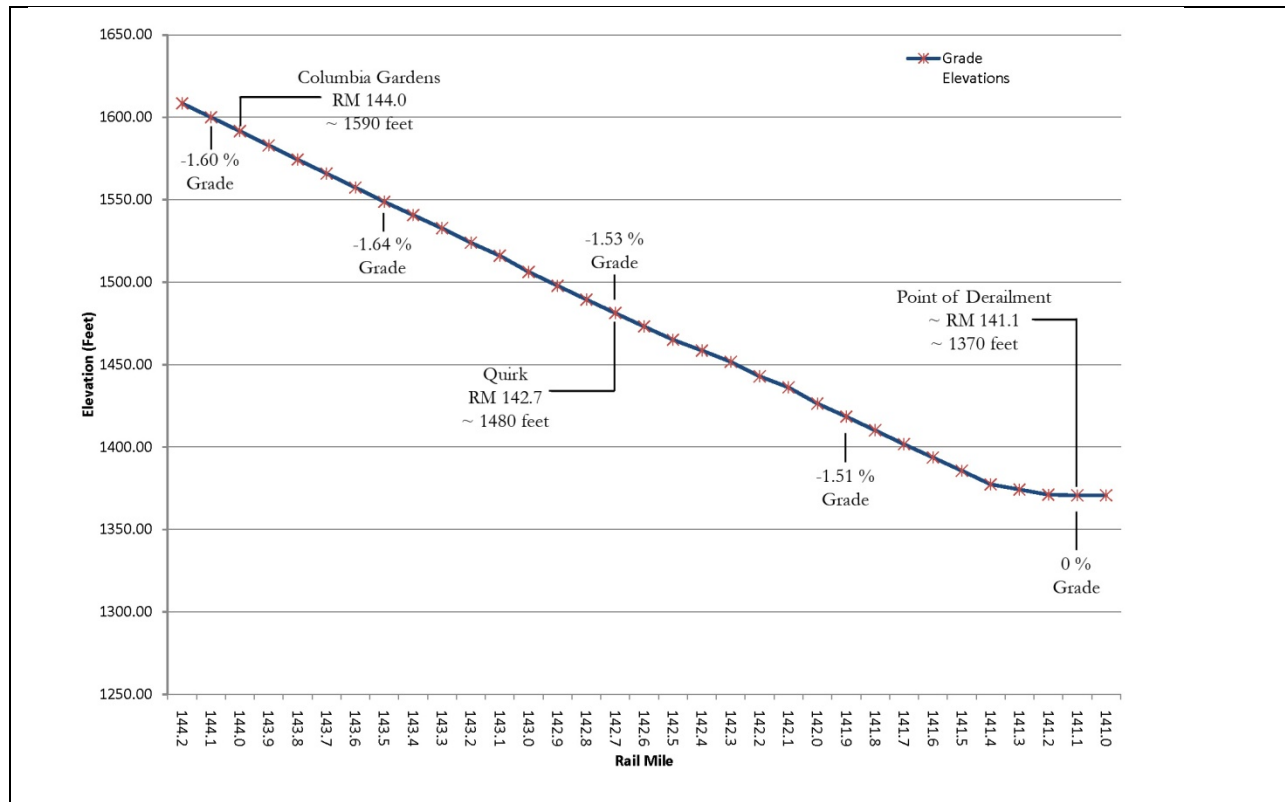
Figure 3. Grade elevations from Columbia Gardens to the point of derailment

The assignment pulled forward. Once clear of the switch, it was unable to reduce speed and continued uncontrolled down the steep grade for a distance of 2.8 miles (see Figure 3), gradually accelerating to about 48 mph when it contacted the stationary cars.

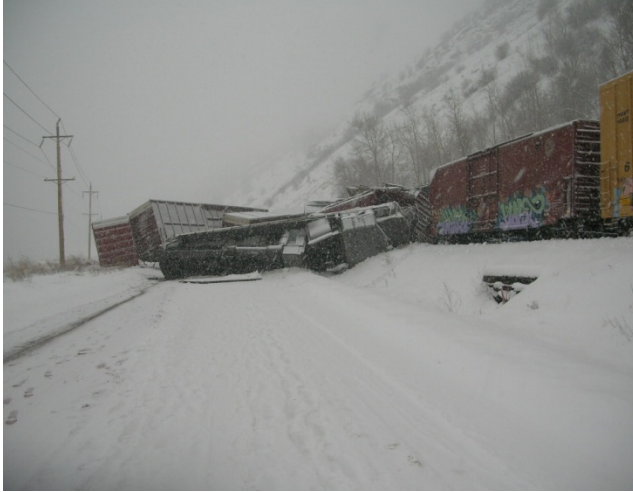
Photo 1. Derailed at Mile 141.2

Two locomotives and 12 cars were derailed at Mile 141.20. The trailing locomotive and four of the cars came to rest on Highway 22A (see Photos 1, 2, and 3).

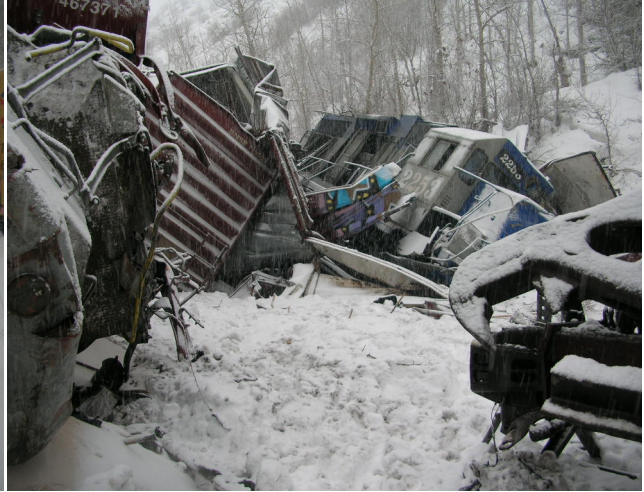
Photo 2. Lead locomotive OMLX 2253

Lead locomotive OMLX 2253 came to rest east of the track, leaning at about 45 degrees to the left. Its fuel tank punctured and approximately 1450 gallons of fuel spilled. Trailing locomotive KFR 6568 was on its side. Its fuel tank detached, punctured, and about 1500 gallons of fuel spilled. From the assignment, one loaded hopper car containing ammonium sulphate fertilizer, four empty box cars, and three loaded boxcars containing wood pulp derailed. The last derailed box car remained upright and coupled to the remaining four loaded boxcars. All but one of the derailed cars were destroyed. From the cars left standing at the bottom of grade, the first four, all empty box cars, derailed and were also destroyed.

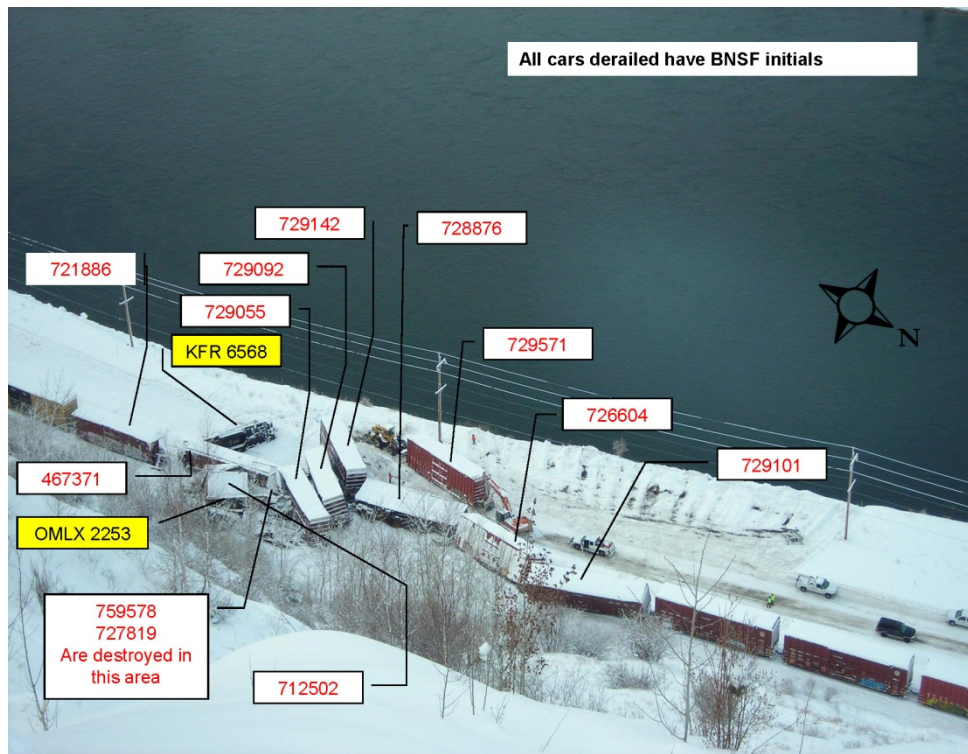
Photo 3. Derailment site

The spilled diesel fuel was contained by Teck Cominco's emergency response team, who responded soon after the accident. Their efforts prevented the fuel from entering the adjacent Columbia River. Some of the ammonium sulphate fertilizer spilled and was recovered. The remainder of the load was transferred to trucks. It posed no environmental hazard.

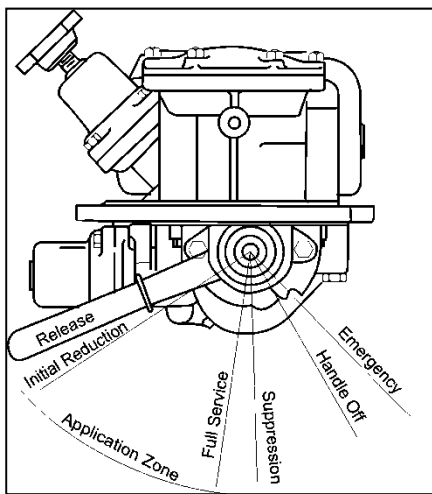
Figure 4. Automatic Brake Valve Handle Positions

- a traction motor was cut-out on the lead locomotive;
- the automatic brake valve handle was in the “handle off” position;
- the independent brake was cut out; and
- the automatic brake valve cut-off valve was between the “in” and “out” positions (see Figure 4 and Photo 4).

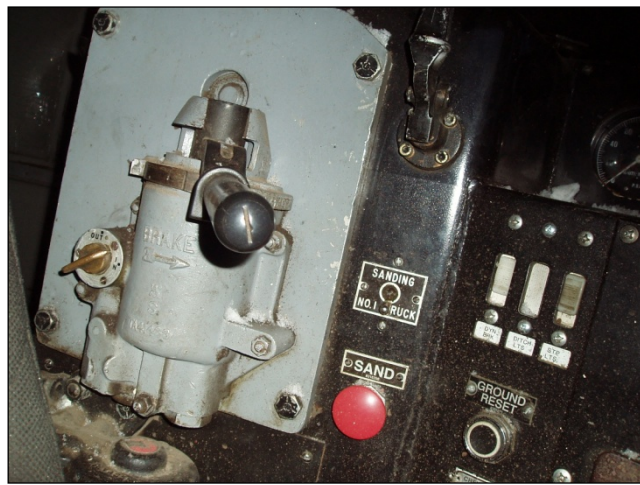
Photo 4. Automatic brake valve and brake valve cut-off cock on lead locomotive. The automatic brake valve handle is in the “handle off” position, the cut out cock is between the “in” and “out” position.

When the assignment failed to respond to efforts to stop, the locomotive engineer reduced the brake pipe pressure below equalization. This action compromised the ability to achieve an emergency brake application throughout the assignment.

In preparation for a change in control from the lead locomotive to the trailing locomotive, the locomotive engineer cut out the dynamic brake along with the automatic and independent brake valves.⁶ Up until that point, the assignment had accelerated gradually, increasing speed by 8 mph over 2 minutes and 35 seconds. However, after the DB was cut out, the assignment accelerated much more rapidly (that is to say, increasing speed by 14 mph over the next 2 minutes and 9 seconds and by 25 mph over the remaining 2 minutes and 51 seconds) until the collision. Because brake force for extended-range DB increases as speed increases above 5 to 7 mph, the DB on the trailing locomotive would have produced more braking effort as the assignment accelerated, at least until a speed of about 20 mph. The aborted attempt to change controlling locomotives eliminated most of the braking effort that was being generated and increased the severity of the collision.

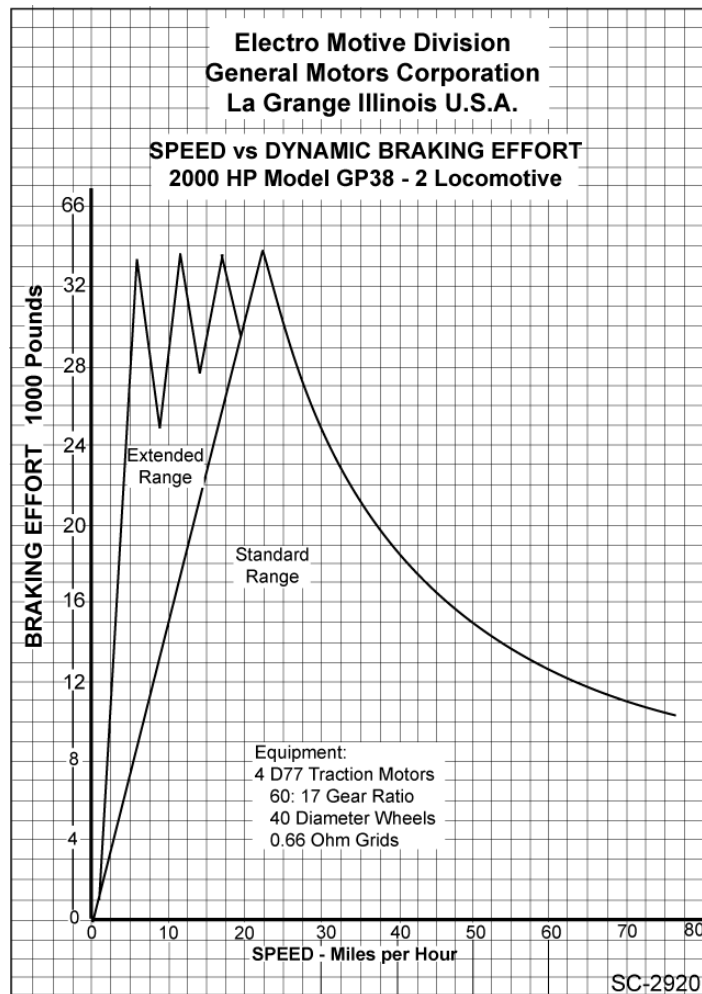
Figure 5. Speed versus DB Effort for Standard Range and Extended Range DB: 2000 HP Model GP-38-2 Locomotive

Both locomotives were equipped with dynamic brakes (DB). However, the dynamic brake on the lead locomotive was inoperative as a traction motor had been cut out. The second locomotive was equipped with extended range dynamic brake, which allows the dynamic brake to be effective at speeds below 10 mph. Dynamic brake reaches maximum effectiveness at about 20 mph (see Figure 3).

The lead locomotive had a traction motor cut out, rendering its dynamic brake inoperable. Recent TSB investigations have highlighted the importance of effective, state-of-the-art dynamic brake systems in heavy grade territory. When locomotives with inoperative dynamic brakes continue in active service in heavy grade territory, an important tool for train control is not available, increasing the risk of a runaway event.

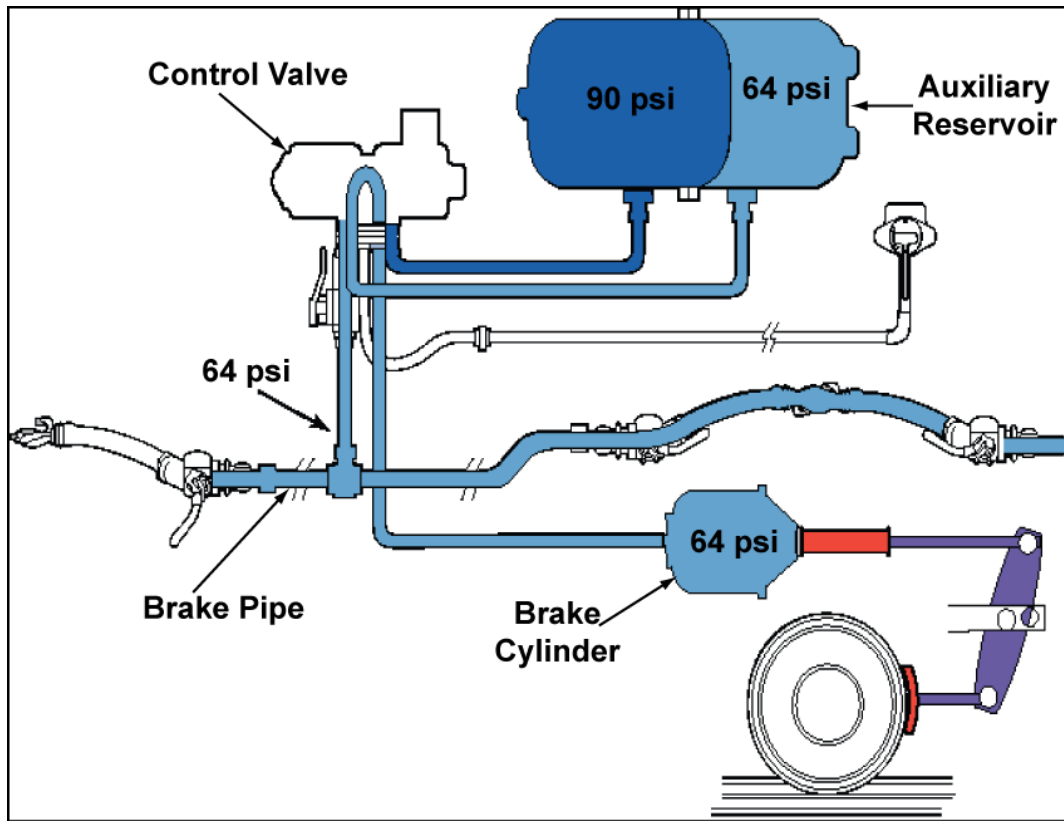
Appendix A – Equalization on a Standard Freight Car Air Brake System

The practice of reducing brake pipe pressure below equalization to achieve additional brake force has been a misconception known to air brake specialists for many years. Extensive railway industry training has minimized the extent of this practice. By reducing the brake pipe pressure below equalization, an unapproved adaptation to safe railway air brake practices was used, compromising the ability to control the assignment. Despite being qualified, experienced, and supervised regularly, the locomotive engineer did not fully understand the effects of reducing brake pipe pressure below equalization.

Note that brake cylinder pressure and auxiliary reservoir pressure have equalized at 64 pounds per square inch (psi). A further reduction in brake pipe pressure (the pneumatic signal) will not result in any further increase in brake cylinder pressure.
