## **RAILWAY INVESTIGATION REPORT R08W0181**

### **CROSSING COLLISION**

**CANADIAN NATIONAL RAILWAY  
TRAIN L53241-09 SOUTH  
MILE 3.66, LETELIER SUBDIVISION  
WINNIPEG, MANITOBA  
09 SEPTEMBER 2008**

Report Number R08W0181

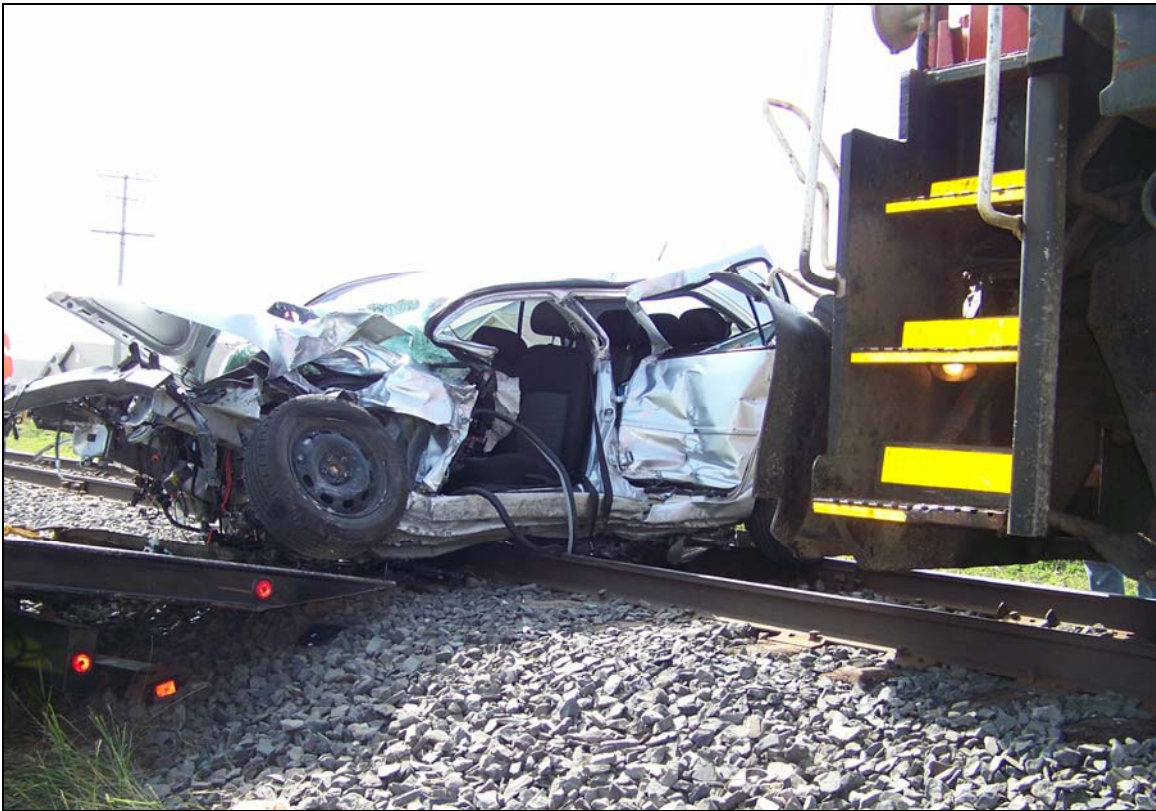
As the train approached the Bison Drive crossing at Mile 3.66 on the Letellier Subdivision with the locomotive bell activated, the crossing signals commenced operation. Westbound vehicles stopped at the crossing. However, eastbound vehicles continued to enter the crossing in both the median and curb lanes. As the train entered the crossing with the locomotive horn sounding, the lead locomotive struck a Volkswagen Golf automobile travelling in the median lane, pushing it into a Cadillac CTS automobile travelling in the curb lane. The train brakes were placed in emergency and the train came to a stop approximately 800 feet south of the crossing with the Volkswagen wedged under the coupler of the lead locomotive (See Photo 1).

**Photo 1.** Volkswagen wedged under front of locomotive

Police, fire, and emergency medical personnel responded to the accident. The Volkswagen was destroyed. Its critically-injured driver was trapped in the vehicle. The emergency responders were not in possession of equipment (such as the “jaws of life”) to aid in extricating the driver. Once freed, the driver was transported to hospital.

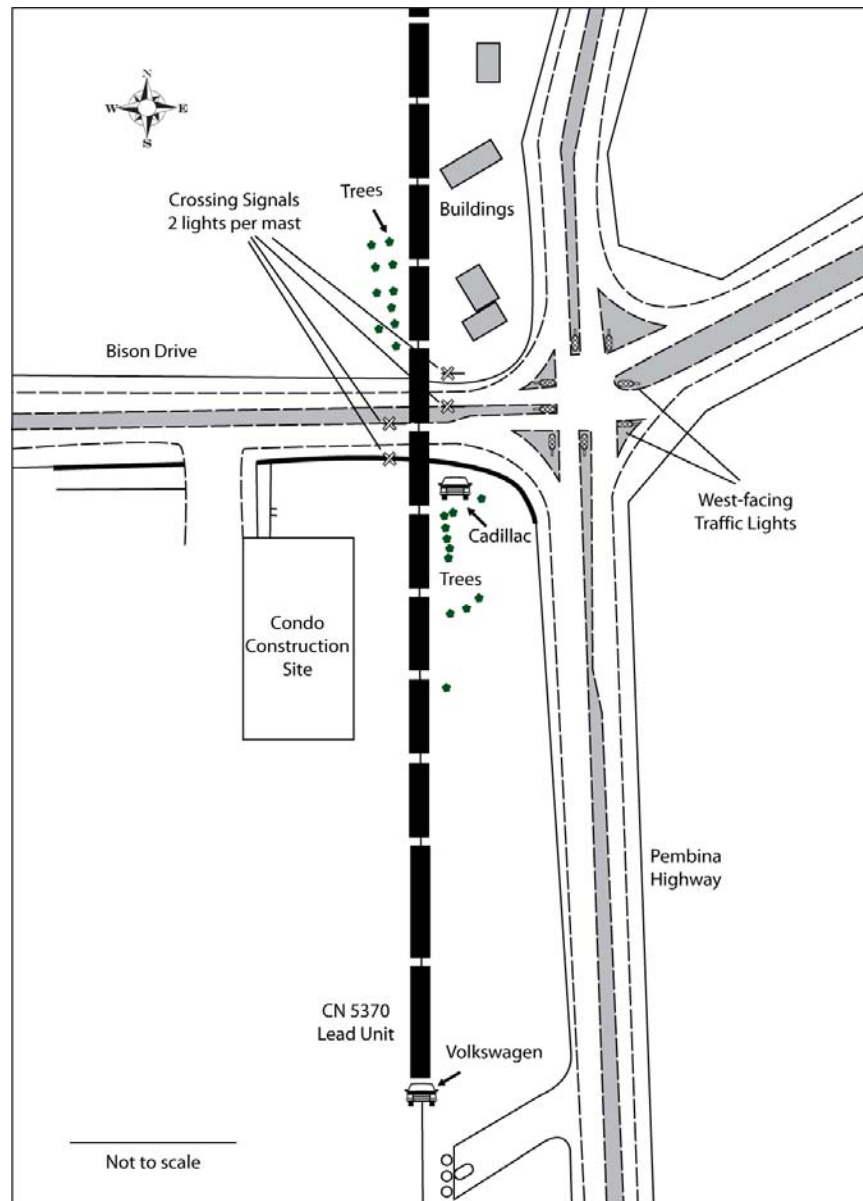
**Figure 1.** Plan view of Bison Drive crossing

The crossing is located immediately adjacent to, and approximately 40 metres west of, the Pembina Highway (see Figure 1). This highway is the main north/south route through the city of Winnipeg. When travelling eastward on Bison Drive, the traffic signals at the Pembina Highway intersection are visible to motorists prior to their passing over the railway crossing (see Photo 2).

Immediately to the north of the railway crossing, there was a row of trees which restricted eastbound drivers' sightlines to the north. A medium-rise condominium under construction restricted drivers' sightlines to the south.

Canadian National and the road authority applied to Transport Canada for a financial contribution to improve the Bison Drive crossing with the addition of automatic gates and improved track circuits. Transport Canada has identified this crossing as a higher priority for funding in 2009.

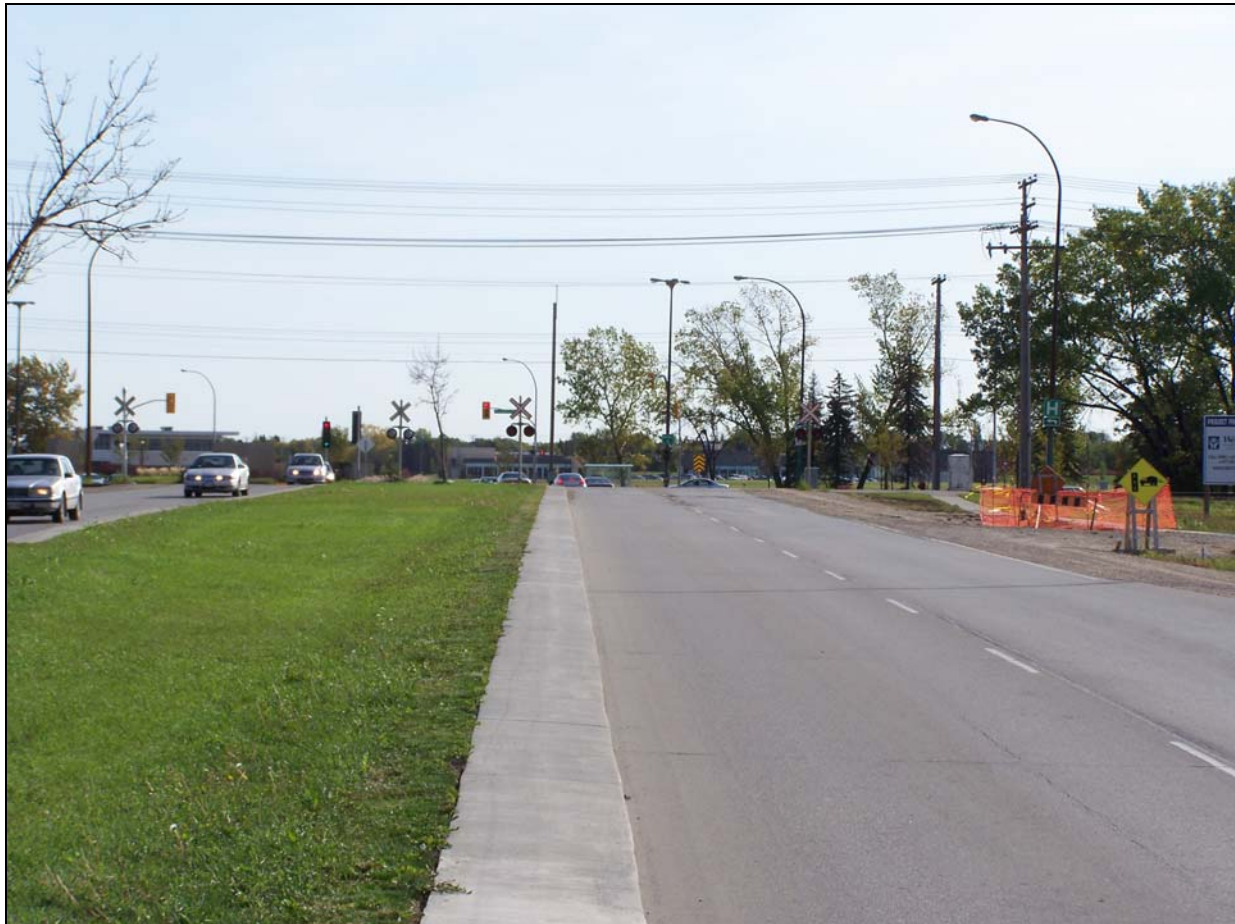
The Bison Drive crossing was equipped with four sets of flashing light emitting diode (LED) lights, four reflectorized crossing signs, and two warning bells. The lights and signs were located on masts positioned adjacent to the median and curb lanes for both the east and west approaches (see Photo 2). There were crossing advance warning signs posted on each side of the eastbound approach, located 200 metres from the crossing.

**Photo 2.** View of the crossing from the median lane of Bison Drive, facing east

Eastbound vehicles at Bison Drive faced contradictory signals. The red flashing crossing signals required vehicles to stop, then to proceed only if it was safe to do so. However, eastbound drivers also faced the interconnected green highway signals and continuing traffic flow ahead of them. The interconnection of the highway and railway crossing signals and the traffic flow created an ambiguous environment where drivers did not acknowledge the crossing signals in an effort to successfully negotiate the traffic intersection.

In 2005 the railway, and in 2006 the road authority, applied to TC for a funding contribution to upgrade the crossing to include four gates, back lights, and constant warning time track circuitry. The estimated cost of these upgrades was \$234 000, of which TC could fund up to 80 per cent. However, TC has limited funds available and prioritizes all outstanding applications each year. The railway and road authorities do not normally construct before funding is granted, as there is no guarantee that the funds will be provided.
