**RAILWAY INVESTIGATION REPORT
R09W0016**

**ROLLING STOCK DAMAGE WITHOUT
DERAILMENT OR COLLISION**

**CANADIAN NATIONAL
FREIGHT TRAIN NUMBER M-30451-11
MILE 238.30, REDDITT SUBDIVISION
DUGALD, MANITOBA
14 JANUARY 2009**

Report Number R09W0016

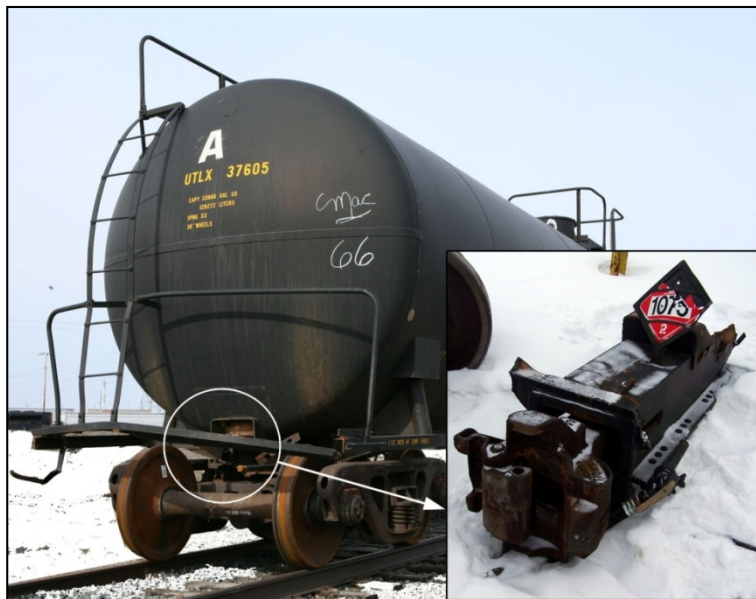
After stopping, the crew performed emergency procedures and determined that the train had separated, with a distance of about 50 feet between the 41st and 42nd cars. The A-end stub sill of the 41st car, dangerous goods (DG) tank car UTLX 37605 loaded with approximately 51 500 pounds of propylene (UN 1075), had broken and severed just behind the rear draft gear stop blocks (see Photo 1). The severed portion of the stub sill assembly, which still contained the

draft gear, yoke and coupler, had pulled out of the car and remained attached to the east end of the 42nd car, DG tank car DLPX 19016 loaded with hydrogen peroxide (UN 2015). The stub sill was heavily bulged in the area of the draft stops.

Photo 1. Car UTLX 37605 missing A-end stub sill

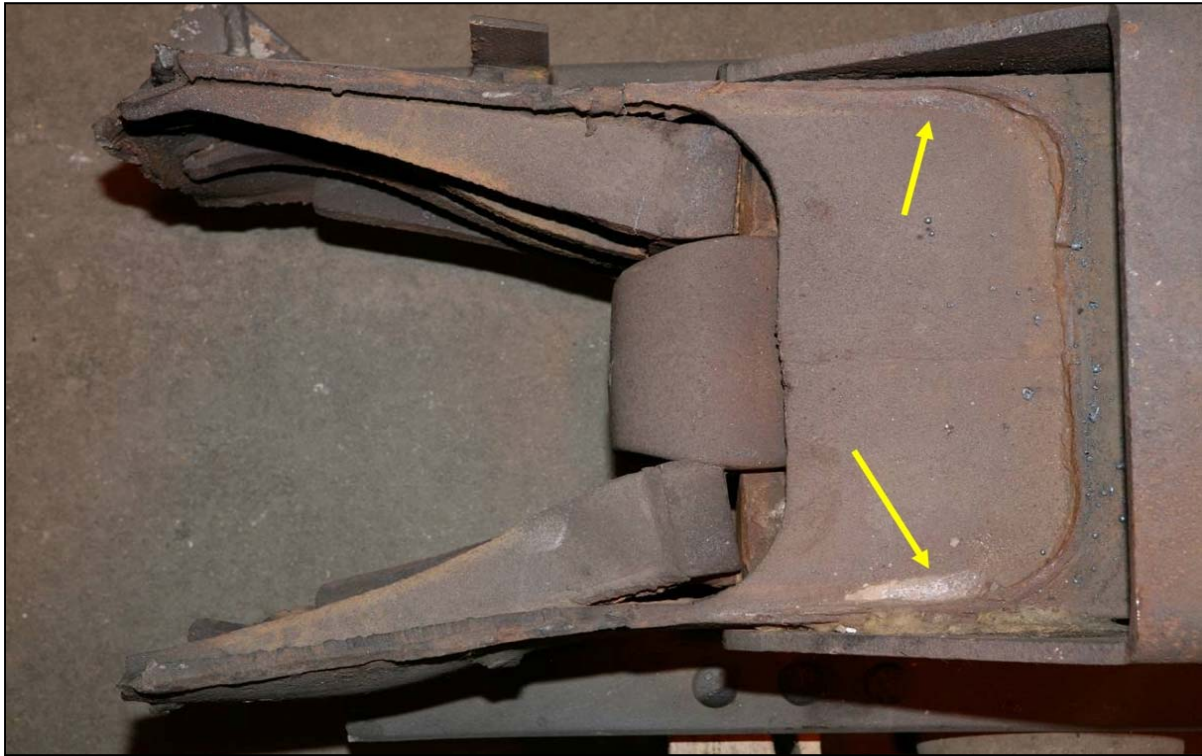
- A significant amount of plastic deformation was observed on the sides adjacent to the fracture. The draft gear stop reinforcing ribs had buckled and torn away from both sides of the stub sill and the draft gear stops were deformed. The striker face and coupler carrier exhibited damage that was consistent with impact forces from the coupler. All of these features are consistent with long-term heavy impact damage (see Photo 3).

Photo 3. Top of stub sill showing plastic deformation. Head brace-to-sill contact is visible (arrows).

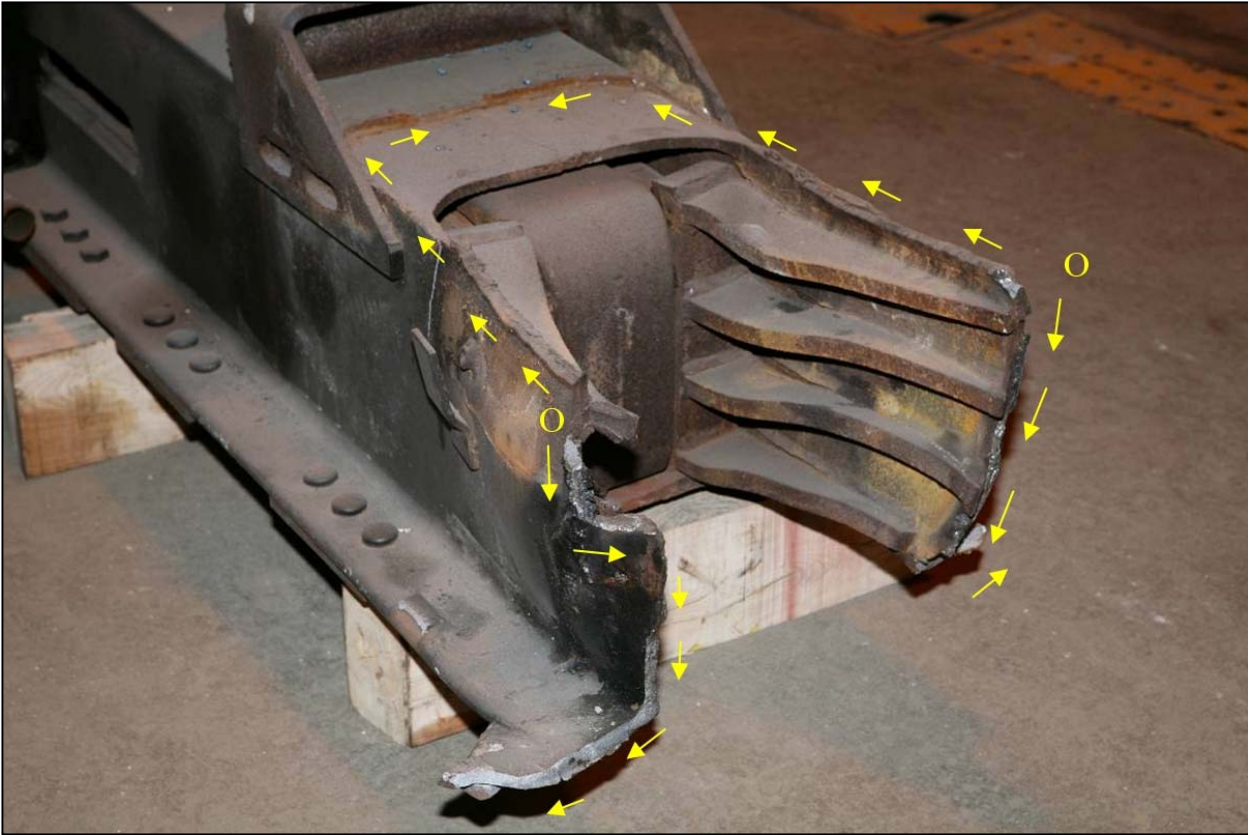
- The stub sill failed in successive overstress fractures (see Photo 4).

Photo 4. View of stub sill fracture, left side. Origin areas are indicated with “O” and the directions of crack propagation are indicated with arrows.

- The primary failure was the head brace-to-sill fracture. Corrosion and rub damage was observed between the mating fracture surfaces, which suggest that the fracture existed for some time prior to the final failure. The fracture initiated in the stub sill material near the extremities of the top reinforcing rib of both rear draft stops. The fracture then propagated rapidly outboard, towards the coupler, on both sides separating the head brace from the stub sill.

- Secondary fractures occurred down the sides of the stub sill and had been weld repaired. The welds extended about ten inches up each side and stopped at the tank jacket, less than four inches from the tank shell. The general shape of the weld deposits suggests that the stub sill was plastically deformed at the time of the last repair.

- Final fracture occurred when the repair welds fractured and the remainder of the sill separated.

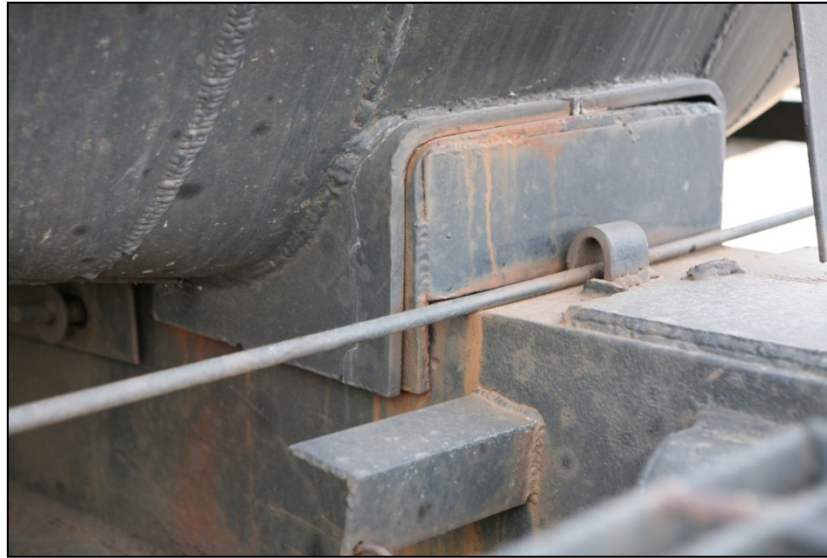
- The stub sill had a bracket affixed to the sill just outboard of the head brace. This bracket mates with a similar one on the car jacket. The B-end of the car shows the original configuration (see Photo 5). Examination of the A-end bracket indicated that the welds attaching it to the stub sill were original and had not been disturbed. This suggests that the bracket was in place during the last stub sill inspection (2004), which would have made visual inspection of the lower head brace weld difficult at best.

Photo 5. Bracket covering head brace
