RAILWAY INVESTIGATION REPORT
R09W0118

MAIN-TRACK TRAIN COLLISION
CANADIAN NATIONAL TRAIN NO. M30131-27 AND
CANADIAN NATIONAL TRAIN NO. Q10131-27
MILE 104.32, REDDITT SUBDIVISION
JONES, ONTARIO
28 JUNE 2009

Report Number R09W0118

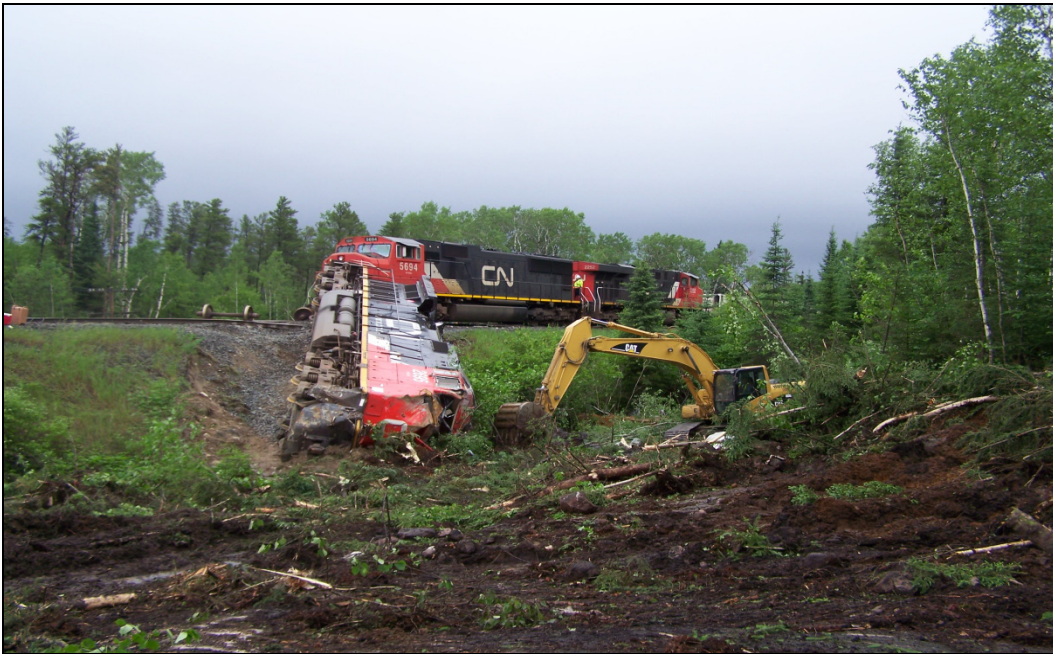
At 0623:00, Train 101 departed westward from Favel on the main track. At 0630:13, Train 101 was travelling at 40 mph in throttle 8 as it exited a four-degree right-hand curve (in the direction of travel) and observed signal 1043 (advance signal to Jones East), about 1200 feet ahead. Train 101's crew observed a restricting signal indication and the tail end of Train 301 stopped on the main track clear, and just west of, the signal. At 0630:37, Train 101's locomotive engineer initiated an emergency brake application. Anticipating the impending collision, the crew exited the rear cab door of lead locomotive CN 2695 and moved toward the tail end of the locomotive. The locomotive engineer climbed onto the footboard between the lead and second unit while the conductor remained on the rear platform deck. At 0631:00, while travelling at 29 mph, Train 101 struck the tail end of Train 301. At 0631:23, Train 101 came to rest at Mile 104.31 (see Photo 1). The conductor had jumped clear of the wreckage; the locomotive engineer had held on to the locomotive. The locomotive engineer sustained minor injuries.

Photo 1. Derailed lead locomotive number CN 2695

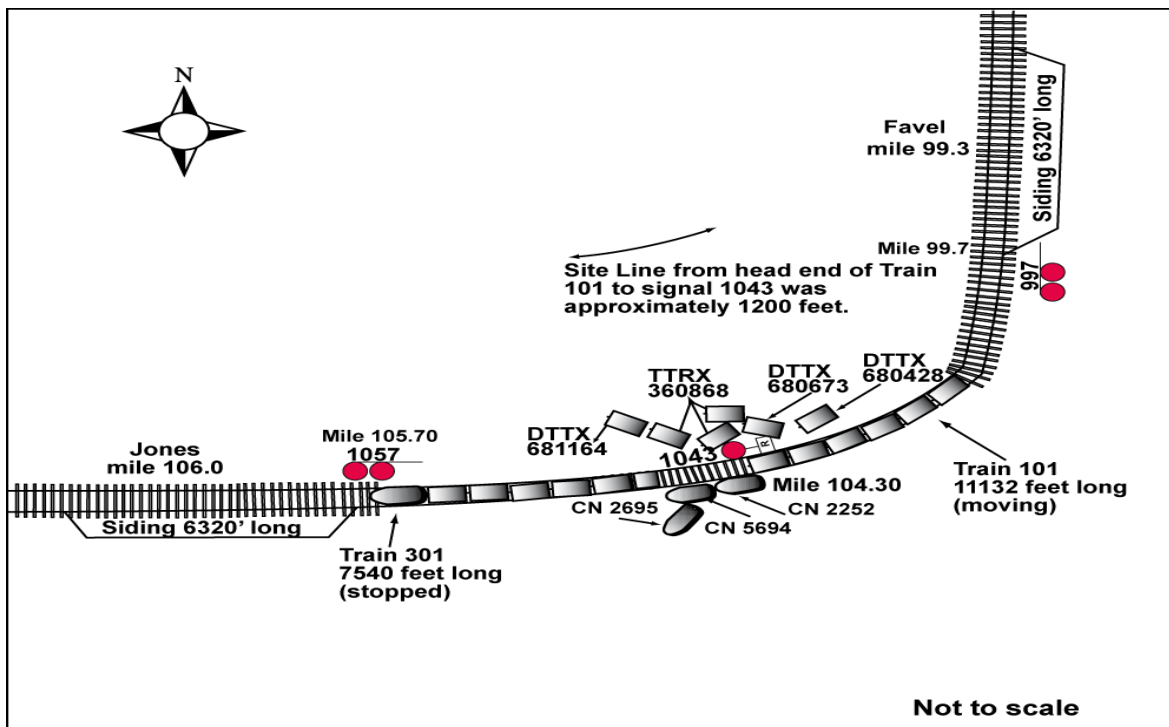
Site examination revealed that the four tail-end inter-modal cars (6 platforms in total) from Train 301 had derailed and come to rest approximately 75 feet north of the main track. The three locomotives from Train 101 had derailed with the lead locomotive CN 2695, coming to rest down an embankment on its side (see Figure 2).

Figure 2. Track layout and derailed rolling stock location

All derailed equipment was heavily damaged and approximately 200 feet of track was destroyed.
