RAILWAY INVESTIGATION REPORT
R10D0088

MAIN-TRACK DERAILMENT

CANADIAN NATIONAL
FREIGHT TRAIN M36831-18
MILE 58.20, KINGSTON SUBDIVISION
LANCASTER, ONTARIO
18 OCTOBER 2010

Report Number R10D0088

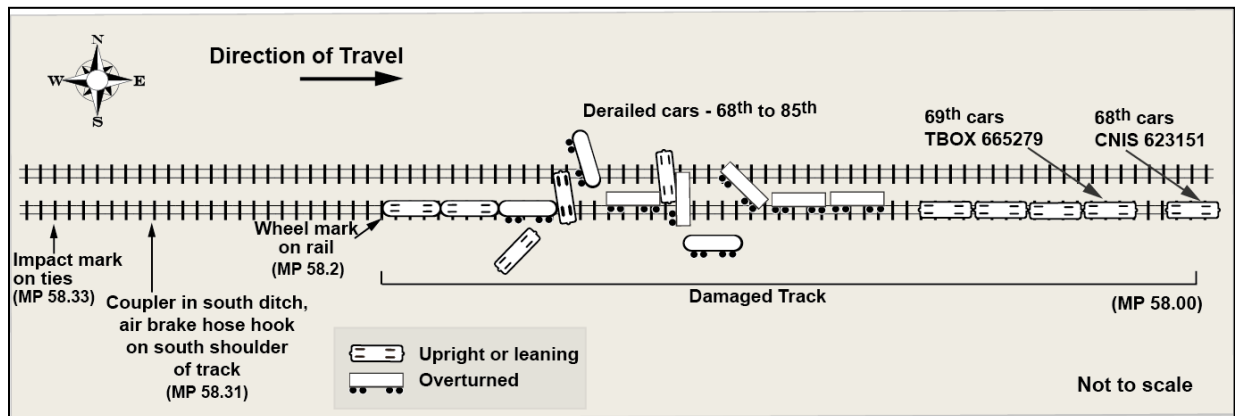
Figure 2. Site Diagram

At Mile 58.33, two ties displayed fresh impact marks between the rails. Wheel marks were observed on the web of the north rail at Mile 58.20, about 700 feet east of the damaged ties. The rail had lifted out of the tie plates and was resting on the spikes. The rail was broken and the track was destroyed for approximately 500 feet. Further east, the north rail was rolled over all the way to the first derailed car, CNIS 623151, the 68th car from the head end. The 69th car, TBOX 665279, and the following 3 cars stayed coupled together and were derailed upright on the track. Sixty feet to the west, cars CNA 404920 and CNA 407068 were overturned off their trucks and were resting on their sides. The remaining derailed cars had piled up and were fouling both the north and south main tracks (see Figure 2).

Car CNIS 623151, an empty centre beam flat car, came to rest at Mile 57.98 with the north wheels of its trailing truck derailed and resting on the gauge side base of the rail. The leading end of the following car, TBOX 665279, an empty box car, was 55 feet to the west of CNIS 623151. The car came to rest with all wheels derailed. The north rail was rolled to the field side and the wheels were resting on the gauge side web. The south side wheels were resting on the gauge side of the rail.

The damage to the ties observed at Mile 58.33 was consistent with impact marks caused by the coupler of car CNIS 623151 (the 68th car) hitting the ground after being pulled away from the yoke and separating the train. The coupler was ejected and fell in the ditch outside of the path of the trailing cars. It did not obstruct their movement as the cars derailed further east where the first wheel marks were visible on the rail.

The moderate damage to the trailing end of the 68th car and the leading end of the 69th car is indicative of a low impact collision between the 2 cars when the trailing portion ran into the head-end portion. The damage to the north side of the 68th car and the resting angle of the coupler of the 69th car, skewed to the north, suggest that the impact force was applied at an angle. As a result, the lateral force generated was sufficient to cause the rail to roll over and the train to derail.

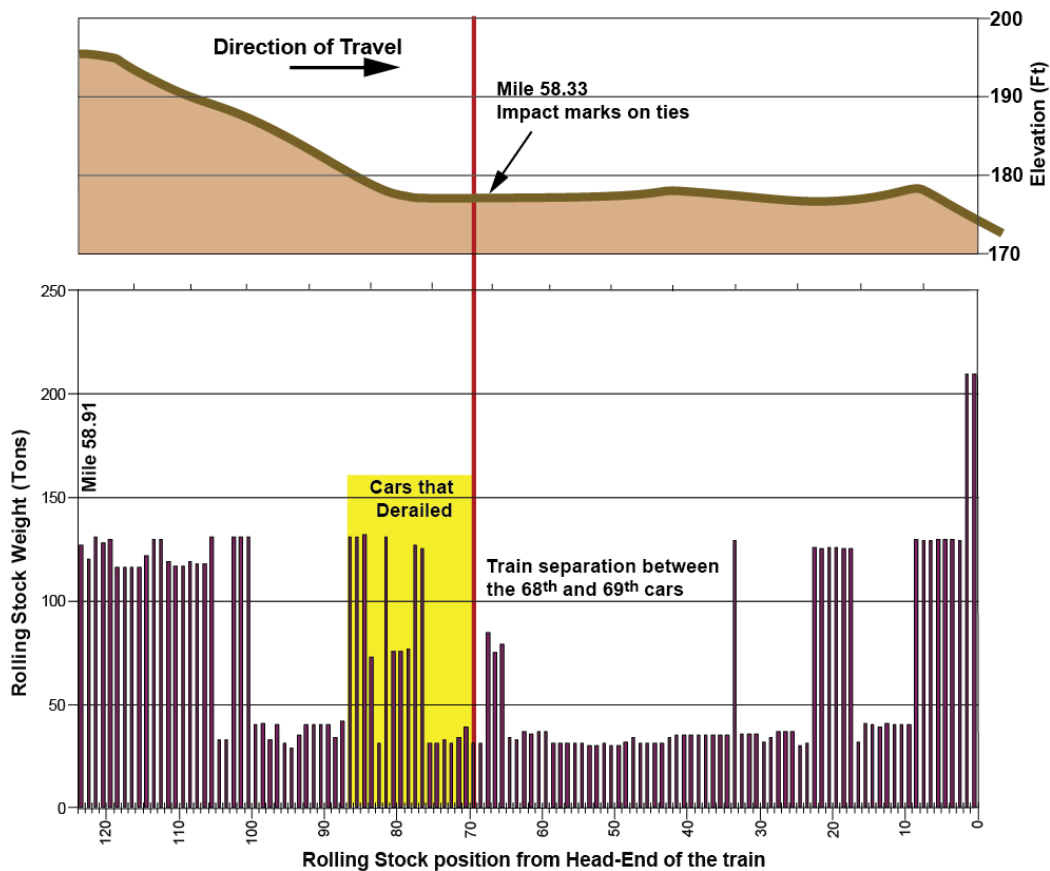
Figure 3. Location of rolling stock at the time of train separation

Before departing MacMillan Yard in Toronto, the train received a certified car inspection. The train consisted of 6 blocks of loaded and empty cars (see Figure 3). The 1st, 5th and 6th blocks from the head end were to be set out in Taschereau Yard in Montréal while the other blocks were destined for Garneau Yard near Shawinigan, Quebec. The tail-end block was composed of 19 loaded cars. The portion of the train trailing the first derailed car, car CNIS 623151, accounted for 44% of the number of cars and 55% of the train weight. The trailing 25% of the train length (32 cars) accounted for 37% of the train weight.

Train M36831-18 was marshalled with a block of loaded cars on the tail end trailing mainly empty cars. This marshalling configuration is susceptible to a derailment through the generation of high in-train forces. When the train experienced an emergency application of the brakes after the separation between the 68th and 69th cars, both portions of the train began to slow. Because the trailing portion of the train was composed of mainly loaded cars and was situated on a steeper descending grade, the brakes were not as effective as on the leading portion composed of mainly empty cars. Consequently, the trailing portion of the train decelerated at a slower rate and collided with the leading portion of the train.

Destination block marshalling is a common operating practice used throughout North America. The primary benefits of this marshalling approach are increased operational efficiency and simplified service delivery for the carrier. While this approach is not inherently unsafe, weight distribution within the train may not always be optimal. Consequently, lighter cars can be placed ahead of heavier cars, leading to higher in-train forces during normal train operations and during emergency brake applications, increasing the risk of derailment.

4. Because the trailing portion of the train was composed of mainly loaded cars and was situated on a steeper descending grade, it decelerated at a slower rate and collided with the leading portion of the train.

Although CN had started developing marshalling rules aimed at reducing in-train forces, the rules were not fully implemented at the time of the derailment. A rule controlling weight distribution was put in place 2 months after the derailment. Had this rule been in effect at the time of the derailment, the weight of the tail end of the train would have been reduced; thus, decreasing the risk of run-in and the magnitude of the collision impact force.

Transport Canada (TC) is monitoring the strategies implemented by Canadian National (CN) for the Kingston Subdivision, including the use of distributed power and marshalling rules, which will be implemented system wide.

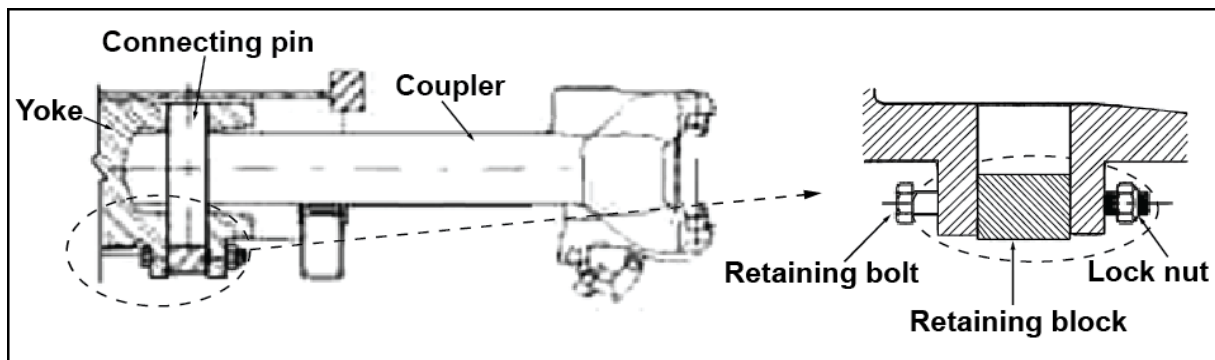
Figure 4. Coupler assembly CNIS 623151

The leading end of car CNIS 623151 was equipped with an E type coupler (code SBE68BE), connected to the yoke with an assembly that consisted of a vertical connecting pin, a retaining block, a 7/8" x 9" retaining bolt and a lock nut (see Figure 4). The trailing end coupler was found laying in the south-side ditch at Mile 58.31, but its connecting assembly was not found. Neither the coupler nor the yoke displayed any fractured surfaces.

The coupler and the yoke of the trailing end of car CNIS 623151 did not exhibit any fracture surfaces; therefore, the train separation was caused by the failure of the connection joining the two components together. The retaining bolt of the connection has been identified by the AAR as being prone to fatigue failure. In this occurrence, the retaining bolt was not found; however, it is likely that the bolt fractured causing the retaining block to fall to the ground. With no redundancy built into the coupler design, the connecting pin had worked its way out of the assembly, no longer securing the coupler to the yoke. As the coupler was pulled away from the yoke, the train separated between the 68th and 69th cars.

3. The train separated when the coupler pin retaining bolt in the yoke/coupler connection of the trailing end coupler of car CNIS 623151 likely failed and the coupler was pulled away from the yoke.

The AAR amended Rule 17, requiring the replacement of the retainer bolt, which secures the coupler to the yoke, with a more robust pin assembly once the car is placed on a repair track. Since the rule came into effect, car CNIS 623151 was repaired on a repair track at least twice by certified car mechanics who were trained and cognisant of the rules. Nevertheless, the car was repaired and returned to service without having the retaining bolt changed.

On 21 October 2010, CN issued a letter to all management staff to re-issue the coupler tail pin poster. Effective immediately, all cars equipped with coupler vertical pins that are inspected by certified car inspectors must be inspected closely to verify that the securement is in place. Either the coupler pin or carrier plate under the pin must be chalked to indicate that the inspection has been completed. In addition, management staff was instructed to ensure that the poster is reviewed during job briefings on all shifts during the week and that it is posted on the staff bulletin boards.

CN implemented a revised repair procedure for coupler tail pin assemblies at all of its repair tracks. TC performed focused inspections on cars equipped with these assemblies. Out shop inspections were performed at maintenance facilities in Windsor, Sarnia, London, Oakville, Macmillan and Belleville to ensure that these pins were applied as required.

Burlington Northern Santa Fe (BNSF) reissued an instruction letter to mechanical car supervisors to standardize the installation of the AAR standard retainer pin at all of its repair shops. The instruction letter explains the requirement for the retainer bolt replacement, and provides step-by-step procedures. In addition, BNSF ensured that its shop in Newton, Kansas is compliant with the AAR Rule. All repair track shifts at Newton Yard were briefed regarding the procedure and supervisors were spot checking for compliance.
