**RAILWAY INVESTIGATION REPORT
R10M0026**

MAIN-TRACK DERAILMENT

**CAPE BRETON AND CENTRAL NOVA SCOTIA RAILWAY
FREIGHT TRAIN NO. 305-13
MILE 65.6, HOPEWELL SUBDIVISION
AVONDALE, NOVA SCOTIA
13 JUNE 2010**

Report Number R10M0026

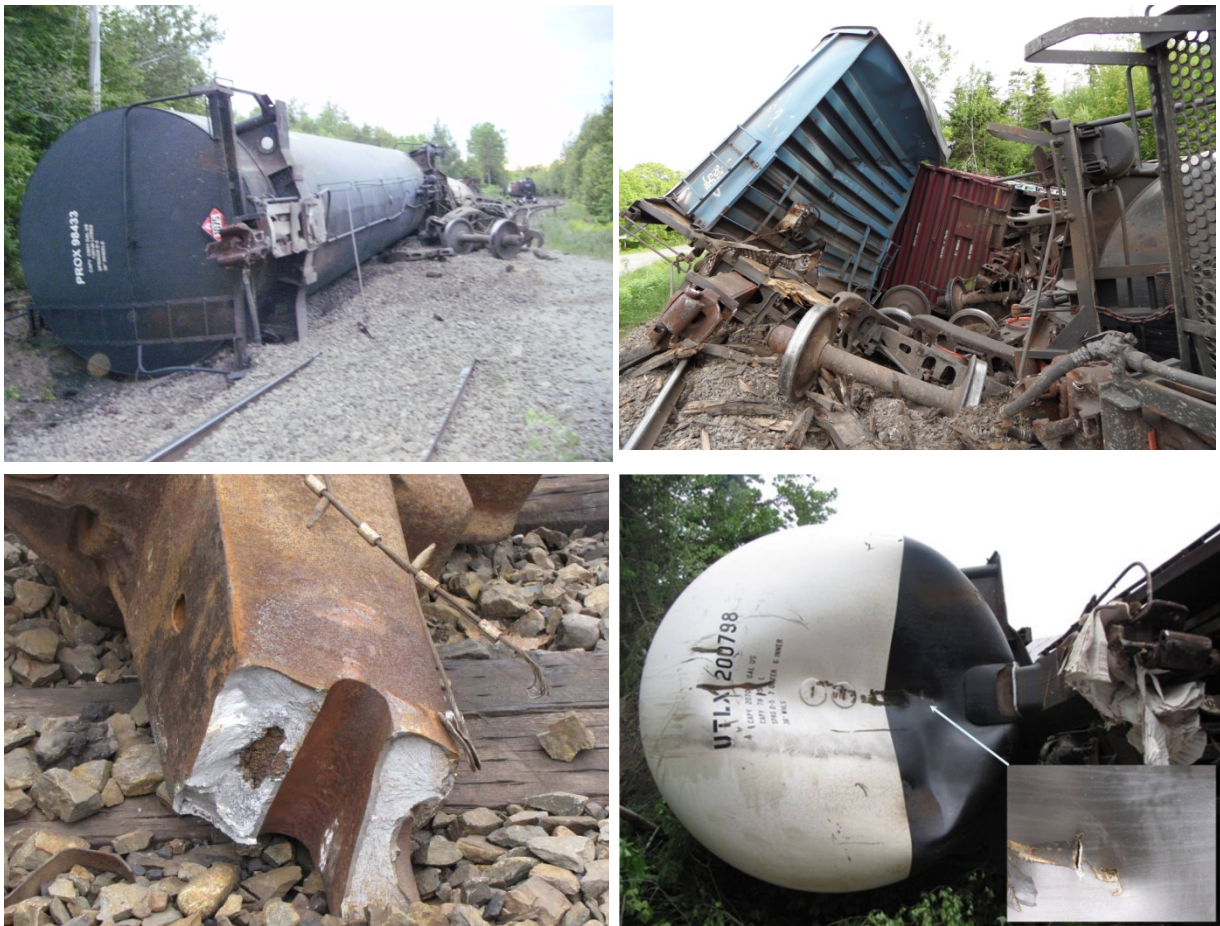
The other derailed tank car was a residue car, which last contained hydrogen peroxide stabilized (Class 5.1 (8), UN 2015). It was on its side and had sustained a head puncture (see Photo 1 - bottom right). The remaining derailed cars were box cars loaded with paper products. They had run into the previously derailed cars, piled up and caused extensive equipment and track damage.

Photo 1. Derailed rail cars. Arrow bottom right (with inset) denotes location of head puncture on the residue hydrogen peroxide car.

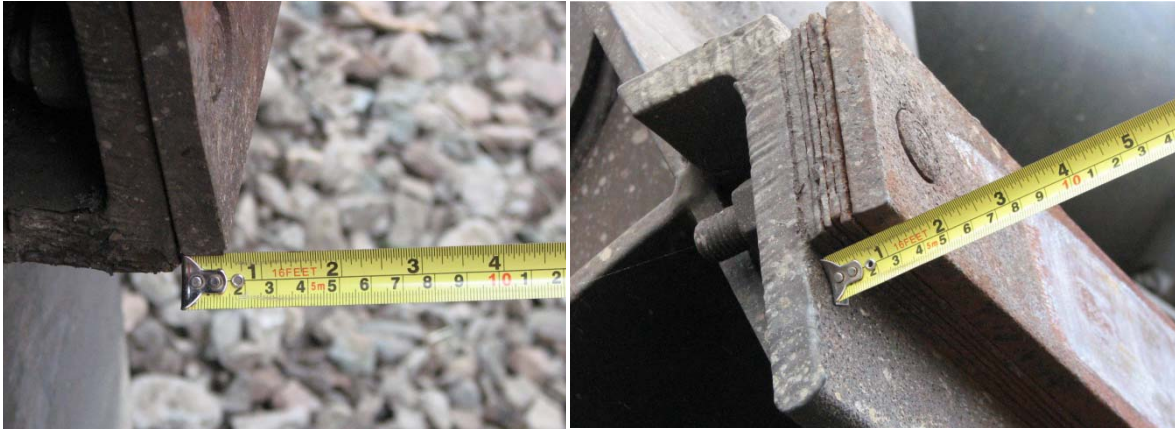
The car was observed with dissimilar body side bearing shims (left versus right) at each end of the car. The left side of the B-end (BL) was shimmed approximately $\frac{7}{8}$ inch while there were no shims on the right side (BR) (see Photo 2). The left side of the A-end (AL) was shimmed at least $\frac{1}{4}$ inch more than the right side (AR).

Photo 2. Body Side Bearings on B-end of car PROX 98433 (Left Photo - No shims at location BR; Right Photo - Approximately $\frac{7}{8}$ inch shims at location BL).

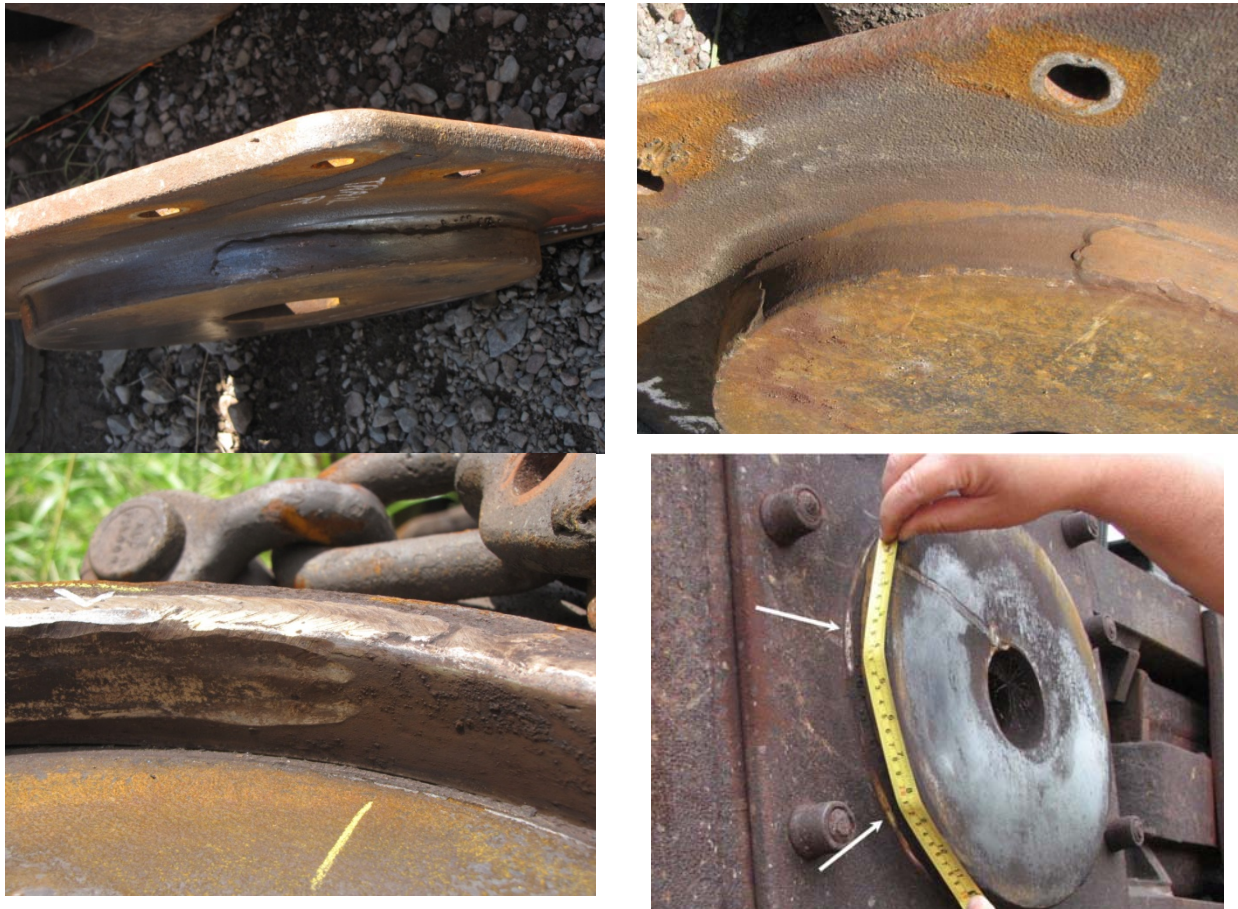
The B-end truck center plate had abnormal side wall wear on the truck center plate bowl ring vertical surface (see Photo 3). The body center plate had its vertical surface built up with heavy weld. The weld ends were not ground to match the original contour as per Association of American Railroads (AAR) and PROCOR Limited (PROCOR) requirements, which state:

Free rotation of the body center plate in the truck bolster bowl is critical to vehicle dynamic curving. If the rotation is blocked or restricted, the truck cannot negotiate freely along curved rail. The forced curving results in high lateral force and large angle of attack (AOA).

Photo 3. Center plate conditions on PROX 98433 - Built-up vertical surface with weld (top left and top right); Gouging in truck bowl wear ring at matching locations (bottom left); and shiny marks around base plate (arrows) from contact with truck bowl (bottom right).

Repairs made to the body centre plates of tank car PROX 98433 by welding the worn vertical surfaces were permitted by AAR and PROCOR rules. However, the approved procedure of machining or grinding smooth the welds to proper contour was not followed. Because the weld was tougher than the truck centre plate bowl, the regular in-train forces led to the formation of wear gouges in the longitudinal axis of the truck centre plate bowl over time. Any out-of-round condition can restrict the rotational movement of the 2 mating centre plates, resulting in increased lateral forces in curved sections of track and increased AOA.

PROCOR has also initiated a shop program and is progressing with its inspection of all of these cars. No conditions similar to car PROX 98433 have been identified. They have also reviewed the correct repair procedures with their shop staff.

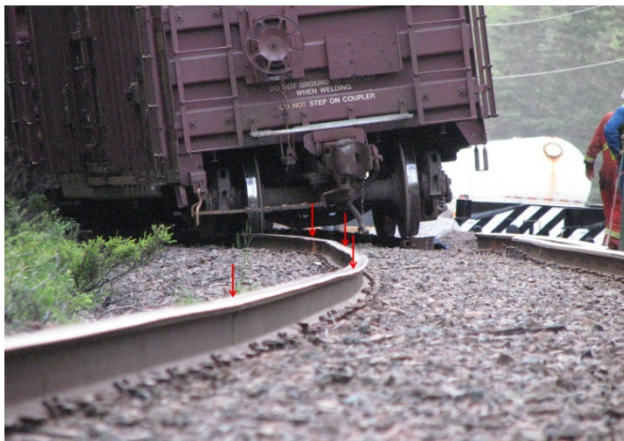
Post-accident track measurements for cross-level and gauge for 15 stations (measured 15 feet 6 inches apart) east of the point of derailment were performed (see Appendix B). The examination of the rail revealed that the rail head was flattened and worn. The combined rail wear (i.e., head and gauge face wear) was 12 mm on the high (north) rail and 19 mm of vertical head wear on portions of the low (south) rail of the derailment curve (see Photos 4 and 5).

Photo 4. View towards POD. Arrows denote flattened rail condition.

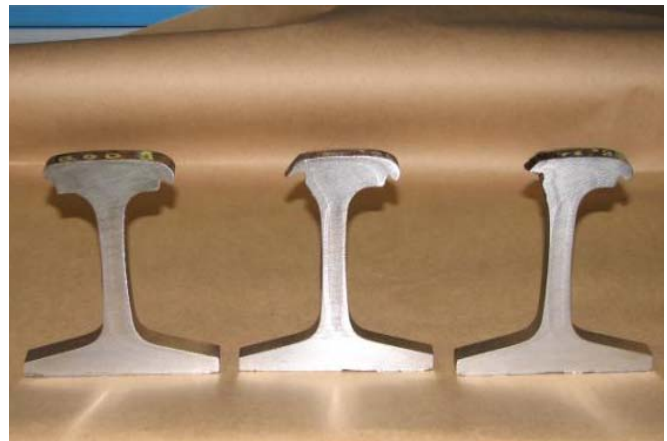
Photo 5. End view of sections of south rail in derailment curve.

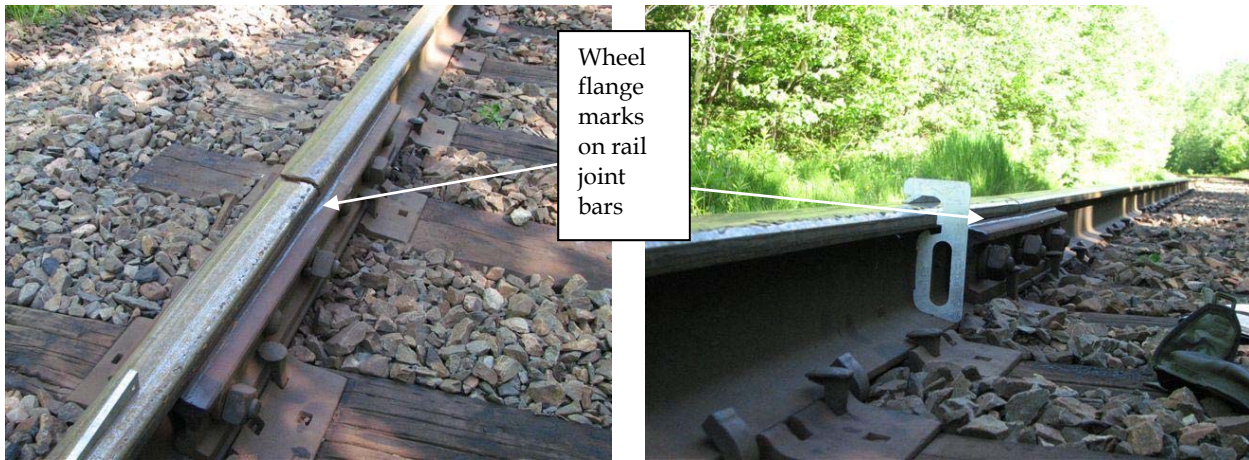
The nearest jointed rail was 820 feet east of the point of derailment. Several of the joint bars examined between Mile 65.6 and 65.9 showed contact marks from wheel flanges due to the severity of the head wear (see Photo 6).

Photo 6. Wheel flange marks on rail joint bars.

Due to the extent of the rail head wear, wheel flanges were striking some rail joint bars east of the POD. Although these marks were clearly visible, they were not identified during inspections and no corrective action was taken. Maximum rail vertical wear limits and the use of high-clearance joint bars are intended to prevent such high impact forces. When head wear exceeds 8mm on 115-pound rail and high clearance rail joint bars are not used, there is a risk of rail joint bars being struck by wheel flanges, which can result in wheel and rail failures, increasing the risk of derailment.

The province of Nova Scotia forwarded the TSB Information Letter and TSB Advisory Letter to Cape Breton and Central Nova Scotia Railway (CBNS) for its attention. CBNS advised that, under its rail replacement program, 80% of the 576 joint bars on its line have been changed and that the use of high clearance joint bars in some locations has been instituted. A rail inspection vehicle was leased in June 2011 to inspect the rail. All rail identified by this car was replaced. In addition, a yearly maintenance program has been developed to ensure that rails are being identified, evaluated and changed on a proactive basis. Track inspections are being performed twice a week on all main line track.

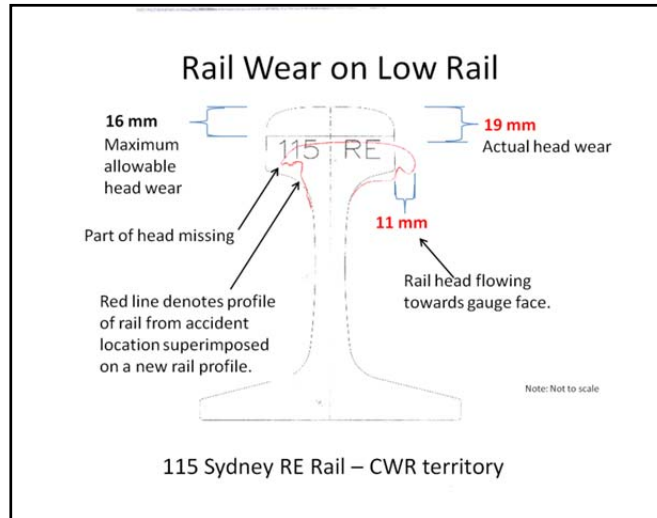
Track geometry inspections were performed by CBNS and TC. However, the excessive rail head wear was not identified and corrected. Rail wear is normally accurately measured by the track geometry car used by CBNS. However, due to the severely worn and deformed condition of the rail head, a correct profile was not recorded at this location and the maintenance crews were not alerted to the severity of wear (see Figure 2).

Figure 2. Schematic showing rail wear on low south rail (red line) superimposed on full 115-pound rail profile.
