**RAILWAY INVESTIGATION REPORT
R11D0099**

NON-MAIN-TRACK DERAILMENT

**AGENCE METROPOLITAINE DE TRANSPORT
COMMUTER TRAIN NO. 805
MILE 73.84, SAINT-HYACINTHE SUBDIVISION
MONTRÉAL, QUEBEC
09 DECEMBER 2011**

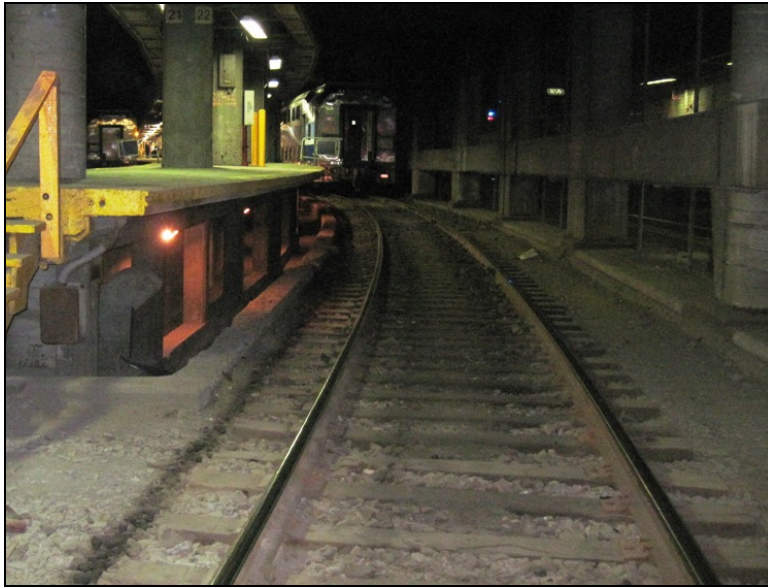
Photo 1. Curve approaching the boarding platform

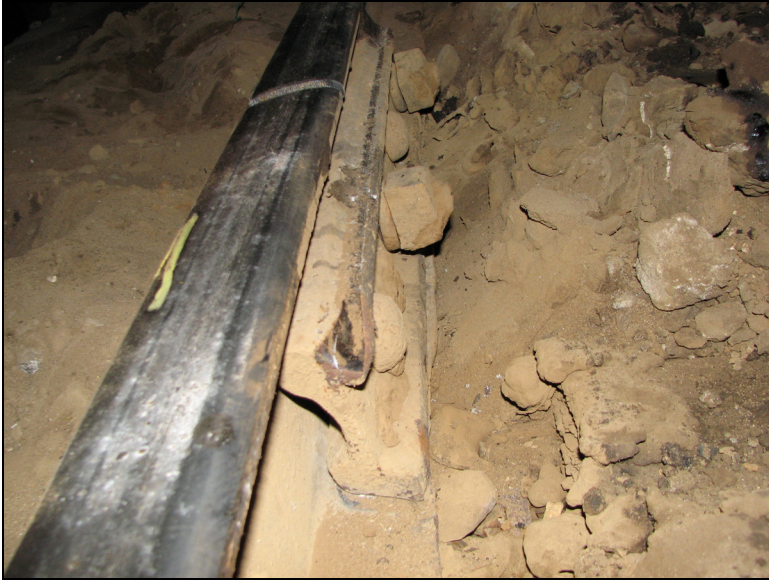
The first impact marks were observed on a rail joint on the south rail located approximately 200 feet west of the start of the boarding platform and 10 feet west of the end of the curve. Further west, the south rail was rolled to the field side and had been displaced laterally outward in some places by approximately 10 inches (Photo 3). Marks were observed on the inside of the rails along the web and base of the south rail, on the tie plates, as well as on the ties, up to the front of the lead locomotive. The north rail had remained in place. The spikes on the gauge side of the north rail at the end of the curve were raised by approximately $\frac{3}{4}$ to 1 inch.

Photo 2. Marks on rail joint in south rail

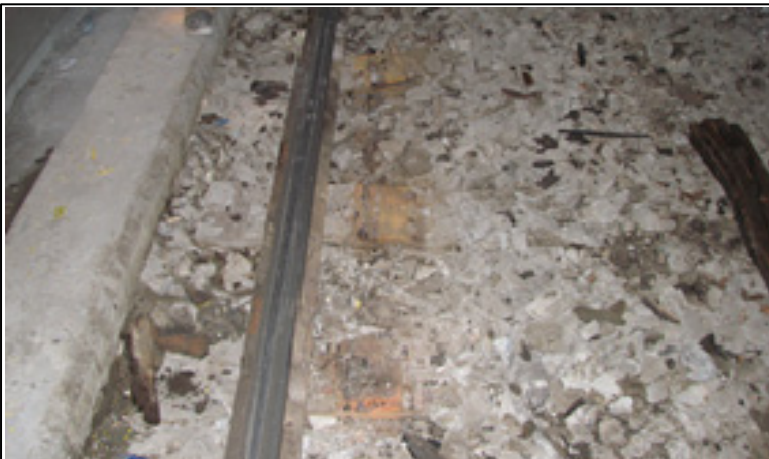
Photo 3. Lateral displacement of south rail

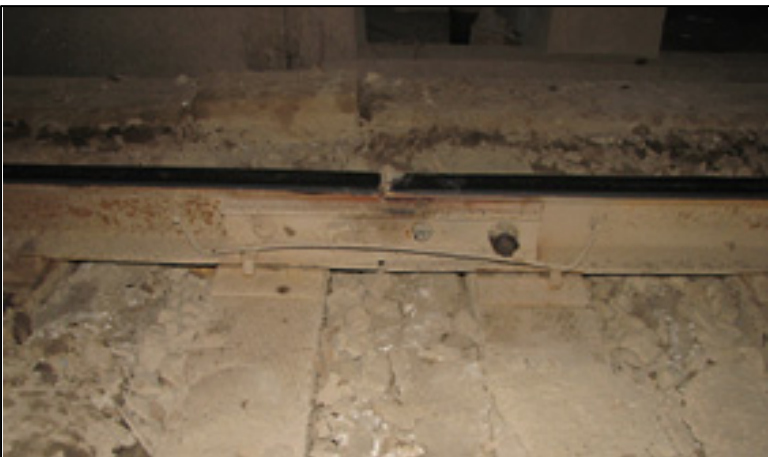
Photo 4. Ballast condition

The track was unanchored. Ballast was crushed gravel (1- to 2-inch diameter) with some locations clogged by grease and mud (photos 7 and 8).

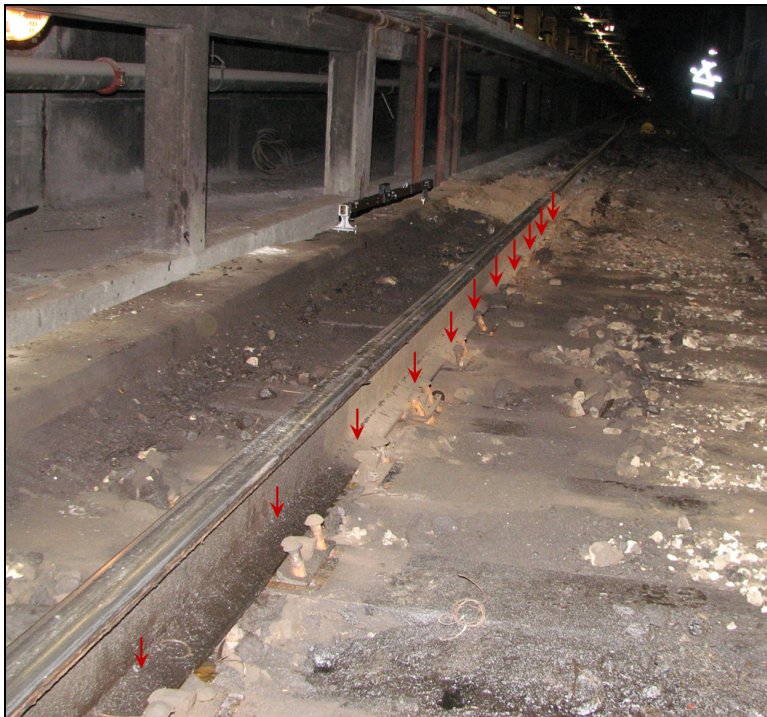
The 14-inch tie plates were used under the ARAA standard rail in the north side of the curve. They were secured with 6 spikes per tie plate. A mixture of 10-inch and 11-inch tie plates was used in the remaining section of the track. There was a cluster of 10-inch tie plates in both rails at the end of the curve (photos 5 and 6). There was a 1/8-inch gap between the tie-plate shoulders and the base of the rail.

Photo 5. Locations of 10-inch tie plates with round spikes, indicated by red arrows – south rail

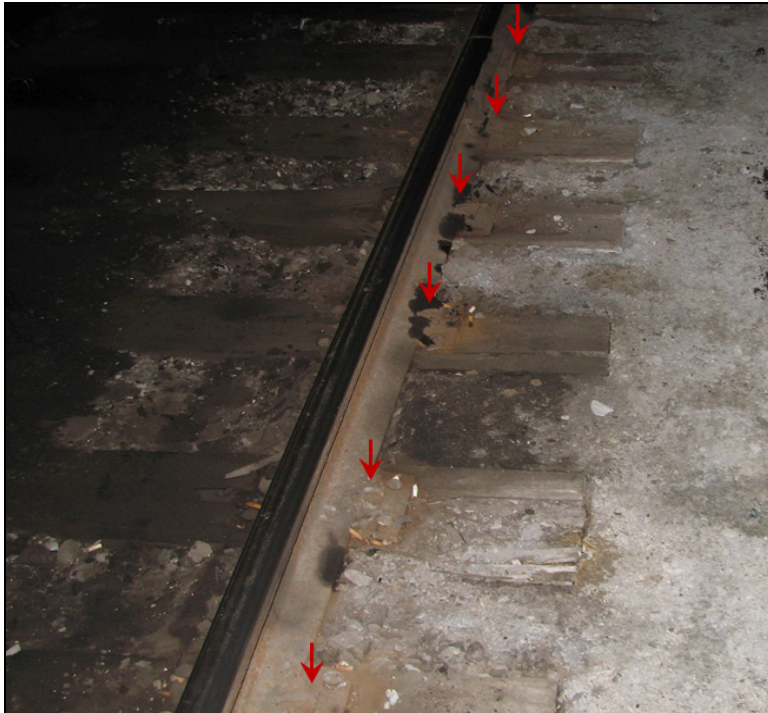
Photo 6. Locations of 10-inch tie plates with round spikes, indicated by red arrows – north rail

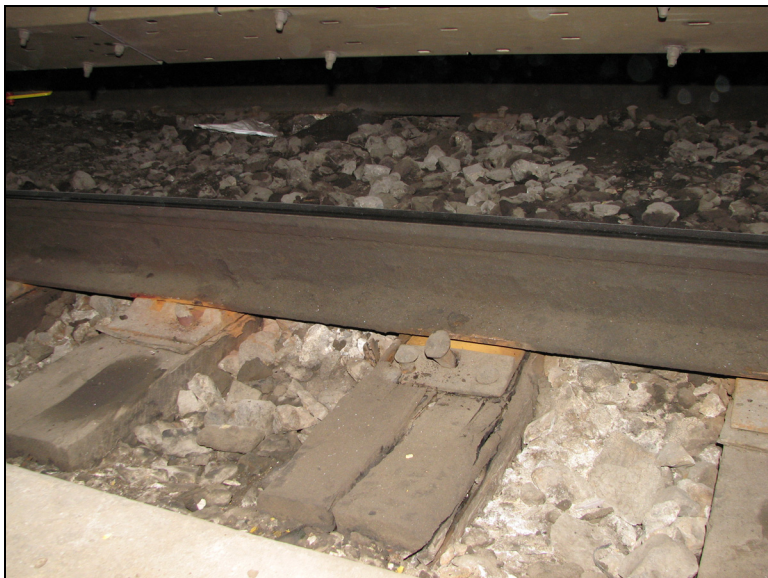
Photo 7. Ties, tie plates, track spikes and ballast

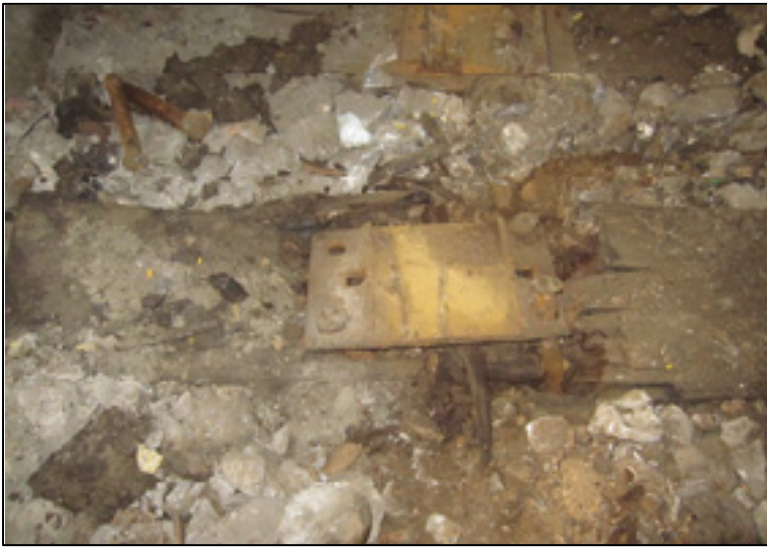
Photo 8. Closer view of tie, tie plate, track spikes and ballast

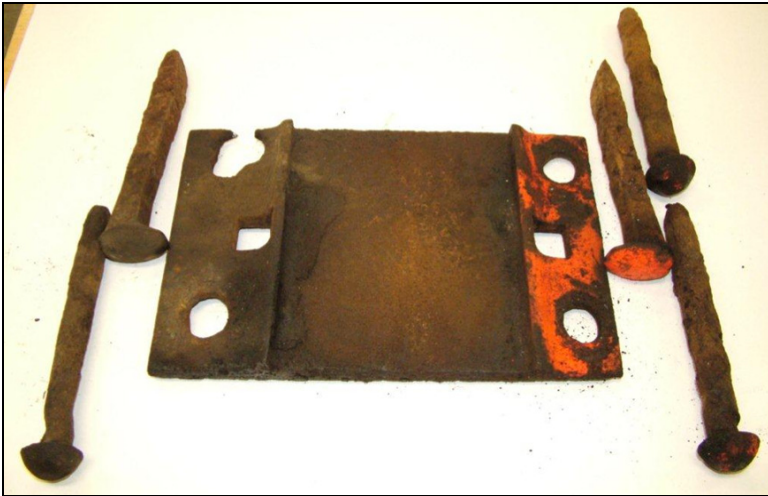
Several of the 10-inch tie plates and round spikes from Track 22 (Photo 9) were sent to the TSB Laboratory (Report LP 099/2012). It was determined that:

- For the round track spikes, the shanks were corroded just below the head where the spikes came into contact with the tie plates. The diameters of the spikes were reduced by up to $\frac{5}{16}$ inch.
- The spike holes in the tie plates were enlarged by up to $\frac{1}{4}$ inch.
- The base of the 10-inch tie plates was approximately 50% thinner than the base of the 14-inch tie plates.

Photo 9. Older style tie plate and round track spikes

Immediately after the accident, Canadian National (CN) increased the frequency of visual-track inspections at Central Station from once a month to once a week. CN also repaired and upgraded tracks 19 through 22, by installing new tie plates with double shoulders and elastic fasteners on every second tie.

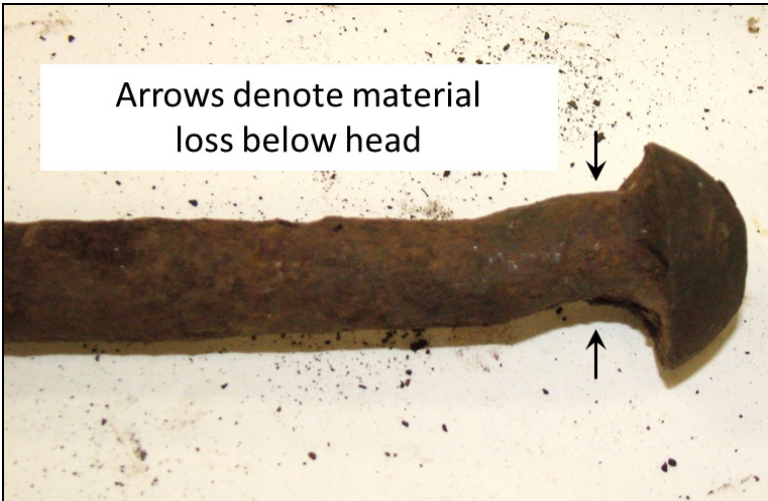
Photo 10. Round track spike showing material loss below spike head

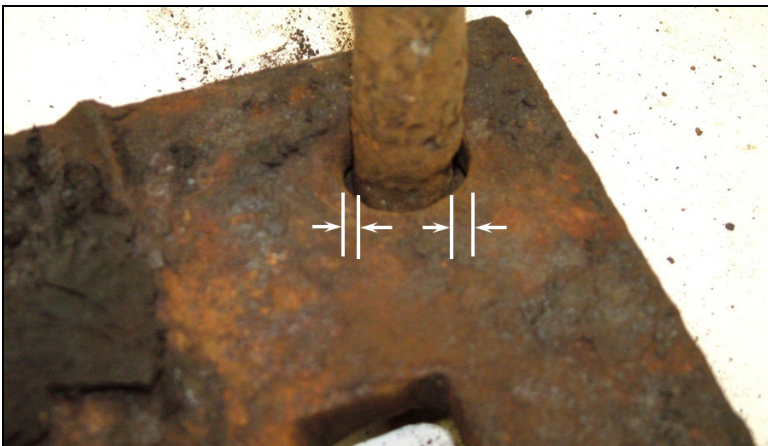
Photo 11. The spike hole in the tie plate is enlarged by up to $\frac{1}{4}$ inch

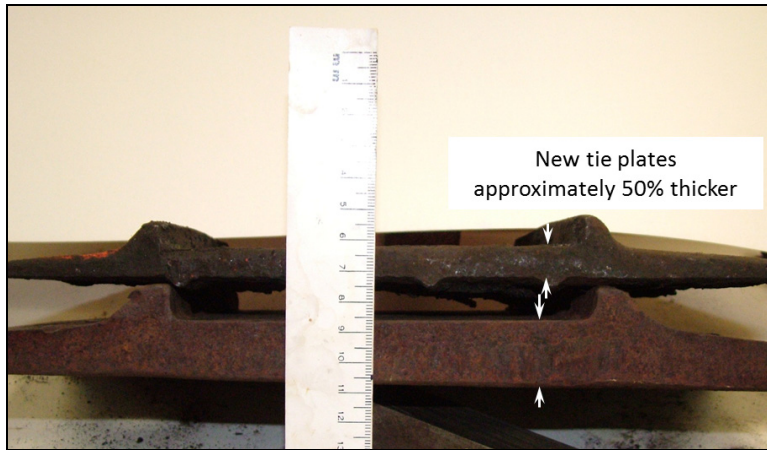
Photo 12. Older-style 10-inch tie plate superimposed on a new 14-inch tie plate; the base of the 10-inch tie plate is approximately 50% thinner than the base of the 14-inch tie plate.

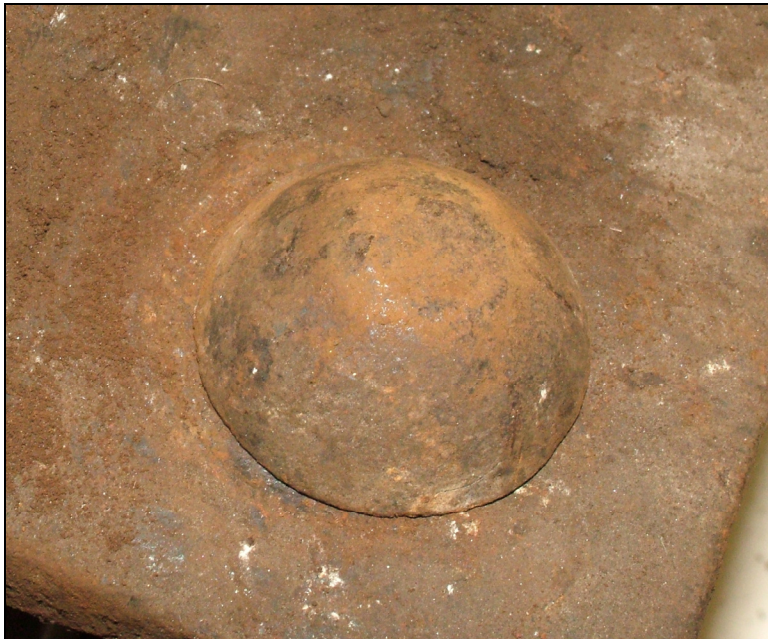
The round track spikes have a head that covers the entire hole in the 10-inch tie plates, making it difficult to assess the wear and corrosion occurring on the shank of the spikes or the tie plate holes (Photo 13).

Photo 13. Top view of head of round track

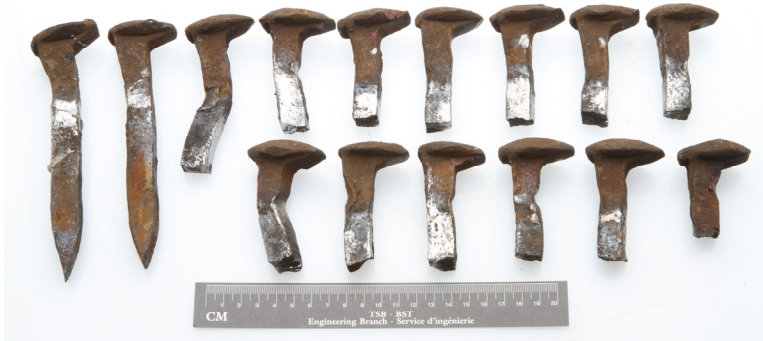
were shiny. Others showed various degrees of oxidation (Photo 14). Examination of these spikes at the TSB Laboratory (Report LP 003/2012) determined that:

- the spikes did not break at the same height;
- the broken spikes failed in fatigue;
- the fatigue cracks varied by their age; and
- the shiny surfaces of the spikes, deformation, and fatigue cracks suggest that there was some significant relative movement of the spikes and tie plates.

Photo 14. Track 21 broken track spikes

The track spikes from Track 21 had failed due to fatigue and the failures had likely occurred before the introduction of the new AMT locomotives.
