**RAILWAY INVESTIGATION REPORT  
R11V0057**

**MAIN TRACK TRAIN DERAILMENT**

**CANADIAN PACIFIC RAILWAY  
UNIT COAL TRAIN 861-060  
MILE 30.0, CRANBROOK SUBDIVISION  
FERNIE, BRITISH COLUMBIA  
08 MARCH 2011**

Report Number R11V0057

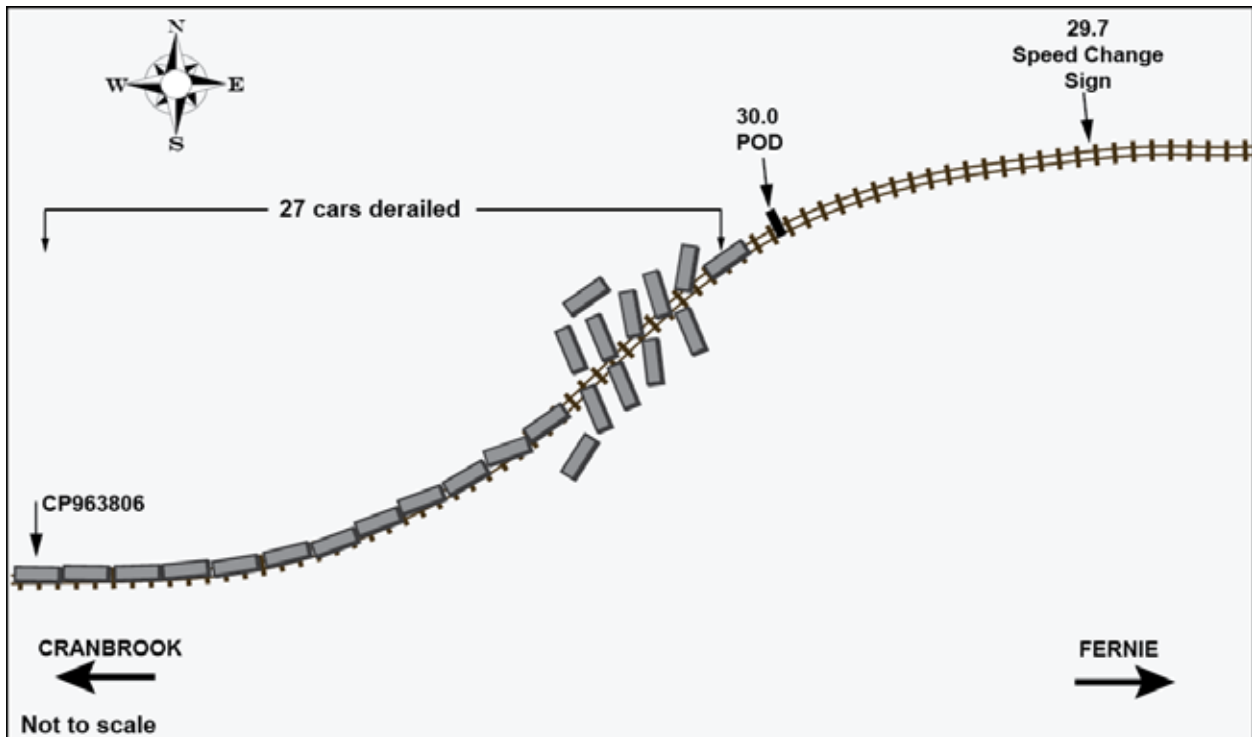
Figure 2. Derailment site diagram

A total of 27 cars derailed west of the point of derailment (POD) at approximately Mile 30.0. CP 963806 was the 32nd car in the train and the first of the derailed cars (Figure 2). At the time of the occurrence, the site was snow covered. Over the previous 4 weeks, this area had experienced a variety of weather conditions, including thawing conditions, rain, and heavy snowfalls followed by freezing temperatures.

At the POD, an examination of the high (south) rail revealed marks on the gauge side of the rail that were consistent with a rail roll-over, wheel-drop event. There were also accompanying impact marks on the adjacent rail anchors made by the derailed equipment.

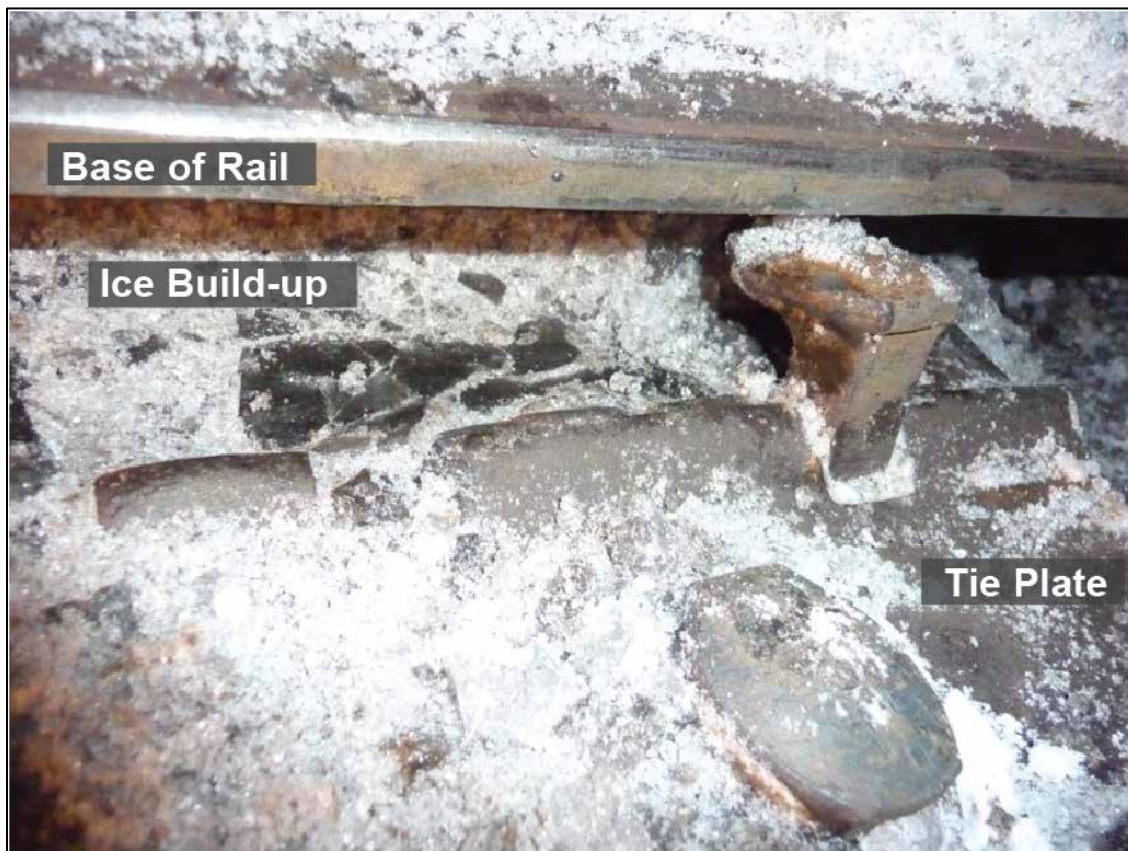
During site examination, ice was present on the high rail tie plates in the vicinity of the POD (Photo 1), including in the rail seat area. A combination of weather conditions and track conditions, including inadequate drainage, is normally required for this condition to develop.

During temperature variations involving freeze/thaw cycles, rain, snow and snow showers, along with melt water can produce ice build-up at the base of the rail. In these situations, the ice build-up can result in the canting of the rail. Rail cant can be difficult to notice during a visual inspection and even more so when the ground is covered in snow.

**Photo 1.** Ice build-up on tie plate

Loss of cant contributes to gauge widening. In this occurrence, the initial gauge widening condition was exacerbated by gradual outward canting of the high rail over time with the passage of many trains. Canting of the high rail occurred when ice built up between the base of the rail and the tie plates to the point of wheel drop-in. This ice accumulation had been facilitated by the pumping action of trains which drew snow or melt water to the base of the rail. With significant temperature variations over the previous 4 weeks, there had been a number of freeze-thaw cycles at the derailment location.

- In September 2011, rolled tie plates were installed in the derailment curve, in conjunction with the installation of new rail.
