Transportation Safety Board
of Canada

**RAILWAY INVESTIGATION REPORT
R11V0254**

**MAIN-TRACK DERAILMENT
CANADIAN NATIONAL RAILWAY
CN TRAIN C 76551 20
MILE 58.83, NECHAKO SUBDIVISION
CARIBOO, BRITISH COLUMBIA
21 DECEMBER 2011**

Report Number R11V0254

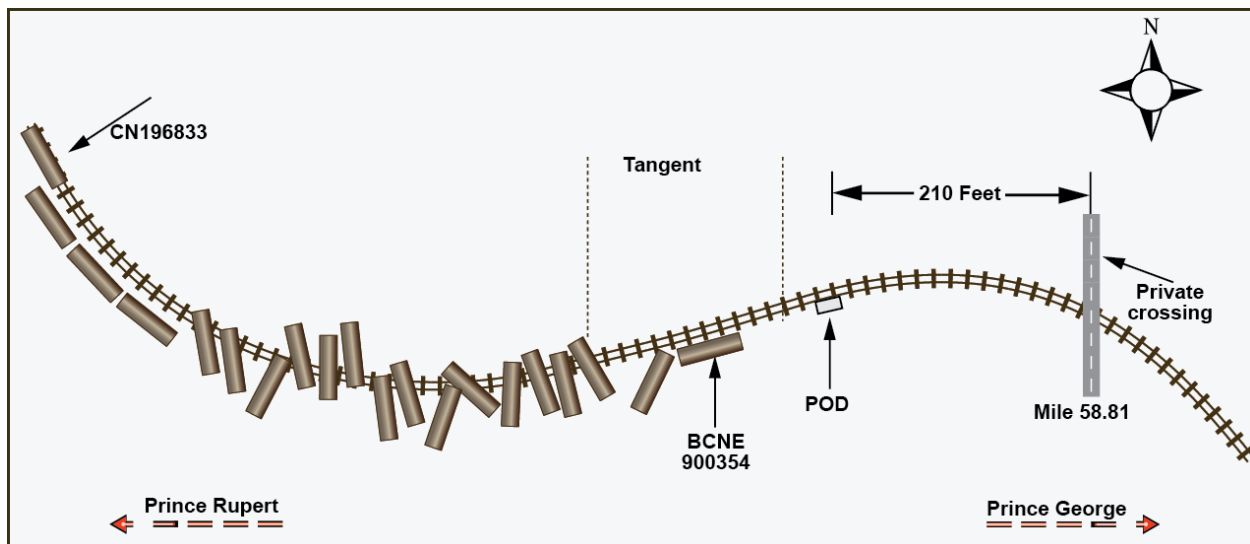
Figure 2. Site sketch (Not to scale)

The L4 wheel on the 38th car, CN 196833 (the car), had broken and had derailed to the gauge side of the south rail. After derailling, the car travelled approximately 504 feet where the L4 wheel re-railed. Approximately 100 feet west of the POD, the rail had rolled over. During the derailment sequence, the 3 cars directly behind CN 196833 derailed in a stringline fashion and the 16 cars behind them derailed in an accordion-type fashion (Figure 2).

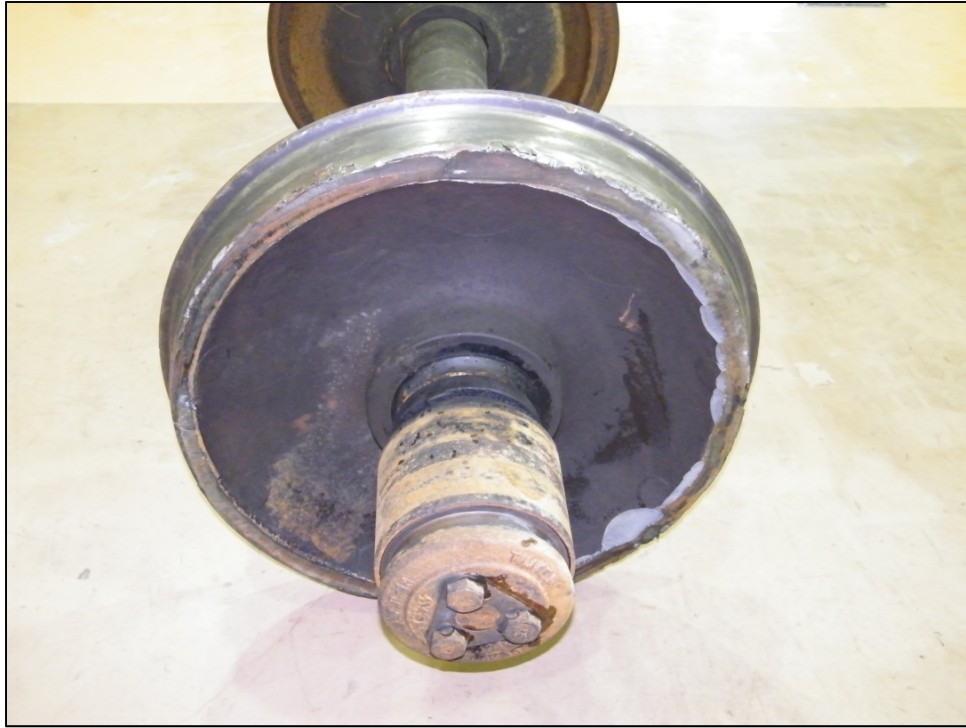
The L4 wheel (the wheel) of CN 196833 was manufactured in November 1993 by the Griffin Wheel Company in Winnipeg, Manitoba (Photo 1). The wheel was a two-wear, cast, wide flange contour, and heat treated wheel.

Photo 1. Wheel set with the broken wheel and mate wheel

- The broken wheel had fractured from a vertical split rim (VSR) from a single origin location.
- None of the recovered wheel fragments mated to the VSR fracture origin. All four wheel fragments had fractured from the wheel in overstress. These pieces likely fractured after the VSR origin area had separated from the wheel.

- The fractured wheel had 2 primary areas of shelling on the tread. One area of shelling covered approximately 40 inches of tread length and the other covered 6 inches of tread length. None of the shells were condemnable based on AAR and Transport Canada standards.

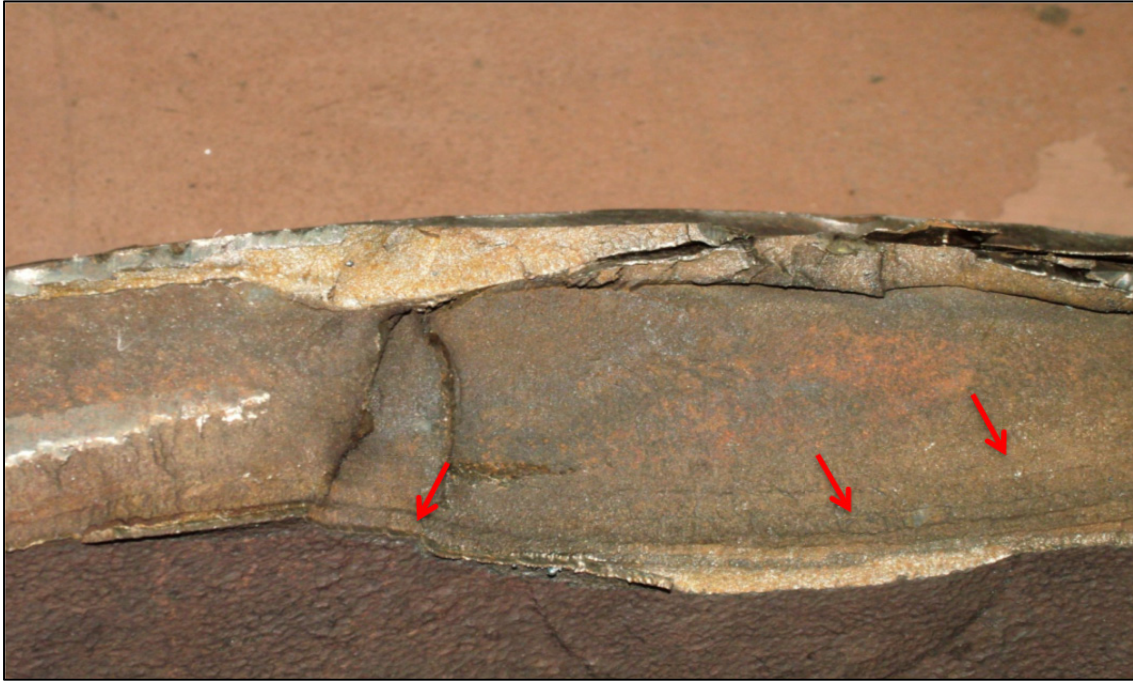
- The origin of the VSR was located approximately 0.5 inch below the wheel tread surface. Beach marks were visible on the fracture surface. There was a shell on the tread of the wheel approximately 1.5 inches from the VSR origin. This shell extended into a sub-surface crack propagating approximately parallel to the tread surface (Photo 2).

Photo 2. The origin area of VSR. Note the visible beach marks (arrows)

- Due to damage on the tread face, it was not possible to determine how far the sub-surface crack had propagated on the other side of the shell. The mating fracture surface at the VSR origin area was not recovered so it is not known if there was a shell directly above it on the wheel tread surface.
- Wheel hardness and chemical composition of the broken wheel were within the AAR limits for class C wheels. There were no metallurgical anomalies observed at the origin of the VSR which may have led to the wheel failure.
- The mate wheel had no observed damage and no areas of shelling were found.
- Both the broken wheel and the mate wheel showed an overheated band adjacent to the wheel tread which was caused by friction heat from heavy braking.

1. There was a non-condemnable shell, per TC regulations and AAR rules on the wheel tread approximately 1.5 inches away from the origin of the VSR. However, since the mating fracture surface was not recovered, it could not be determined if the VSR initiated from the shell.
