**RAILWAY INVESTIGATION REPORT
R11V0257**

MAIN-TRACK DERAILMENT

**CANADIAN PACIFIC RAILWAY
FREIGHT TRAIN CP 353-267
MILE 41.50, MOUNTAIN SUBDIVISION
MOBERLY, BRITISH COLUMBIA
27 DECEMBER 2011**

Report Number R11V0257

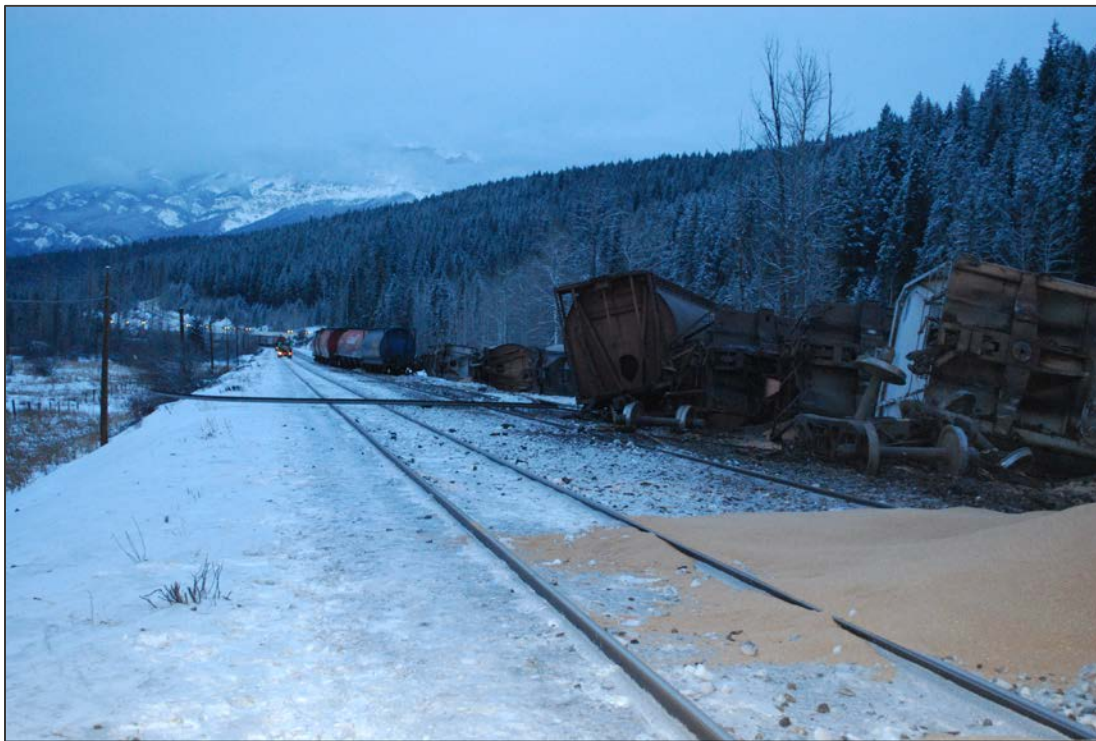
The next 26 cars were not derailed. These cars were followed by 3 cars which derailed in a stringline fashion. The first of these 3 cars (CP608303) had derailed its trailing truck at the east back-track switch. The following 30 cars were derailed in an accordion manner on the north side of the north main track (Photo 1 and Figure 2).

As a result of the derailment, the east back-track switch was destroyed. A total of 2900 feet of track was damaged, including 900 feet of the back track, 1800 feet of the north main track, and 200 feet of the south main track.

Photo 1. Derailment site (facing west)

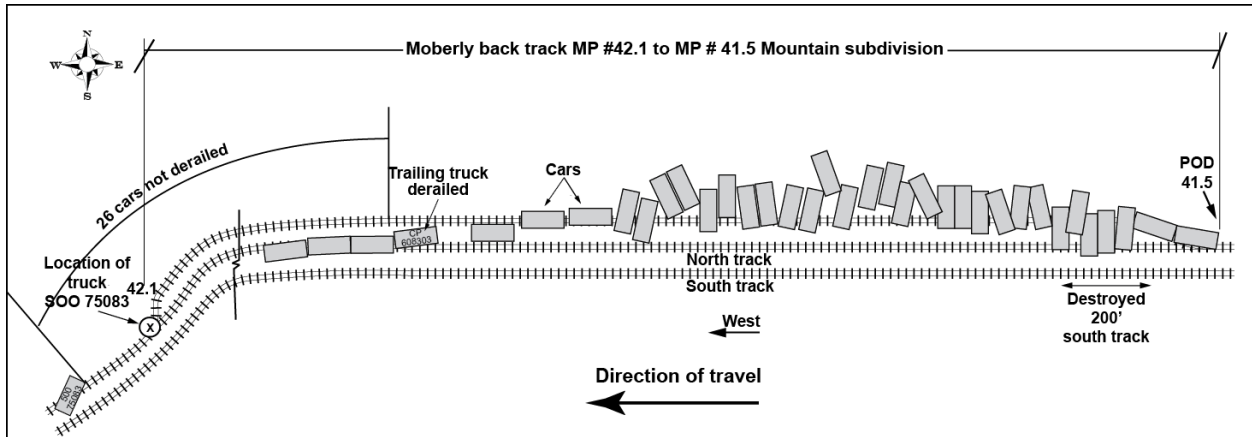
Figure 2. Accident site diagram

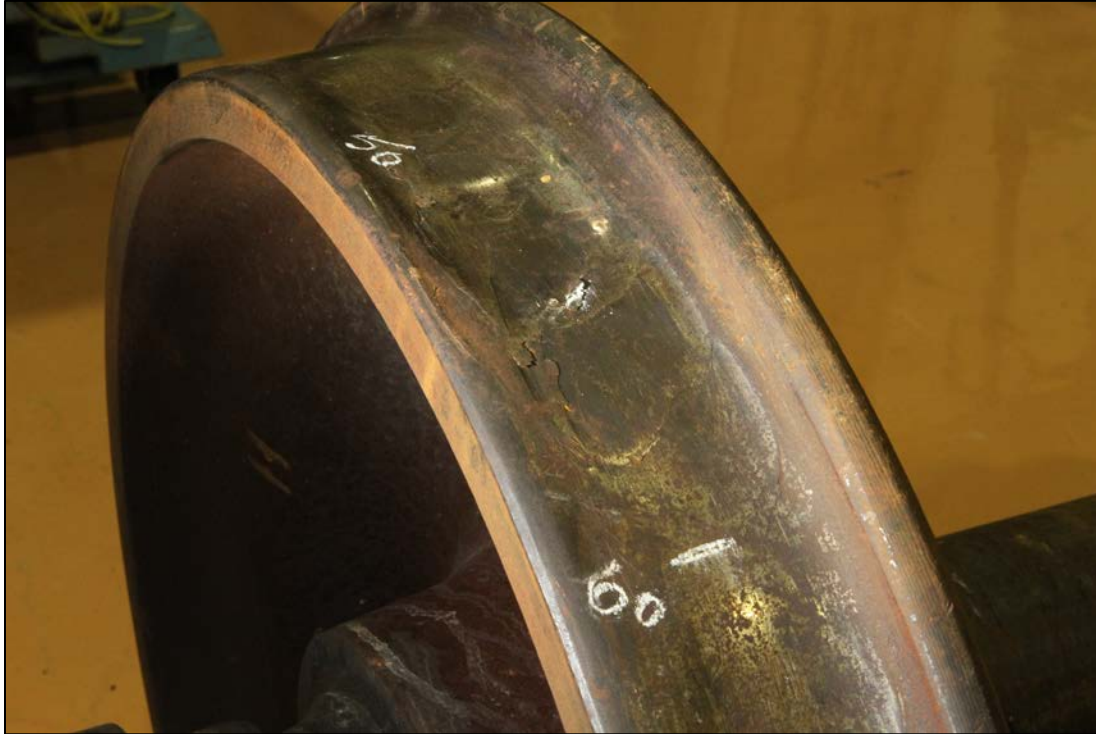
- The wheels had multiple flat areas (i.e., slid flats) situated around most of the circumference of the wheel treads (Photo 2). The coloration and rounded edges of these slid flats and the fact that several slid flats blended into each other indicated that the slid flats were not fresh and pre-dated the occurrence.

- Runout⁶ for the wheels on the No. 2 wheel set was measured. The 8 deepest runouts varied in depth from 0.118 inch to 0.280 inch. Rail wheels are condemnable by AAR rules when any run-out exceeds 0.070 inch.⁷

- Slid flats are also condemnable by AAR rules when found to exceed 2 inches in length for a single slid flat or 1.5 inches for 2 or more adjoining spots.⁸ On the L2 wheel, there

were 9 condemnable slid flats ranging from 3 inches to 11 inches in length. On the R2 wheel, there were 8 condemnable slid flats ranging from 2 inches to 14 inches in length.

Photo 2. Typical slid flats on the R2 wheel of the No. 2 wheel set

The wheels on the No. 2 wheel set were found to have multiple condemnable slid flats and to be in condemnable out-of-round condition. The coloration and rounded edges of these slid flats, and the fact that several slid flats blended into each other, indicated that the slid flats were not fresh and pre-dated the occurrence. Although the slid flats and the out-of-round condition of the No. 2 wheel set on SOO75083 were condemnable, the WILD readings for this wheel set were

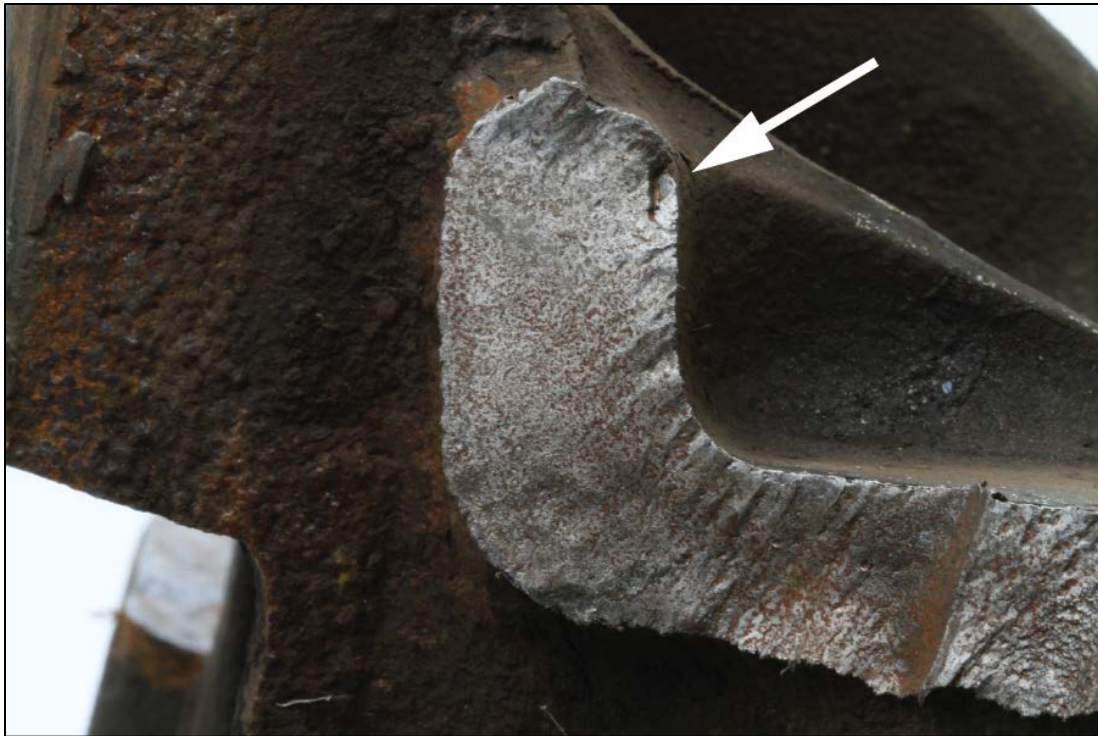
- The brake beam failed due to an instantaneous overstress extension of a pre-existing fatigue crack.
- The fatigue cracking was likely caused by abnormal cyclic stresses due to interaction of the brake beam with an out-of-round wheel set.
- The fatigue cracking initiated at a casting surface irregularity located just inboard of the separated brake head (Photo 3).
- The brake beam material met the manufacturer's specification.
- The brake beam was in operation without brake shoes long enough for the brake heads to have taken on the profile of the respective wheel treads (Photo 4).

Photo 3. Close-up of origin area after cleaning (Note: The casting surface irregularity is visible towards the top right of the fracture surface.)

The TSB laboratory examination of the No. 2 brake beam on SOO75083 determined that it had failed due to an instantaneous overstress extension of a pre-existing fatigue crack. The fatigue cracking had initiated at a casting surface irregularity located just inboard of the separated brake head. The fatigue cracking was likely caused by abnormal cyclic stresses due to the interaction of the brake beam and the out-of-round wheels on the No. 2 wheel set.

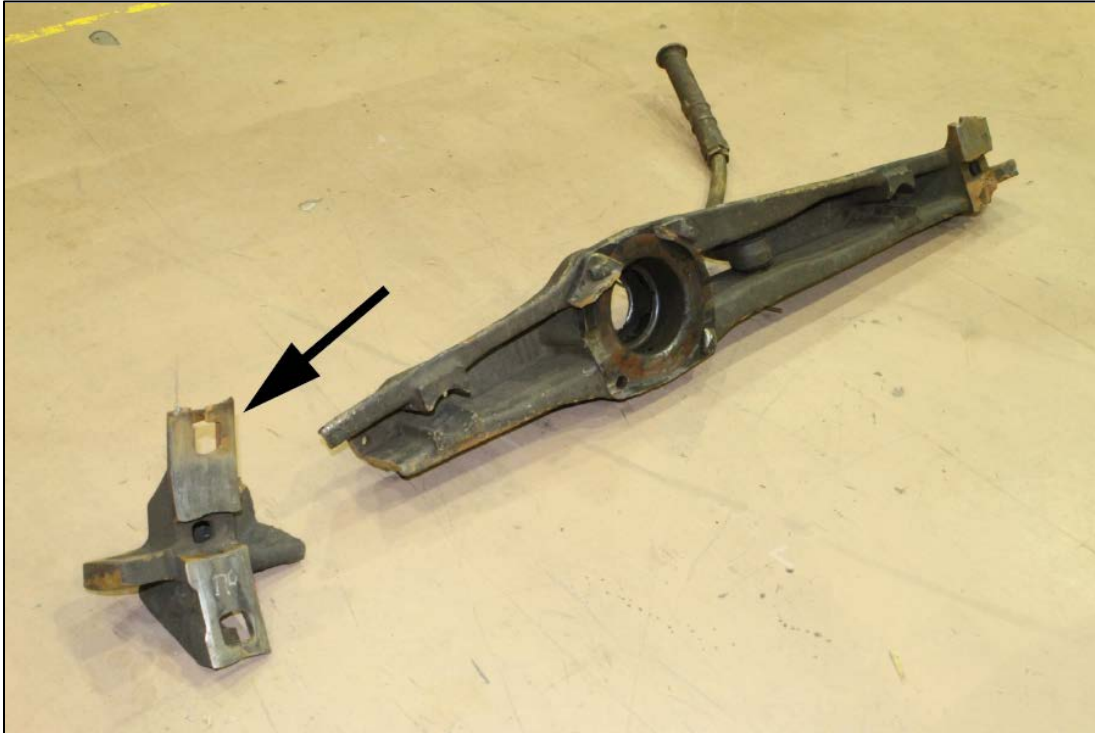
Photo 4. Fractured brake beam (Note: Brake head has taken on the profile of wheel tread)

Brake applications through normal train operation had brought the brake shoes in contact with the slid flats and out of round wheels, resulting in accelerated wear of the brake shoes until they were completely worn away. The lab analysis determined that the brake beam had been in operation without brake shoes long enough for the brake heads to have taken on the profile of the respective wheel treads.
