**RAILWAY INVESTIGATION REPORT
R13C0008**

**CROSSING COLLISION
CANADIAN PACIFIC RAILWAY
FREIGHT TRAIN 118-19
MILE 50.61 BROOKS SUBDIVISION
TILLEY, ALBERTA
19 JANUARY 2013**

Railway Investigation Report R13C0008

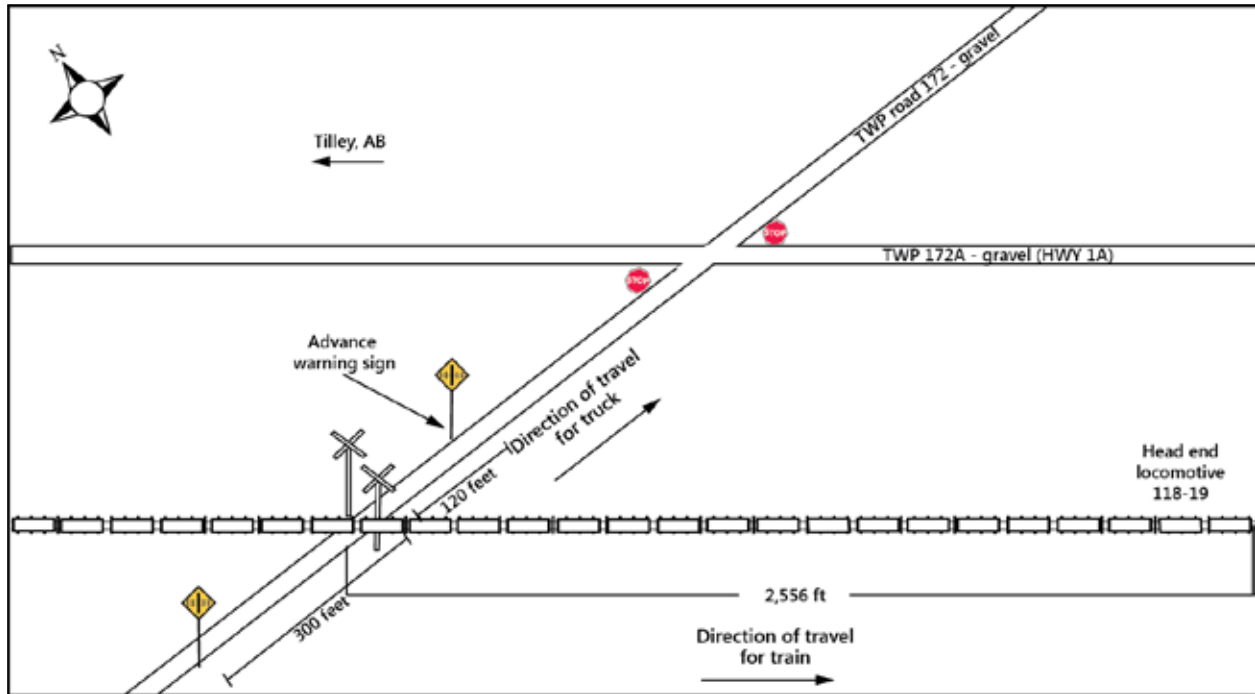
Figure 2. Diagram of the occurrence site

Township Road 172 is a two-lane, gravel rural road that crosses the railway track at an angle of nearly 40°. The public crossing is protected by standard railway crossing signs, also commonly known as crossbucks. The posted speed limit on Township Road 172 is 80 km/h.

Approximately 264 feet north of the crossing, Old Highway 1A (Township Road 172A) runs parallel to the Brooks Subdivision. This road is a two-lane rural road that runs between Brooks, Alberta, and Suffield, Alberta, and is used as a secondary road between the two towns. As Old Highway 1A intersects Township Road 172 at a 40° angle, it can be difficult for northbound vehicles to execute a left turn onto Old Highway 1A. Stop signs are placed so as to stop traffic in both directions travelling along the Old Highway 1, giving the right of way to traffic moving along Township Road 172 (Figure 2).

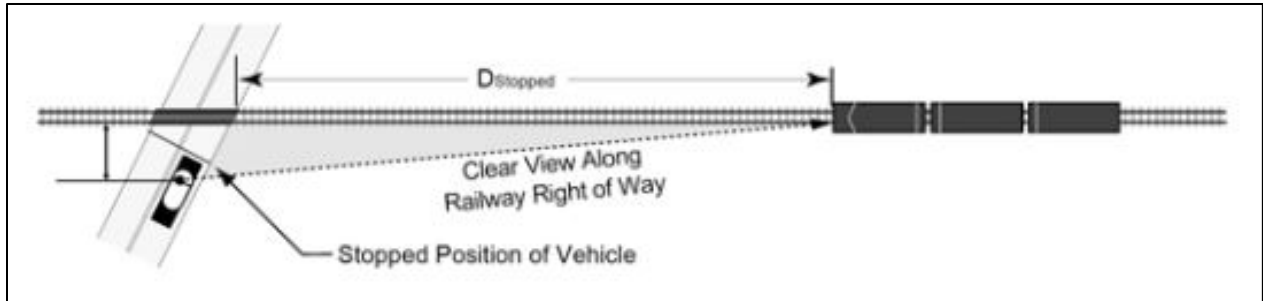
Figure 3. Minimum sightlines for drivers stopped at a crossing with railway crossing signs or stop signs (Source: Transport Canada, Draft RTD 10 - Road/Railway Grade Crossings - Technical Standards and Inspection, Testing and Maintenance Requirements, Part B, Section 8).

The draft RTD 10 also indicates that the minimum sightlines for a grade crossing (without a road crossing warning system) must conform to a clear sight triangle. This triangle is based on the maximum train speed for the track and the maximum allowable speed for the road. The sightline distances are measured at a height of 1.0 m (3.3 feet) above the road surface, at the centre of the roadway, and 1.2 m (4 feet) above the top of the track, at the centre of the rail (Figure 3).

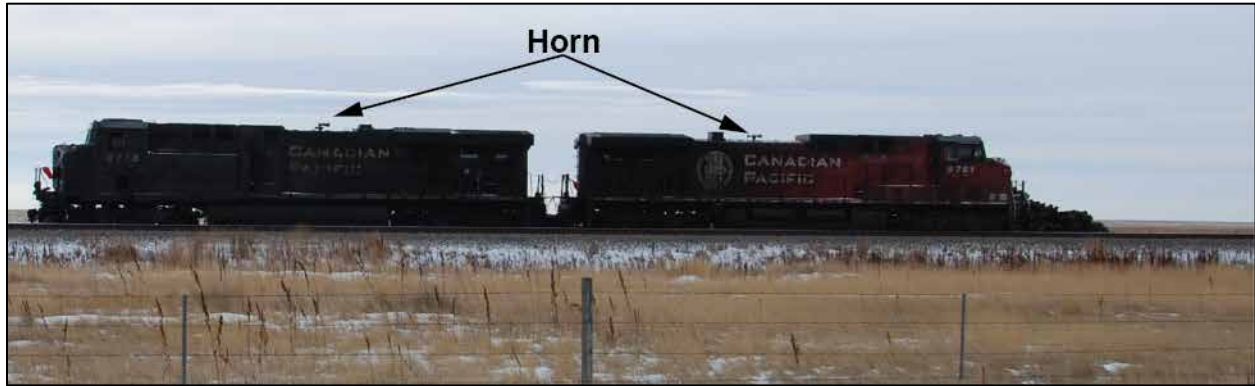
Photo 1. Horn placement on occurrence locomotives

The sounding of the locomotive horn as the train approaches a crossing provides an auditory warning to drivers and pedestrians in the vicinity of the crossing. The effectiveness of the horn is diminished by the attenuation of the sound pressure levels. Forward-propagating sound pressure levels are reduced with

- increased distance travelled by the sound waves;
- increased operating speeds of the locomotive;
- reduced proximity of the horn to the front of the locomotive; and
- increased proximity to any obstructions in front of its flutes, such as exhaust vents on the locomotive or nearby buildings and vegetation.

In this occurrence, the locomotive horn on the freight train was positioned on top and in the middle of the locomotive in an area that was recessed (Photo 1).

In comparison, for locomotives in passenger service, TC issued modified *Railway Locomotive Inspection and Safety Rules* in 2010¹⁷ that required the installation of a new horn by 01 January 2012 on locomotives operating in the lead position and travelling in excess of 65 mph. The new horn must be capable of generating two sound levels: a high-level mode used for emergencies and a lower-level mode used in normal train operations. The horn must be placed near the front of the roof, no more than 5 feet behind the rear of the cab, with no obstructions or exhaust outlets ahead of or beside it.

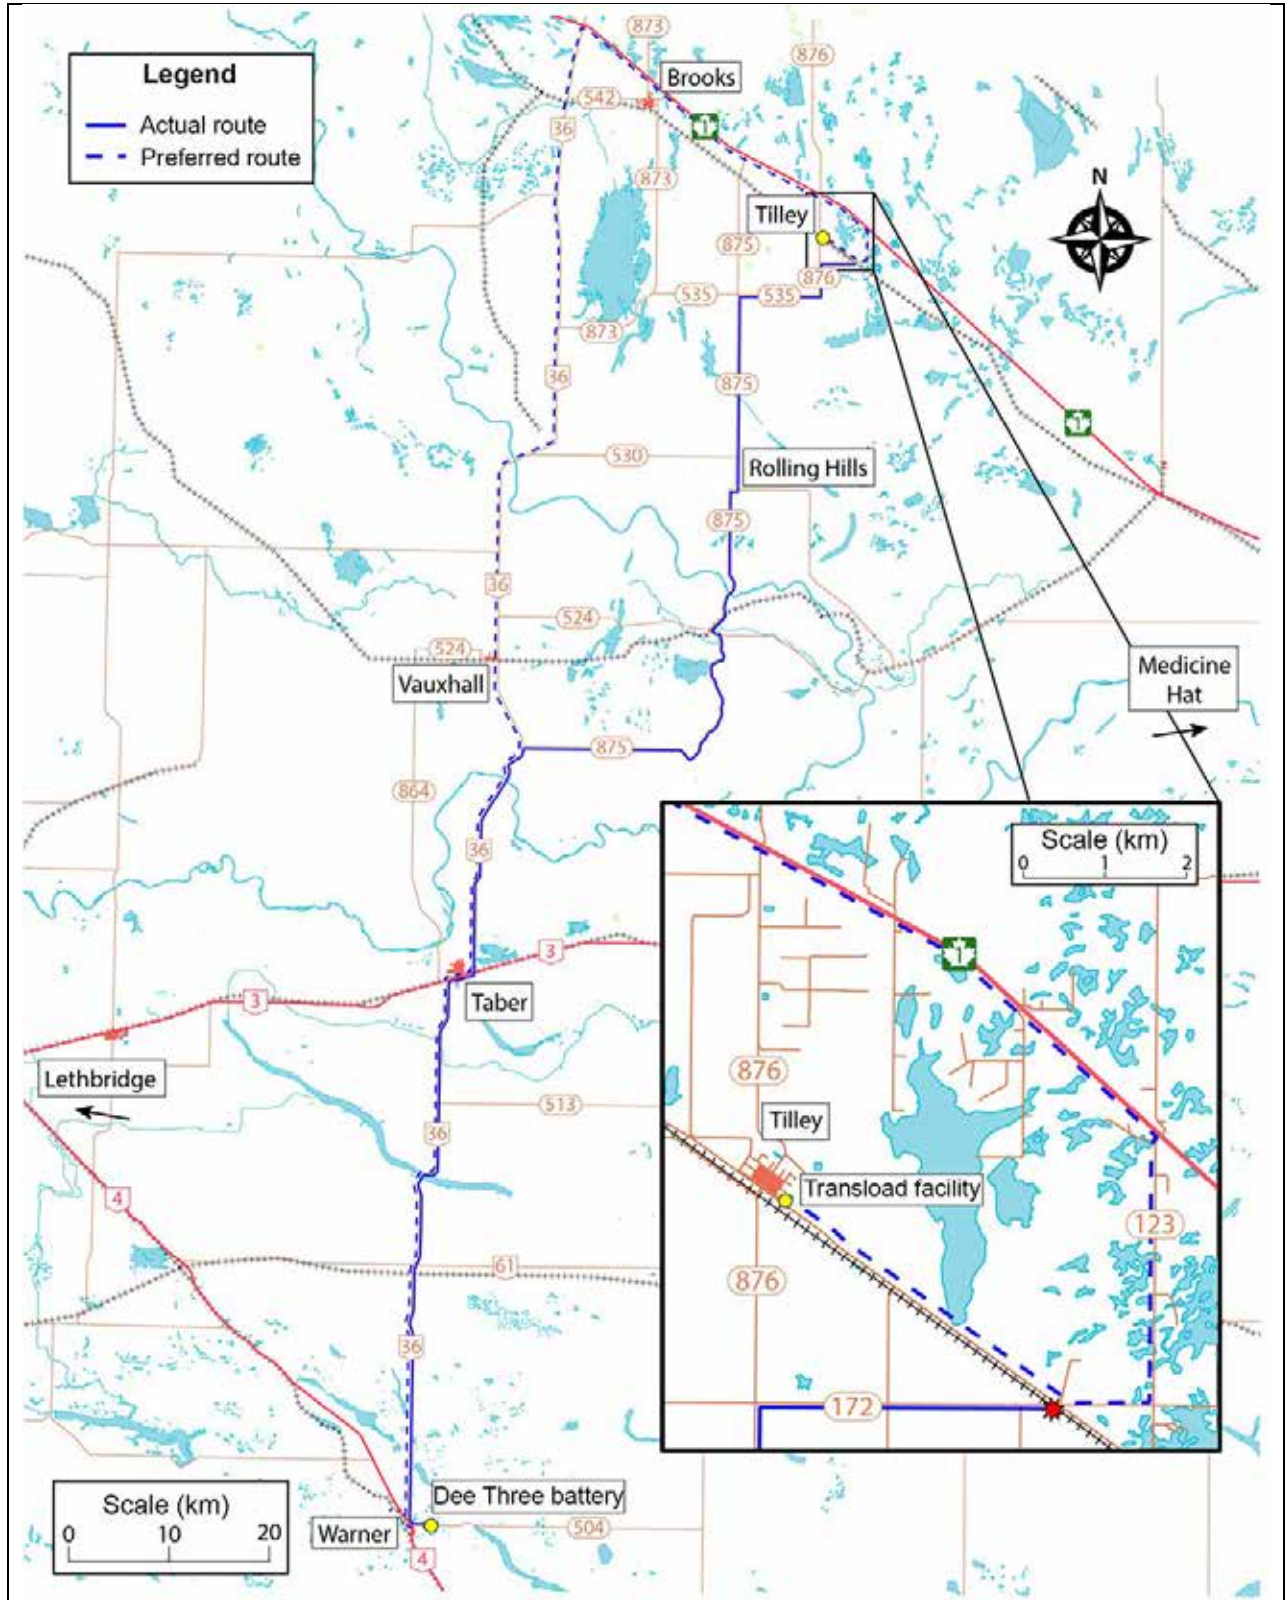
Appendix A – Preferred route vs actual route

From the Trans-Canada Highway, the preferred route for trucks travelling to the Tilley transloading facility is to exit south on Range Road 123, turn west onto Township Road 172, and then head northwest on Old Highway 1 (i.e., Township Road 172A, 171A, 173A). Trucks would then enter the Tilley transloading facility from Township Road 173A. Once the trucks are offloaded, the trucks exit the facility at the northwest corner of the site and then head southeast on Old Highway 1, to follow the same route in reverse back to the Trans-Canada Highway.

The driver in this occurrence had been given verbal directions on the preferred route. He was advised to avoid the residential areas, but he was not provided with detailed information on the preferred route. Approaching Tilley, the driver left Highway 36 and continued north via Highway 875. He then took Township Road 172, which would take him to the transloading facility, but would still avoid the town of Tilley.
