**RAILWAY INVESTIGATION REPORT
R13D0001**

CROSSING COLLISION

**VIA RAIL CANADA INC.
TRAIN NUMBER 601
MILE 98.79, JOLIETTE SUBDIVISION
JOLIETTE, QUEBEC
09 JANUARY 2013**

Report Number R13D0001

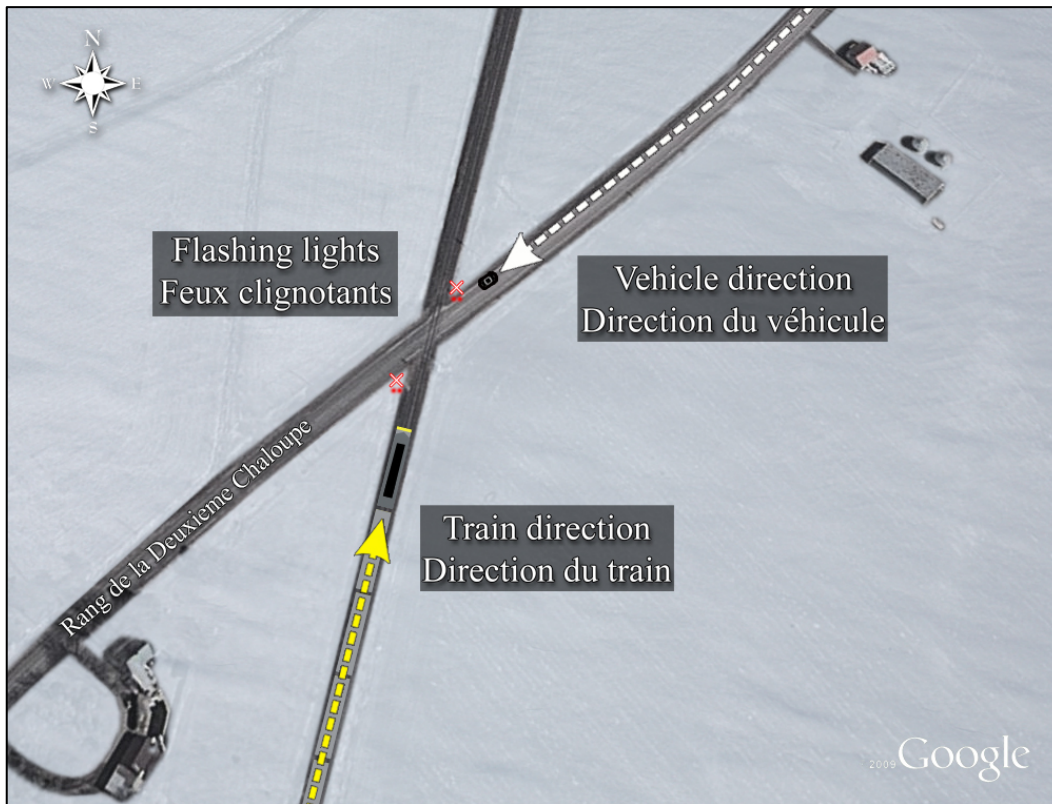
Figure 2. Rang de la Deuxième-Chaloupe crossing

Rang de la Deuxième-Chaloupe is a paved, 2-lane, undivided rural road that intersects the track at a 35°/145° angle (see Figure 2). Under normal visibility conditions, sightlines along the railway right-of-way were clear. The crossing is protected by flashing light signals (incandescent) and a bell. In good weather conditions, the light signals are visible to approaching motorists for at least 600 feet. Advanced warning signs are installed about 600 feet from the crossing along the roadway approach in both directions and are visible to approaching motorists for at least another 600 feet. The road has a maximum speed limit of 80 km/h.

Prior to the accident, the crossing was last inspected by the railway in May 2008. During this inspection, it was noted that the advanced warning sign, which is maintained by the road authority, was showing the crossing angle to be 90°. This advanced warning sign depicting the crossing at 90° was still present at the time of the accident.

The replacement of incandescent signal lights with LEDs under the Transport Canada Grade Crossing Improvement Program is a positive step to improve the visibility of flashing lights. The railways have ongoing programs to change out the incandescent lights. However, with the large number of crossings to be retrofitted, it may take some time before all the identified crossings are completed. Had LED lights been in place at the rang de la Deuxième-Chaloupe crossing, the visibility of the crossing signal would have been improved.

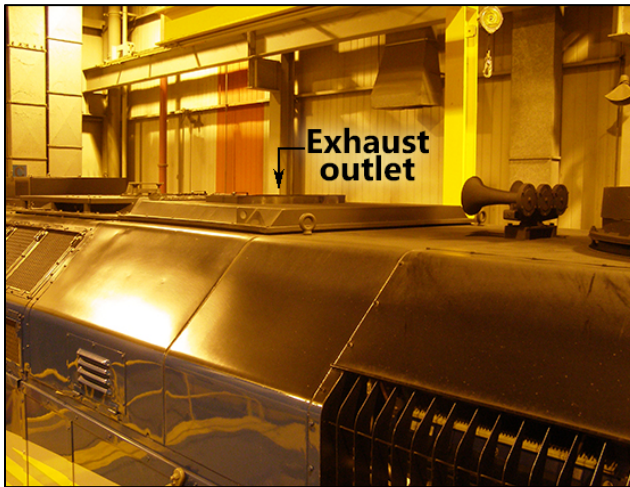
Photo 1. 3-flute horn on locomotive VIA 6404

Locomotive VIA 6404 is a F40PH2D model locomotive built by General Motors in 1987. The original horn on this type of locomotive was a forward-facing 3-flute horn positioned mid-locomotive along its centreline and directly behind the exhaust outlet (see Photo 1). To comply with the *Railway Locomotive Inspection and Safety Rules*, VIA 6404 was recently retrofitted with a second, louder 5-flute emergency horn positioned over the cab (see Photo 2). The 3-flute horn is used during normal service operations, including whistling at crossings. The 5-flute horn is limited to emergency situations in order to reduce the train crew's exposure to high level sounds. *Canada Occupational Health and Safety Regulations* restrict the maximum sound level in the locomotive cab to 96.7 dB(A). No specific instructions are issued to operating crews outlining conditions where the use of the emergency horn is required.

The locomotive event recorder from train 601 indicates that the 3-flute horn was first activated about 1450 feet from the crossing. This horn was sounded for about 16 seconds and then stopped just prior to impact. The 5-flute emergency horn was not used during the approach to this crossing.

In this occurrence, the train horn (that is, the 3-flute horn situated mid-locomotive) was sounded from the whistle post (that is, about 1450 feet from the crossing) to close to the crossing. However, it was not effective in alerting the drivers of both the first vehicle and the following vehicle to the presence of the train. The driver of the first vehicle and the driver of the vehicle that was stopped on the west side of the crossing did not hear the horn until the train was very close to the crossing.

The emergency horn is generally used only for high risk or emergency situations (for example, when trespassers are walking along the track facing away from oncoming trains). However, during severe weather conditions such as dense fog or blowing snow, when visibility in the vicinity of the crossing is hindered, proactive use of the train's emergency horn could provide an effective warning to oncoming vehicles, reducing the risk of crossing collisions.
