**RAILWAY INVESTIGATION REPORT  
R13E0015**

**CROSSING COLLISION**

**CANADIAN NATIONAL TRAIN L51141-23  
MILE 33.70, BLACKFOOT SUBDIVISION  
PAYNTON, SASKATCHEWAN  
24 JANUARY 2013**

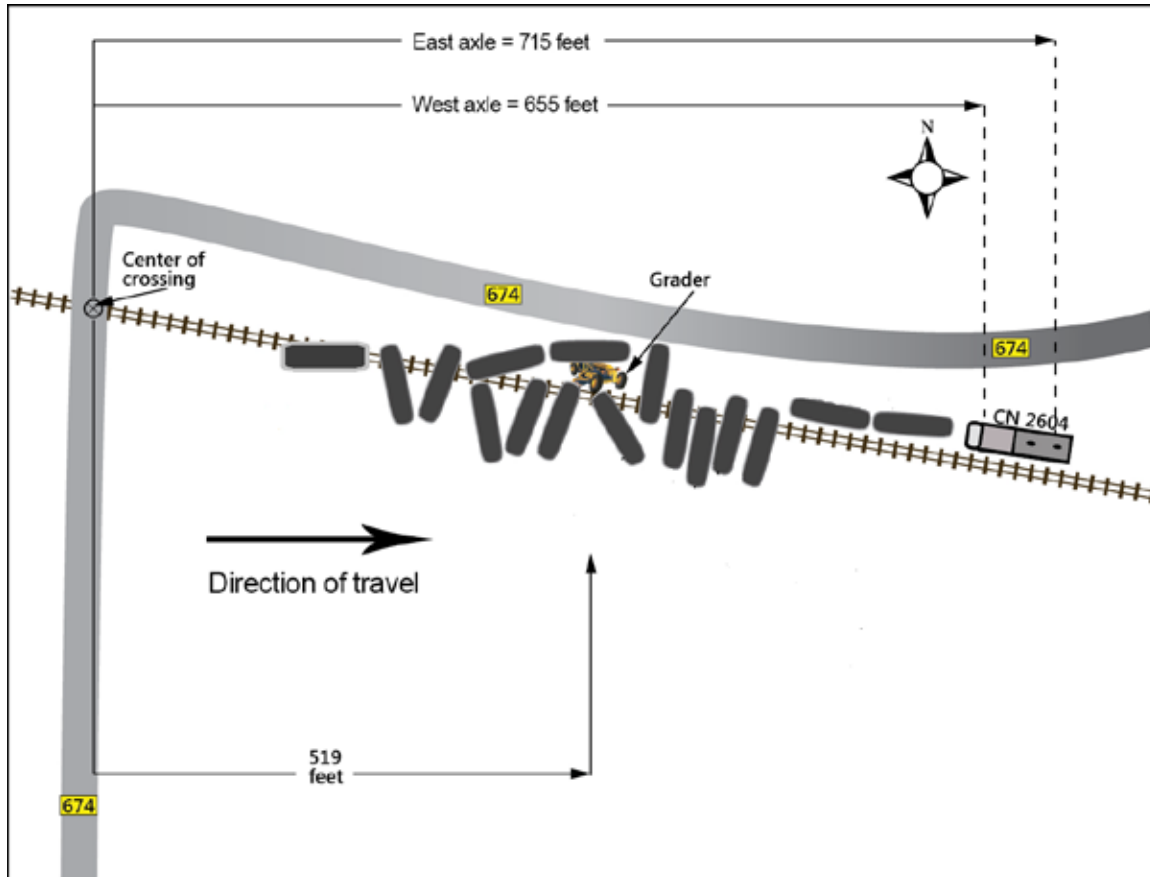
Figure 2. Accident site sketch

Unable to stop in time, the train collided with the stationary road grader. The force of the collision propelled the road grader eastward for approximately 519 feet where it came to rest on the north side of the track. The grader operator sustained fatal injuries. The lead locomotive (CN 2604) continued east and derailed approximately 715 feet past the crossing. In addition, 16 loaded dangerous goods tank cars carrying petroleum crude oil (UN 1993) derailed (Figure 2). Four DOT Class 111 cars were breached and released 106 000 L of crude oil. The locomotive sustained damage to the long hood and running gear due to the collision and derailment. The crew was uninjured.

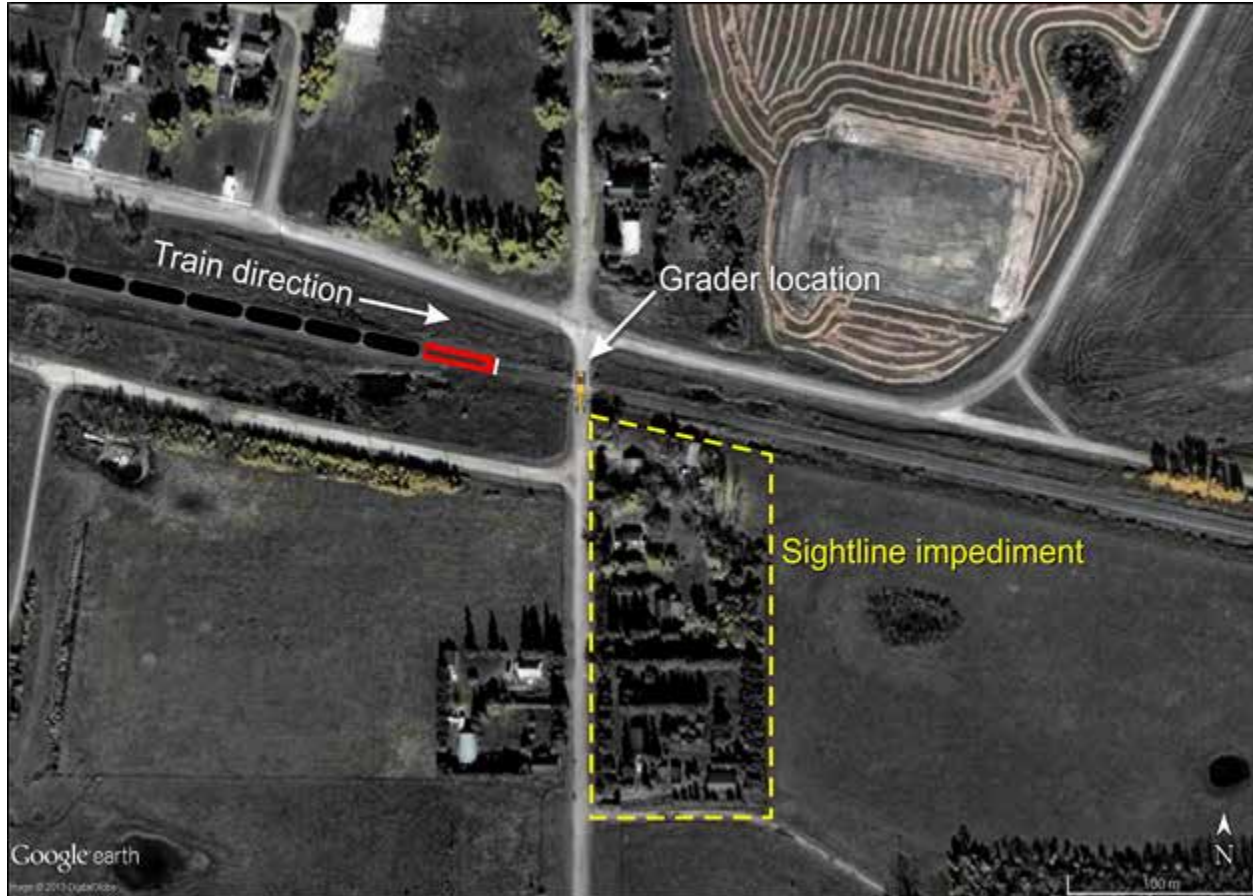
Photo 1. Crossing accident location (Source: Google Earth, with TSB annotations)

For vehicle traffic traveling south, the sightlines at the crossing in both directions were clear (i.e., RTD 10 clear-sight guidelines were achieved). However, for vehicle traffic traveling north, the sightline to the east was partially obstructed by trees and buildings, necessitating the installation of the Stop sign (Photo 1).

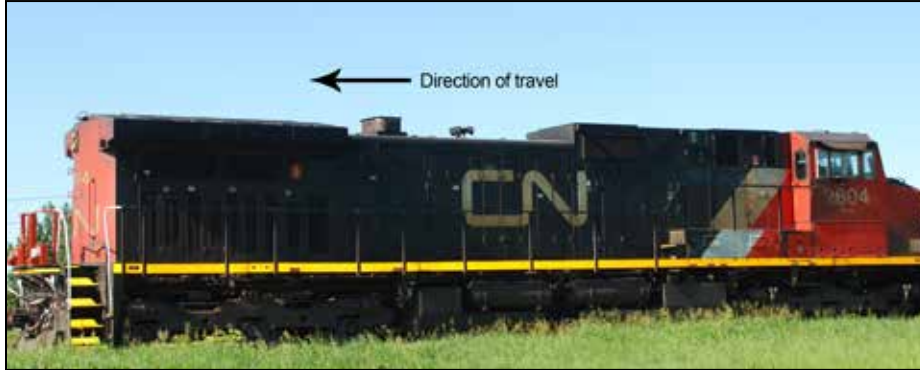
Photo 2. Placement and configuration of the horn on the locomotive

The occurrence locomotive had the horn positioned in the middle of the locomotive in an area on the roof which is recessed. At this location, the horn is below the bulkhead of the locomotive cab. When operating the locomotive in long hood leading orientation, the flutes of the locomotive face opposite the direction of travel (Photo 2).
