RAILWAY INVESTIGATION REPORT R14M0002

MAIN-TRACK DERAILMENT

**CANADIAN NATIONAL
FREIGHT TRAIN M30831-06
MILE 152.60, NAPADOGAN SUBDIVISION
PLASTER ROCK, NEW BRUNSWICK
07 JANUARY 2014**

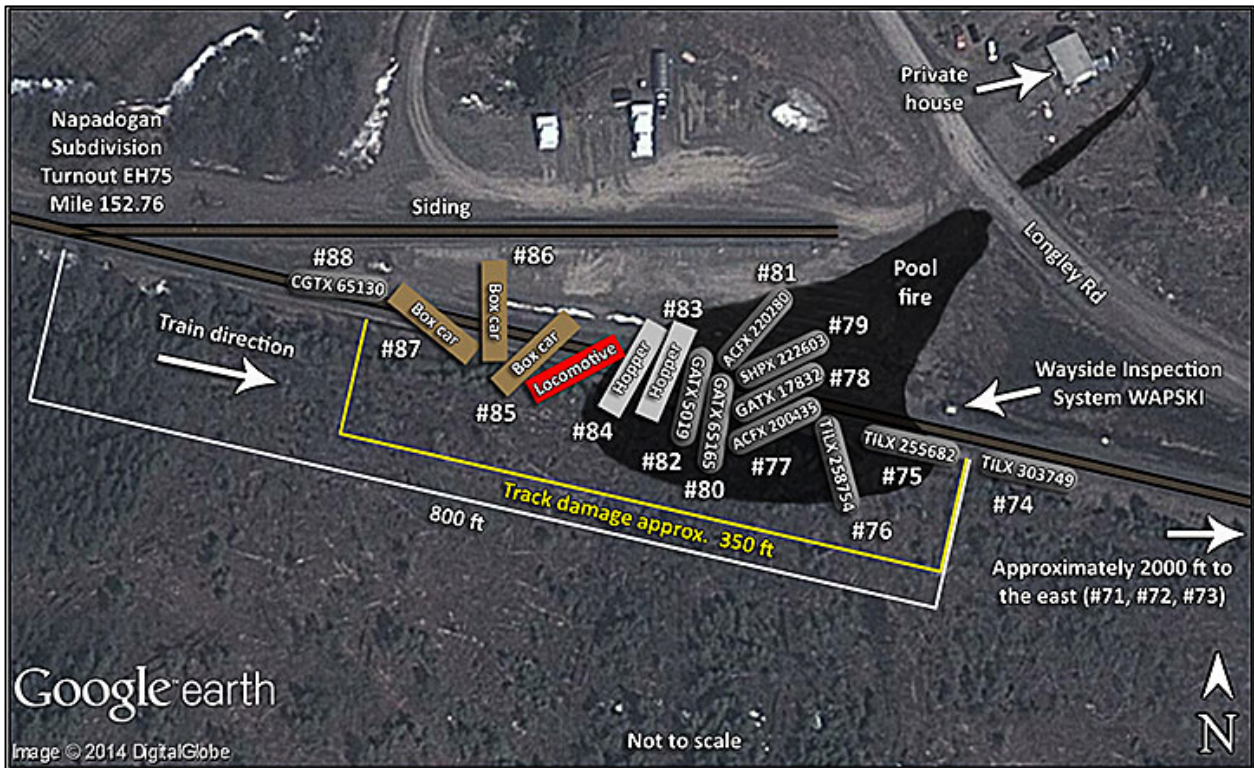
Figure 2. Diagram of the pile-up of derailed cars (Source: Google Earth, with TSB annotations)

A piece of rail measuring about 2 feet was found on the south side of the track beside the last 2 derailed cars (the 87th and 88th). There were batter marks at one end of the piece of rail. Approximately 350 feet of track was completely destroyed where the pile-up occurred. The EH75 turnout, about 800 feet west of the WIS, was also damaged (Figure 2). In addition to the

damage to the rolling stock and railway track, the fire caused by the crude oil spill damaged a nearby house.

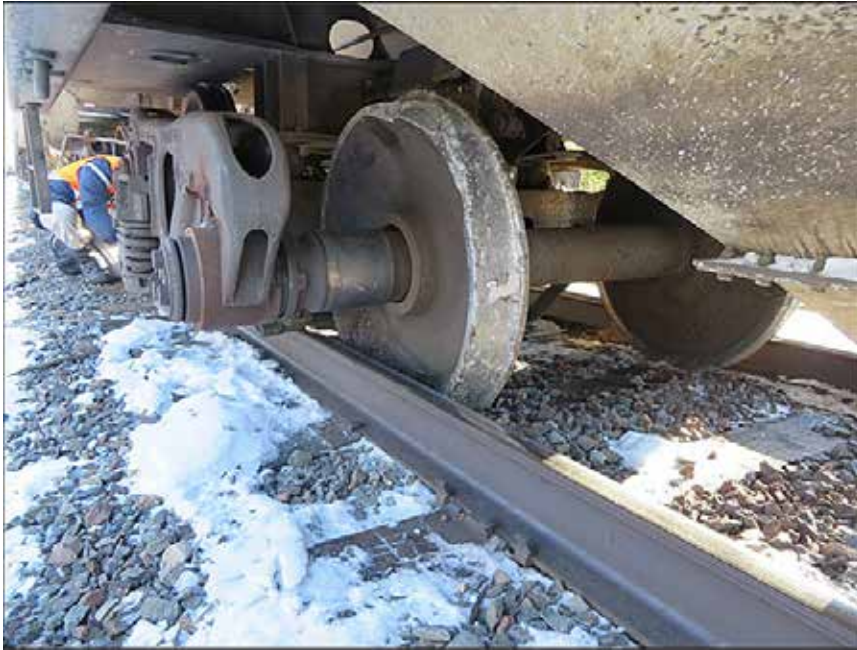
Photo 1. Derailed axle of car CRDX 15109

Examination of the eastbound track, from the site of the car pile-up, showed the presence of grooves in the snow and impact marks on the rail anchors and tie plates that extended up to car CRDX 15109 (13th car). This car came to a stop at Mile 151.44, and the trailing axle of its leading truck (Photo 1) had derailed.

The examination of the derailed cars and distributed power locomotive revealed no mechanical malfunction (except for the broken wheel of the 13th car) before the accident. Furthermore, the train was operated in compliance with company instructions and regulatory requirements. The analysis will focus on the L3 wheel failure of the 13th car, the rail failures and the damage to the tank cars.

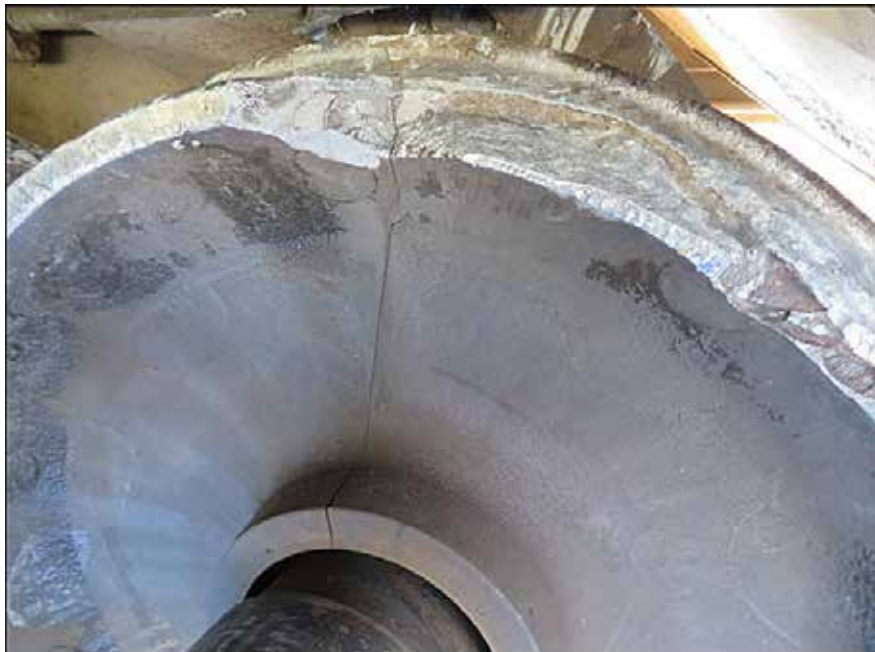
Photo 2. Crack in L3 wheel of car CRDX 15109

The L3 wheel had separated from the wheel seat and shifted inward. Its wheel tread was broken and a section measuring about 24 inches had separated. An open crack extended across the wheel web, from the wheel tread to the hub (Photo 2). The R3 mating wheel showed significant shelling on its entire circumference.

- An open crack extended across the wheel web from the wheel tread to the hub. There was no evidence of progressive failure on the crack surface. Chevron markings pointed to the wheel tread, indicating that the crack began when a section of the running surface shattered; the subsequent wheel pounding caused the crack to spread.
- The L3 wheel tread was broken and a section measuring about 24 inches in length was missing.
- The wheel tread was 1 1/16 inches thick, exceeding the AAR limit of 7/8 inch.
- The 3 retrieved fragments were about 14 inches long and partially matched the missing wheel tread section.
- The running surface of the retrieved fragments showed no surface defects.

When the crack spread, a part of the wheel tread detached from the wheel, resulting in a high impact load that caused an overload failure of the wheel plate, from the wheel tread to the hub. The wheel then came loose from the axle, began sliding inside the gauge and then derailed. After the L3 wheel left the running surface of the rail, the R3 mating wheel derailed inside the gauge and began striking the spike heads and anchors over several miles. The train continued to travel at the allowable speed and the derailed axle only triggered the alarm, alerting the train crew, when it passed the wayside inspection system (WIS) at Mile 152.50.

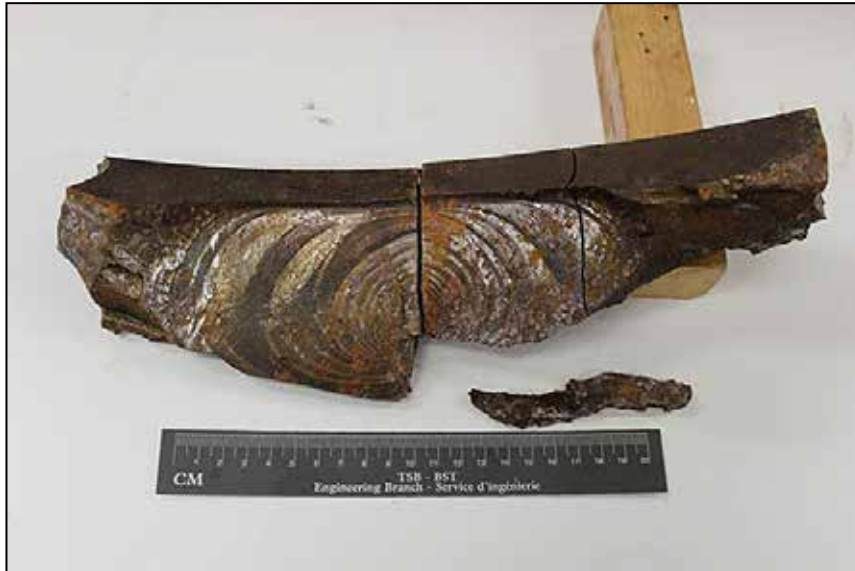
Photo 3. Shattered rim of L3 wheel

- Growth rings were visible on the fragments and indicated that fatigue cracking led to a shattered rim. Concentric marks pointed to a single point of origin, located about ½ inch below the surface of the wheel tread and 2 7/8 inches from its gauge face (Photo 3).
- The undulating pattern observed indicated slow crack growth.
- The R3 mating wheel showed significant shelling,¹³ but less than 1 inch in diameter, on its entire circumference.

The metallurgical analysis of the L3 wheel and the fragments revealed an area of porosity of about 4 mm in diameter at the crack’s point of origin. A sample of the failed wheel was sent to an external certified laboratory for a detailed chemical analysis (American Society for Testing and Materials [ASTM] E415-08). The chemical analysis of the fractured L3 wheel showed that it met the AAR specifications for a Class C wheel (Table 3).

Before the accident, no external defect had been detected on the L3 wheel of car CRDX 15109. The wheel had passed through a wheel impact load detector (WILD) the day before the accident, and no anomaly was reported. The wheel components complied with the specifications of the Association of American Railroads (AAR) for a Class C wheel; however, the wheel had an area of subsurface porosity that led to fatigue cracking, which in turn caused the wheel tread to shatter.

though it had a defect. In 2006, the wheels were reprofiled and, according to the company that performed the work, ultrasonic testing was performed, but no defect was found. Since the porosity defect observed during the metallurgical analysis of the L3 wheel was greater than 1/8 inch, it should technically have been detected during the testing performed after it was reprofiled. However, it was impossible to verify the results of the tests conducted on the L3 wheel since, at the time, there was no requirement to keep test results. However, this deficiency was corrected in 2010 and companies conducting ultrasonic tests must now keep the results for at least 10 years.

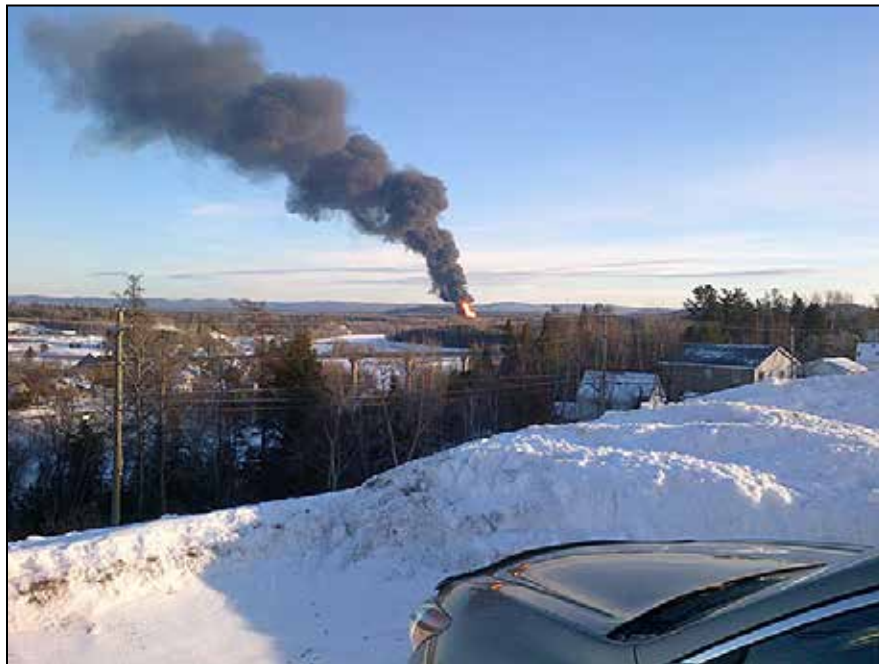
Photo 4. Vent and burn operations

On 10 January 2014, CN submitted a plan to the Ministry of the Environment to the effect that a specialized explosives contractor was to conduct vent and burn operations on 3 tank cars loaded with butane. The Ministry of the Environment and Transport Canada approved the vent and burn plan, which was executed at about 1400 (Photo 4).
