RAILWAY INVESTIGATION REPORT R15D0103

Runaway and derailment of cars on non-main track

Canadian Pacific Railway
Stored cut of cars
Mile 2.24, Outremont spur
Montréal, Quebec
29 October 2015

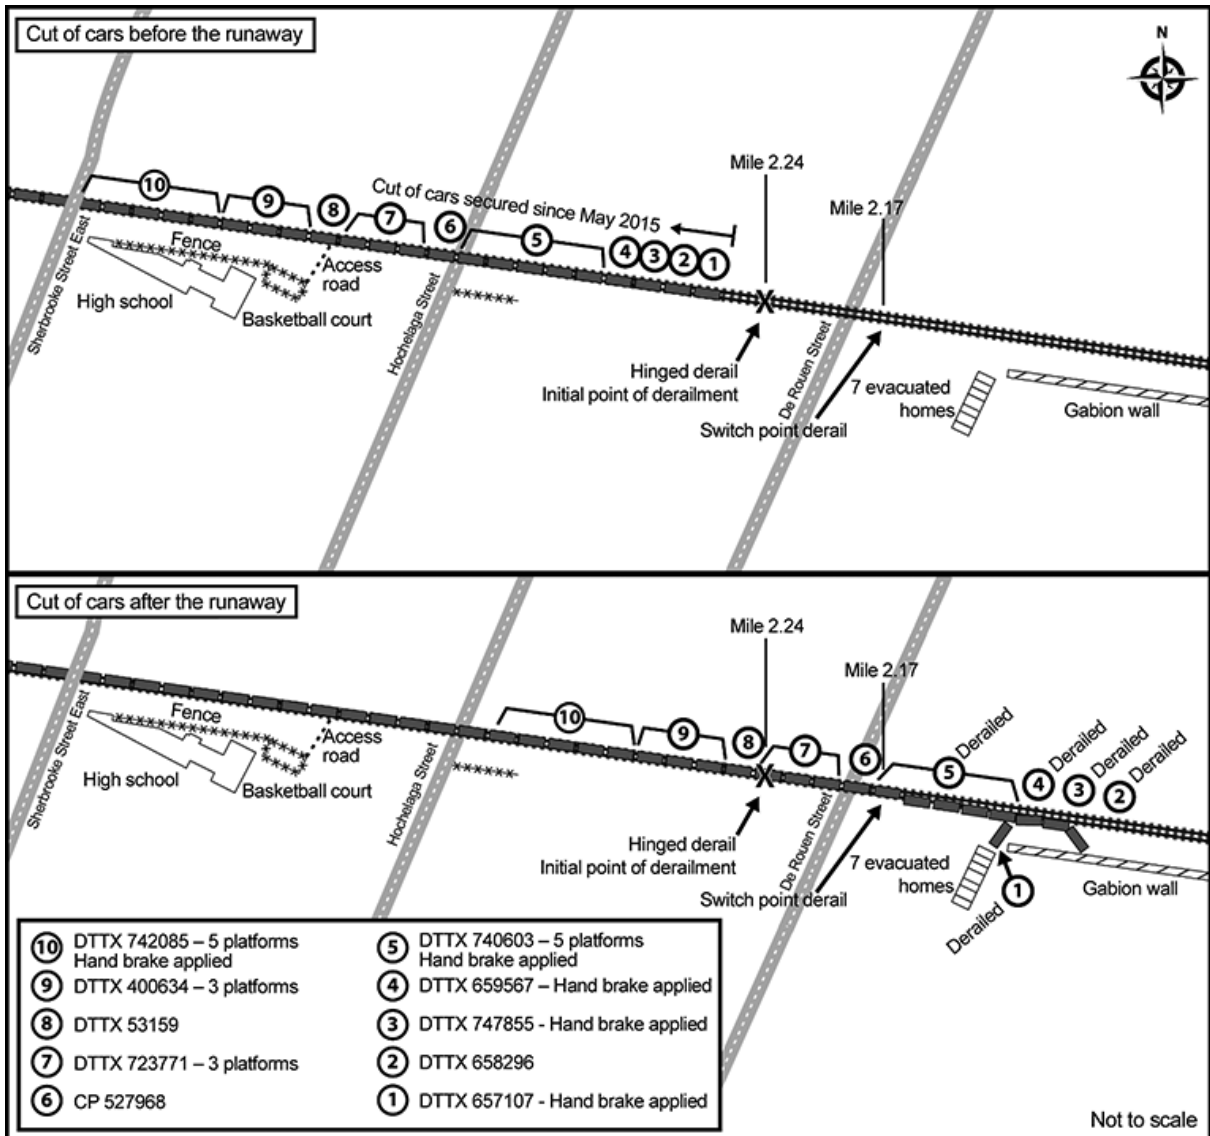
Figure 2. Accident site

The first 5 cars of the cut derailed south of the switch point derail on the west side of track HT4T, obstructing a private CP gravel road running alongside the track. Car DTTX 657107, the lead car of the cut, came to a stop perpendicular to the track (Figure 2), about 500 feet from the derail sign located at Mile 2.24.

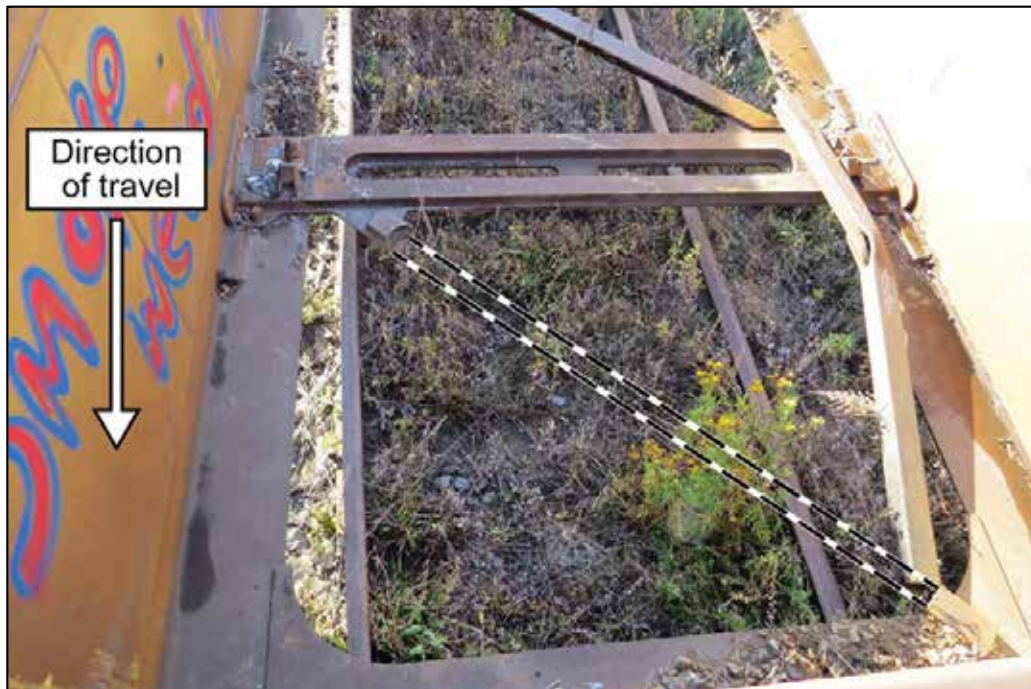
Car DTTX 657107 separated from the other cars of the cut and lost its 2 trucks. It was pushed beyond the embankment, and struck the wall of a house adjacent to the railway right-of-way. The first diagonal member of the car decking was severed (Photo 1).

Photo 1. First diagonal member of the car decking (original position shown by dashed line)

Once the wheels dropped off the rails, the clearance of the car's first diagonal decking member was only about 7½ inches above the ties. This clearance was insufficient to pass over the derail, which was 9½ inches high. The severing of the decking member and damage to the lag screws and the 2 ties on which the derail was mounted indicate that the hinged derail was struck by the member, then torn from the ties and pushed about 5 feet from its original position. Since the hinged derail was torn out, no other wheels were derailed and the rolling stock continued to descend the grade.

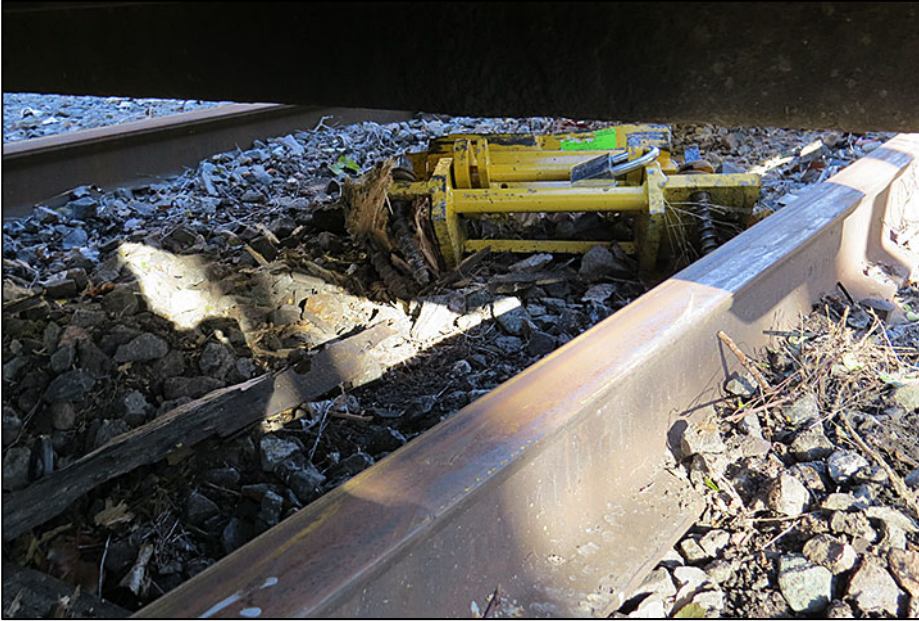
The hinged derail was torn from its position and was found between the rails approximately 5 feet south of the derail sign at Mile 2.24 (Photo 2). An examination of the derail revealed that it was locked. Furthermore, the lag screws of the device were bent, and pieces of wood were still attached to it.

Photo 2. Torn-off derail

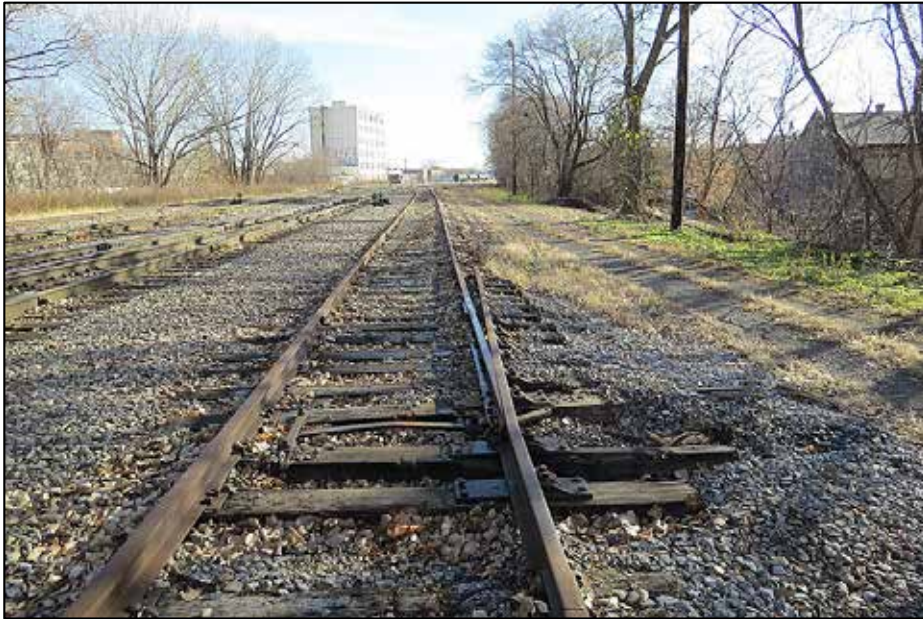
- The switch point derail is designed to derail rolling stock by creating an opening in the rail by means of 1 or 2 switch points (Photo 3).

Photo 3. Switch point derail

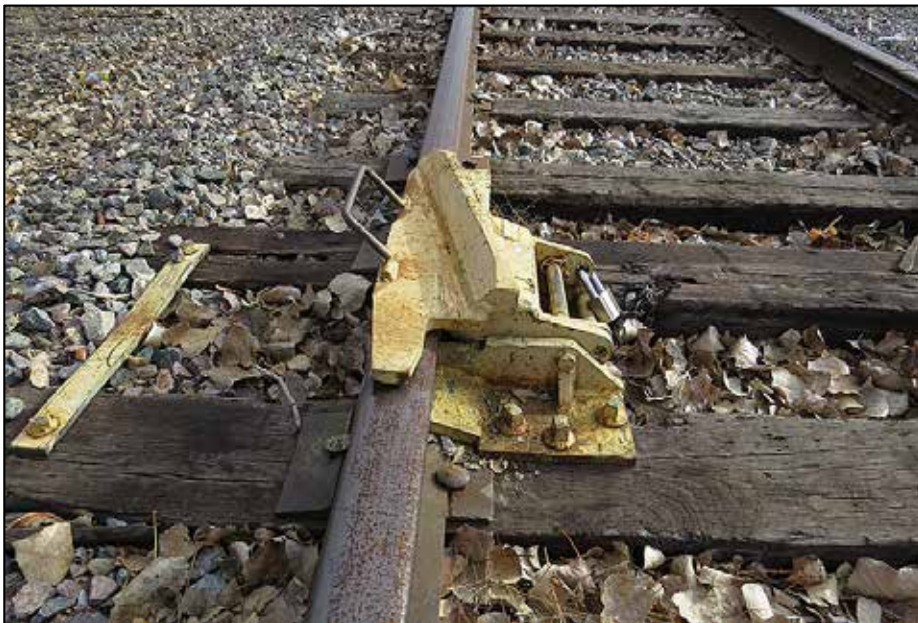
- A hinged derail is made up of a block attached to the ties that must be swung manually atop the running surface of the rail to be in derailing position. This device is used against low-speed movements. When a hinged derail is in the derailing position, its height is 9½ inches from the top of the wood ties and it projects about 3 inches above the rail (Photo 4).

Photo 4. Hinged derail

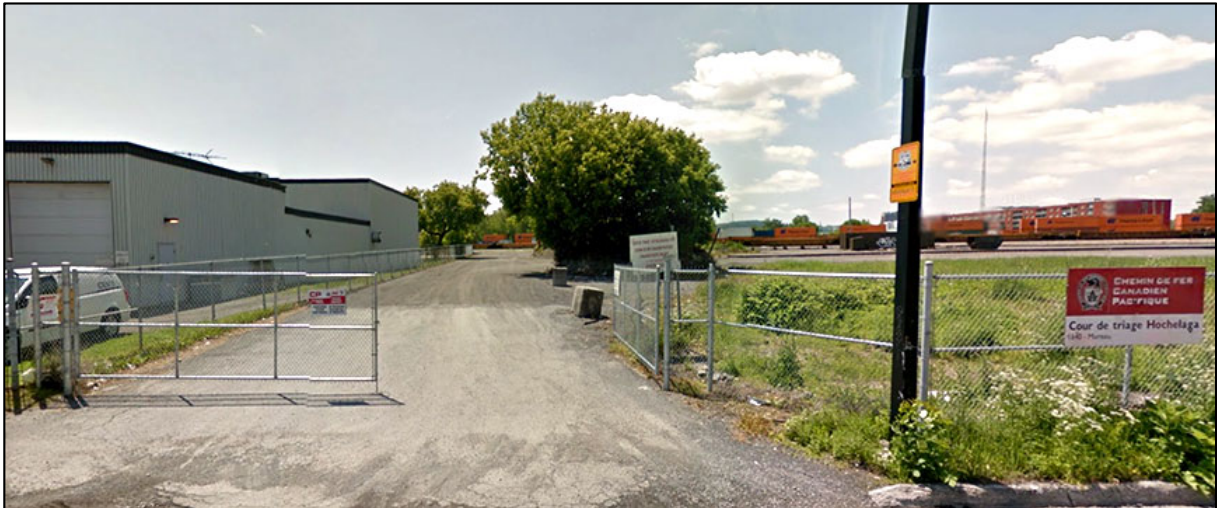
In the immediate vicinity of the Hochelaga Yard and adjacent to homes, the railway right-of-way was protected by a chain-link fence some 6 feet tall (Photo 5). The fence was in good condition.

Photo 5. Chain-link fence in Hochelaga Yard (Source: Google Earth)

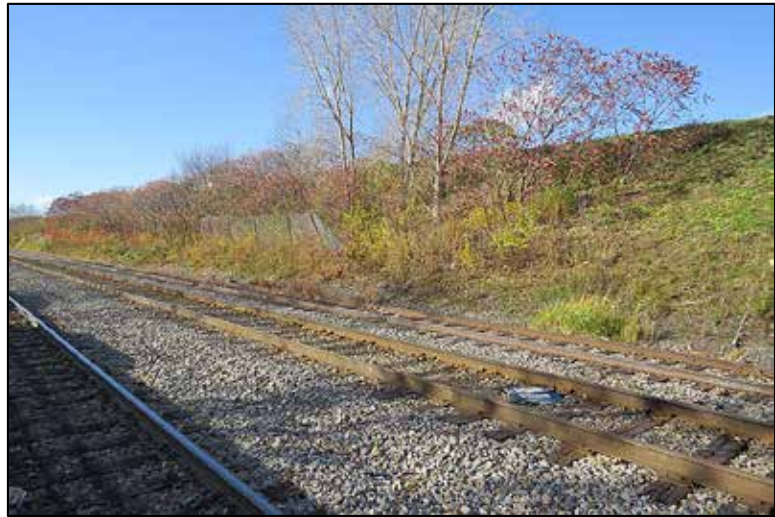
Bordering industrial buildings and near engineering structures, the fence was poorly maintained. In several places, the fence was missing, had breaches or was damaged, allowing easy access to railway tracks and to the rolling stock located there (Photo 6). Openings were visible at numerous locations where unauthorized pedestrians could cross the tracks. Footpaths perpendicular to the railway tracks were present on the west side, one passing near a basketball court and a high school close to the location where the cars in positions 6 to 10 were stored.

Photo 6. Poorly maintained or missing fence

The fences defining the boundaries of the railway right-of-way had breaches and were non-existent in places, which allowed unauthorized pedestrians to easily access the railway tracks and rolling stock found there. The fences defining the boundaries of the railway right-of-way, given their state and location, did not constitute an adequate physical barrier to prevent trespassers from gaining access and tampering with rolling stock stored on the tracks.

Additional measures were taken by CP to eliminate trespassing. A special program was launched to repair damaged fences. Employees working on the site were advised to warn trespassers of the potential hazards associated with railway traffic. CP police conducted surprise inspections of the site and imposed fines on violators.

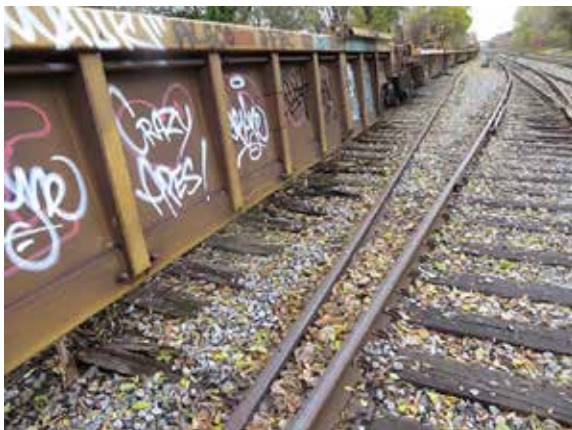
There were cans of spray paint and empty bottles on the railway right-of-way. In addition, graffiti was painted on most of the cars, railway engineering structures, and neighbouring buildings (Photo 7 and Photo 8). Railway personnel indicated that they regularly encountered trespassers, and that the fences required constant work, because new openings appeared as soon as the old ones were repaired.

Photo 7. Graffiti on derailed cars

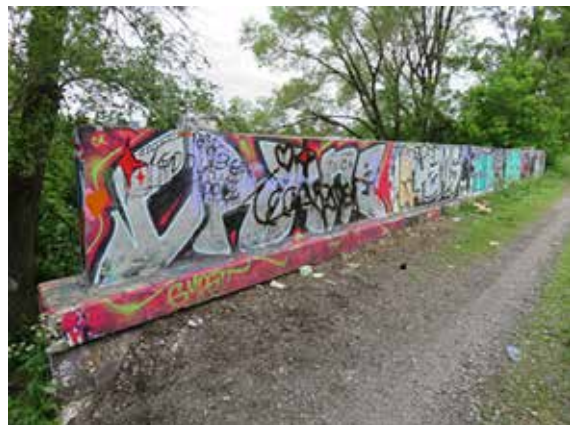
Photo 8. Graffiti on bridge railings
