RAILWAY INVESTIGATION REPORT R15D0118

Main-track derailment

VIA Rail Canada Inc.

Passenger train No. 605

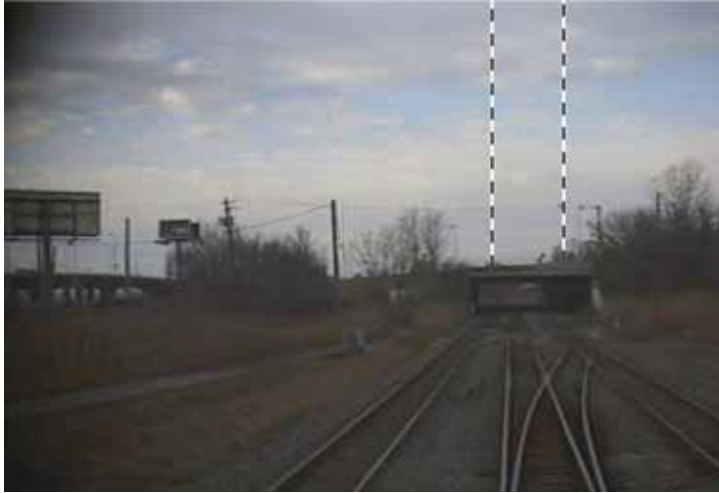
Photo 1. View from locomotive before crossover 75 (0923:34)

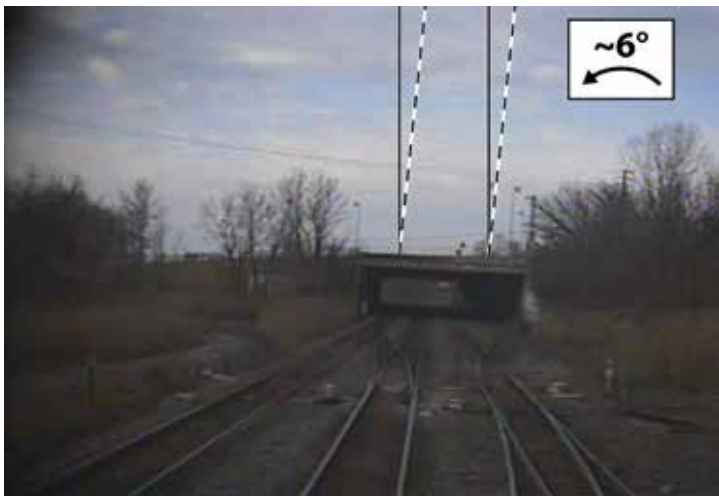
Photo 2. View from locomotive tilted to the left (0923:36)

When the train entered crossover 75, it was travelling at about 55 mph, while the authorized speed for this type of crossover is 15 mph. Based on still images from the locomotive forward-facing cameras, while negotiating the crossover, the train swayed from side to side. These oscillations are due to dynamic forces caused by the high speed and the change in curvature at the crossover. These forces tend to push rolling stock to the outside of the curve and cause tilting and weight transfer, which could lead to wheel lift. In this occurrence, the angle reached was 17 degrees and, as a result, the wheels completely left the rail surface. The dynamic forces caused by the 55 mph speed of the train and the geometry of crossover 75, which was designed for a speed of 15 mph, caused a transfer of weight that resulted in a wheel lift and the derailment of locomotive VIA 6413.

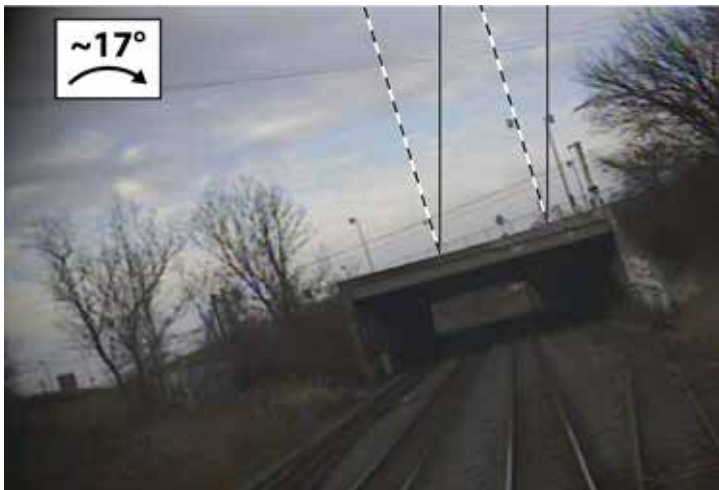
Photo 3. View from locomotive tilted to the right (0923:38)

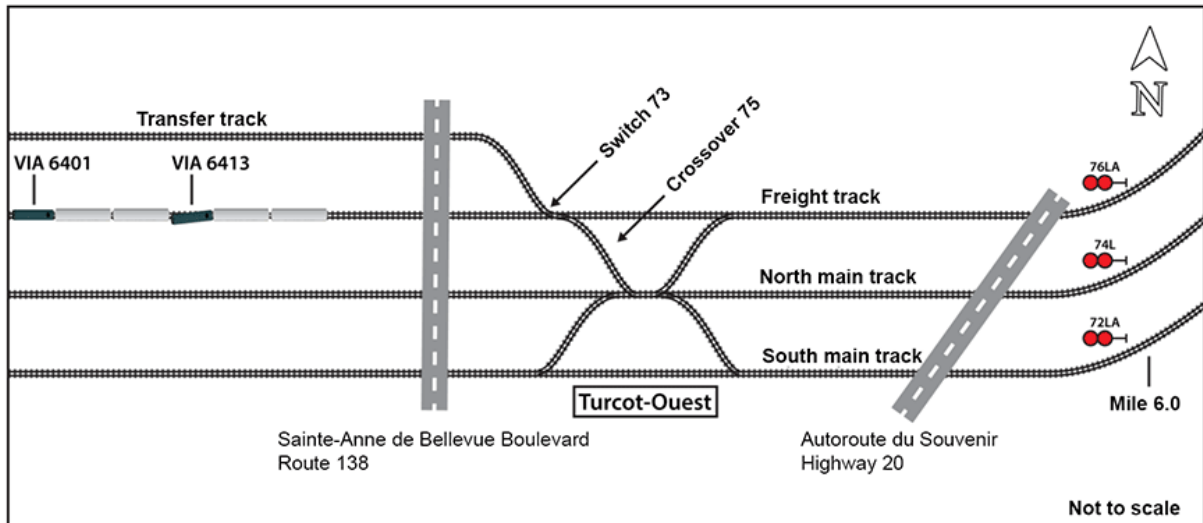
Figure 2. Derailment site

The train came to a stop on the freight track, west of the Sainte-Anne-de-Bellevue Boulevard overpass, in way of Mile 6.6. The lead truck of the second locomotive (VIA 6413) derailed and shifted 22 inches to the south of the track. Locomotive VIA 6413 sustained minor damage to the pilot and traction motor gear case of the first axle. The first locomotive and other cars remained on the track, coupled together.

From the derailed truck of locomotive VIA 6413, 2 grooves, one between the rails and the other south of the track, were visible on the ties and ballast. They extended eastward for a distance of about 1600 feet, ending 50 feet from crossover 75. Over this distance, the ties were cut out. Spikes, tie plates, anchors, and one joint bar were damaged.

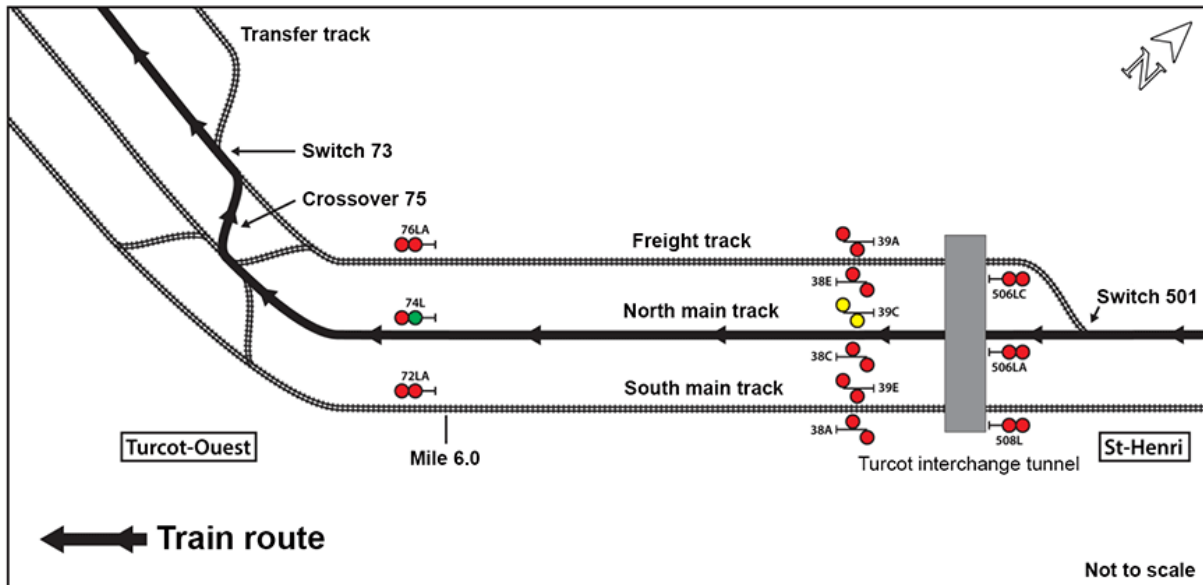
Figure 3. Train route

The route established by the RTC for the train from Central Station to Turcot-Ouest was recorded in the rail traffic control system. The route revealed no incompatible movement. It allowed the train to travel on the north track, then switch at crossover 75 to access the freight track. Train movements at this location are governed by advance signal 39C and controlled signal 74L (Figure 3).

Examination of recordings confirmed the signal indications of these 2 signals. At the exit of the Turcot interchange tunnel (Mile 4.23), advance signal 39C, located 2500 feet further, was visible and displayed “Clear to Slow.”⁴ The crew members called out signal 39C, and agreed that it displayed “Clear to Slow.” Signal 74L became visible at a distance of 1600 feet and displayed “Slow to Clear.”⁵ The crew members did not call out this signal, contrary to CROR Rule 34.
