**RAILWAY INVESTIGATION REPORT
R15V0046**

**MOVEMENT EXCEEDS LIMITS OF AUTHORITY
CANADIAN PACIFIC RAILWAY
FREIGHT TRAIN 672-024
MILE 103, CRANBROOK SUBDIVISION
CRANBROOK, BRITISH COLUMBIA
11 MARCH 2015**

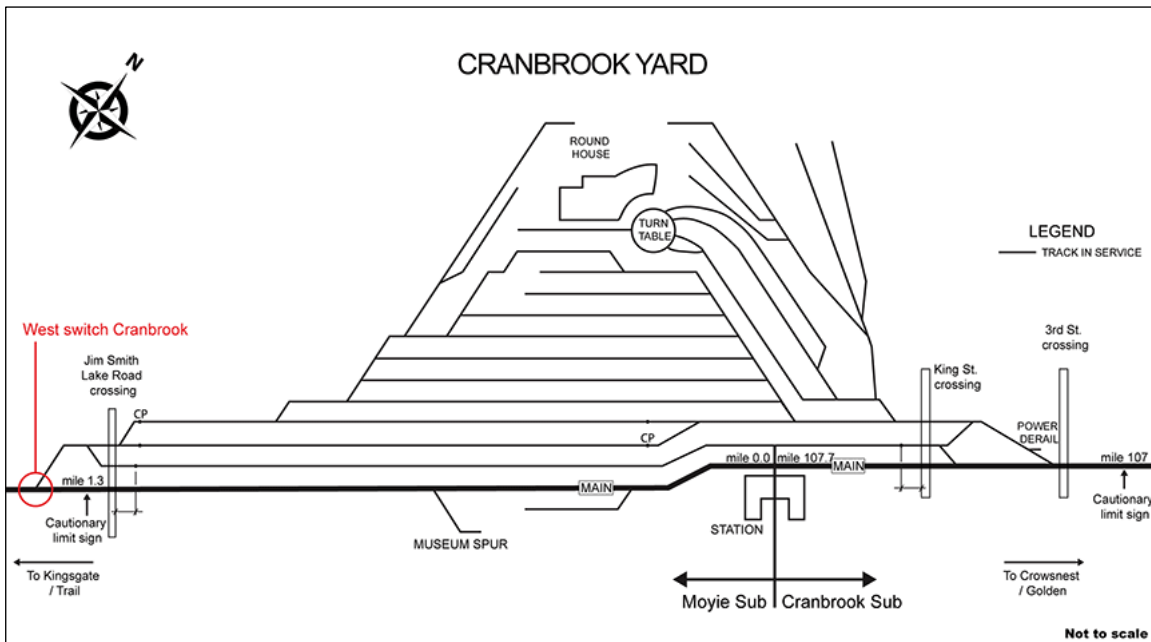
Figure 2. Track schematic of Cranbrook Yard (Source: Canadian Pacific Railway, with TSB annotations)

Prior to departing Kingsgate at Mile 51, and after getting under way, the crew copied several occupancy control system (OCS)³ clearances, giving them authority on the main track from Glenlily, British Columbia (beginning of OCS, Mile 48.9 on the Moyie Subdivision), to the west siding switch at Swansea, British Columbia (Mile 9.4⁴). At Swansea, the train took the siding for an opposing train. While at Swansea for the meet, the train crew copied another OCS clearance giving them authority on the main track from the east siding switch at Swansea to the beginning of the cautionary limits at Mile 1.3, near the west switch at Cranbrook Yard (Figure 2).

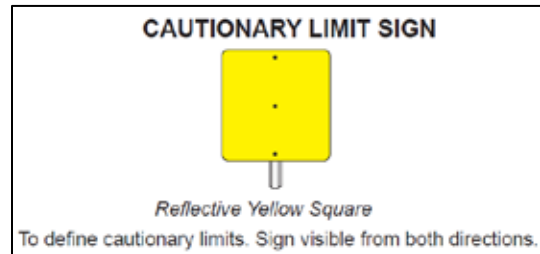
Figure 3. Cautionary limit sign

The train then passed the west cautionary limits sign (Figure 3) and continued into the cautionary limits on the Moyie Subdivision at Cranbrook. When the tail end of the train cleared the west main track switch, the train crew contacted the RTC for the Moyie Subdivision. The train crew provided a track release⁵ and confirmed that the main track switch was restored to normal.

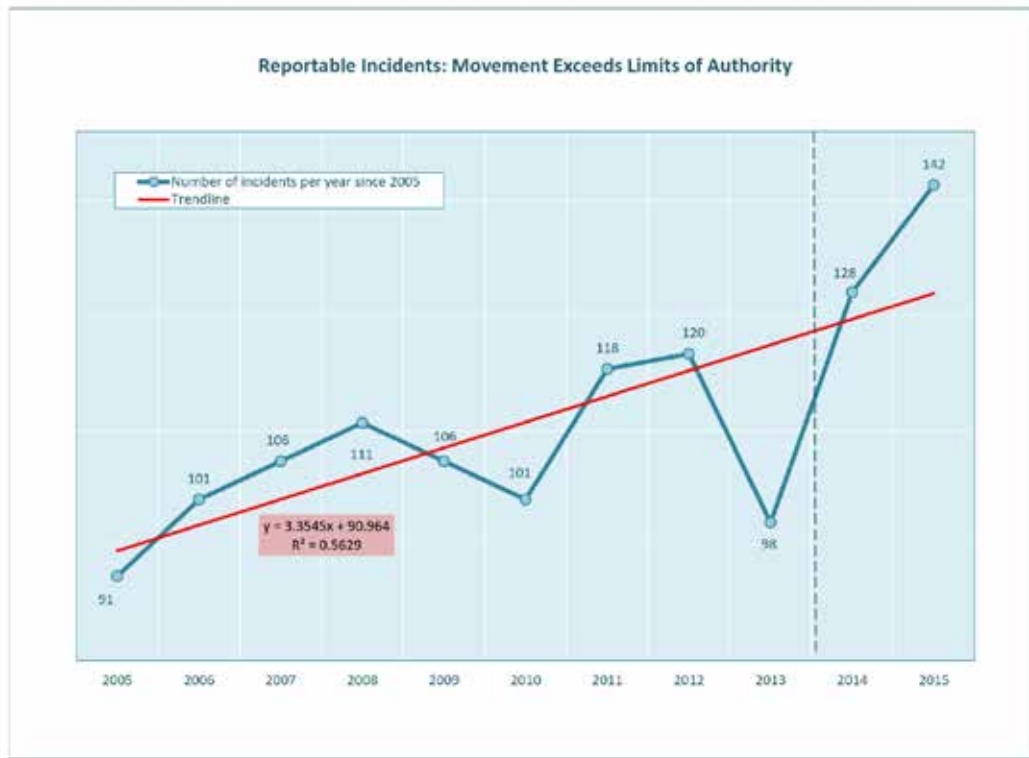
For the 11-year period from 2005 to 2015 (Figure 4), which includes the change in the TSB Regulations, the reporting category of “movement exceeds limits of authority” for the rail industry in Canada showed a general increase. The number of occurrences increased from about 90 in 2010 to 142 in 2015.

Figure 4. Movements exceeding limits of authority reported to TSB from 2005 to 2015 (Note: The dotted vertical line depicts when the change in TSB reporting requirements occurred and when Canadian Pacific Railway added the stop signal alarm.)
