RAILWAY INVESTIGATION REPORT R16E0051

Main-track train collision

Canadian National Railway Company
Freight trains Q11251-03 and M30251-02
Mile 34.9, Edson Subdivision
Carvel, Alberta
04 June 2016

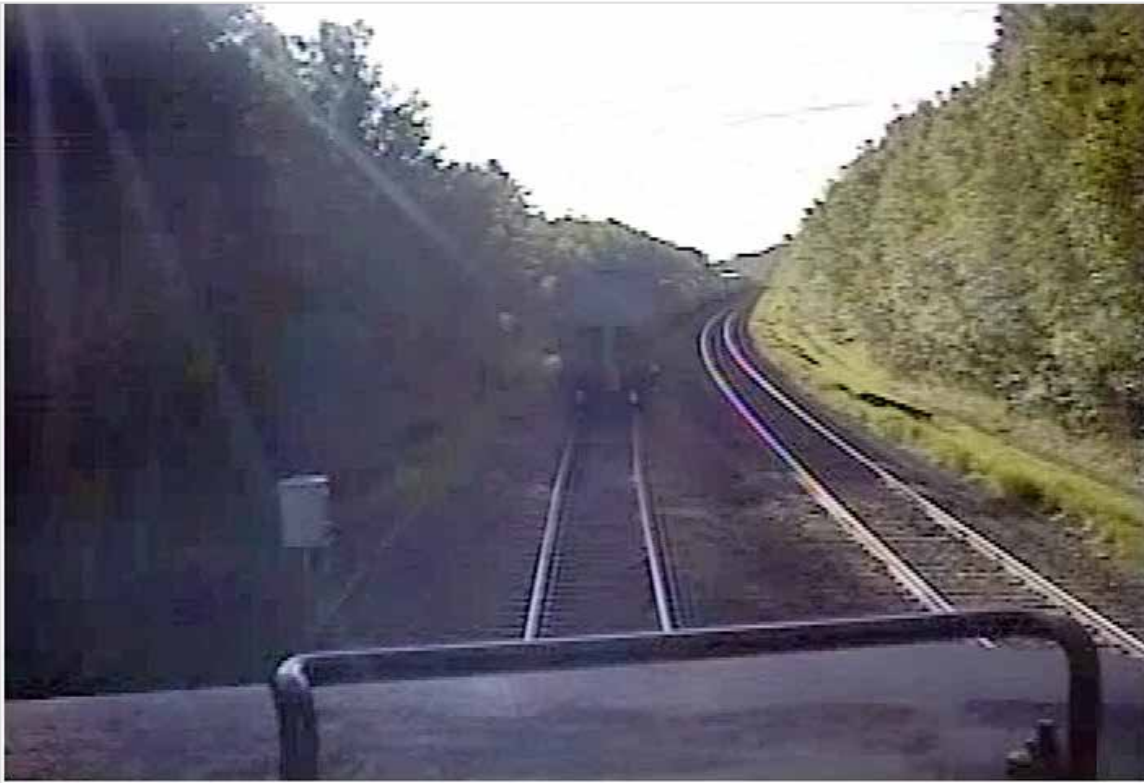
As train 112 entered a right-hand curve and was about 840 feet from the tail end of train 302, the crew saw that a train was stopped ahead (Figure 2).

Figure 2. Image from train 112's forward-facing video just prior to collision (Source: CN)

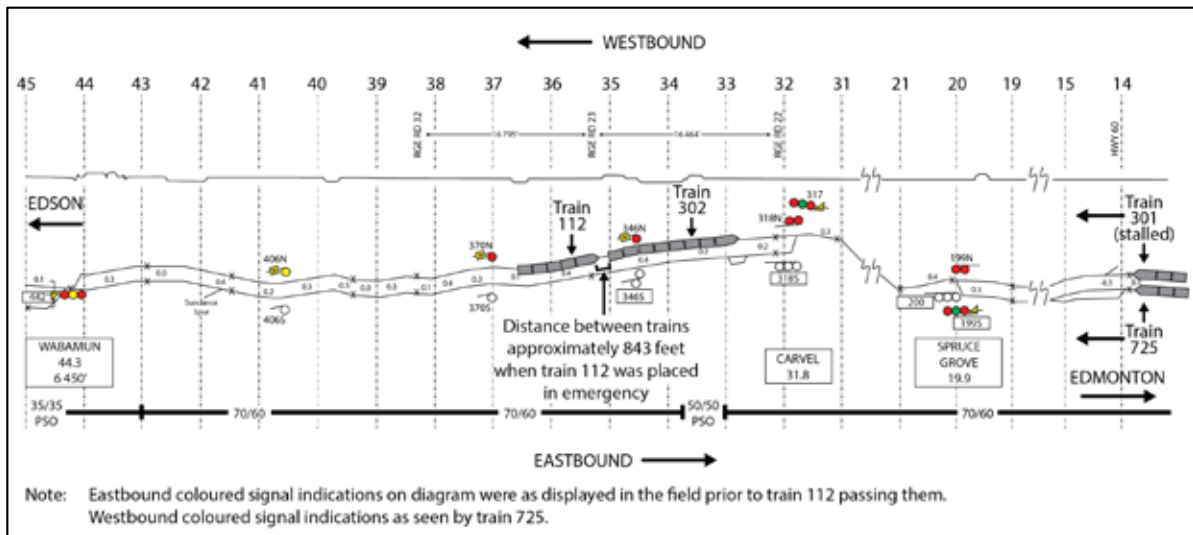
At 0747:16, operating at 27 mph, the conductor (and immediately after that, the LE) initiated an emergency application of the train brakes (Figure 3).

Figure 3. Site diagram at time train 112 was placed in emergency

At 0747:37, while in emergency and travelling at about 18 mph, the lead locomotive of train 112 collided with the tail end of train 302.

No cars derailed as a result of the collision. There was minor damage to an empty hopper car on train 302. There were no injuries.

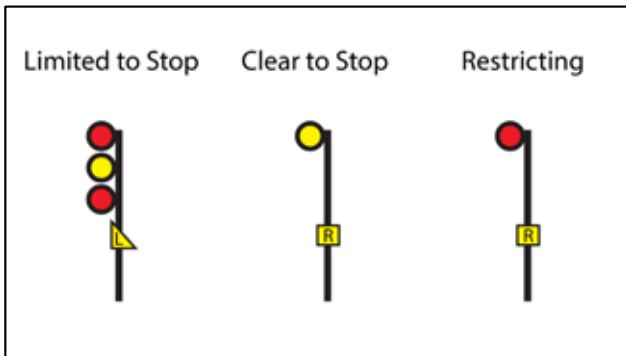
These signals were properly identified and communicated by the train crew.

Figure 4. Limited to Stop, Clear to Stop, and Restricting signals displayed to train 112

The crew of train 112 proceeded past the restricted Signal 370N, despite having encountered (and correctly called) the restricting signal indication, at a speed that did not allow them to stop within half the range of vision of equipment. Upon entering a curve while travelling at 27 mph, the crew of train 112 observed train 302 stopped about 840 feet ahead. An emergency brake application was initiated, slowing the train to about 18 mph prior to the collision.

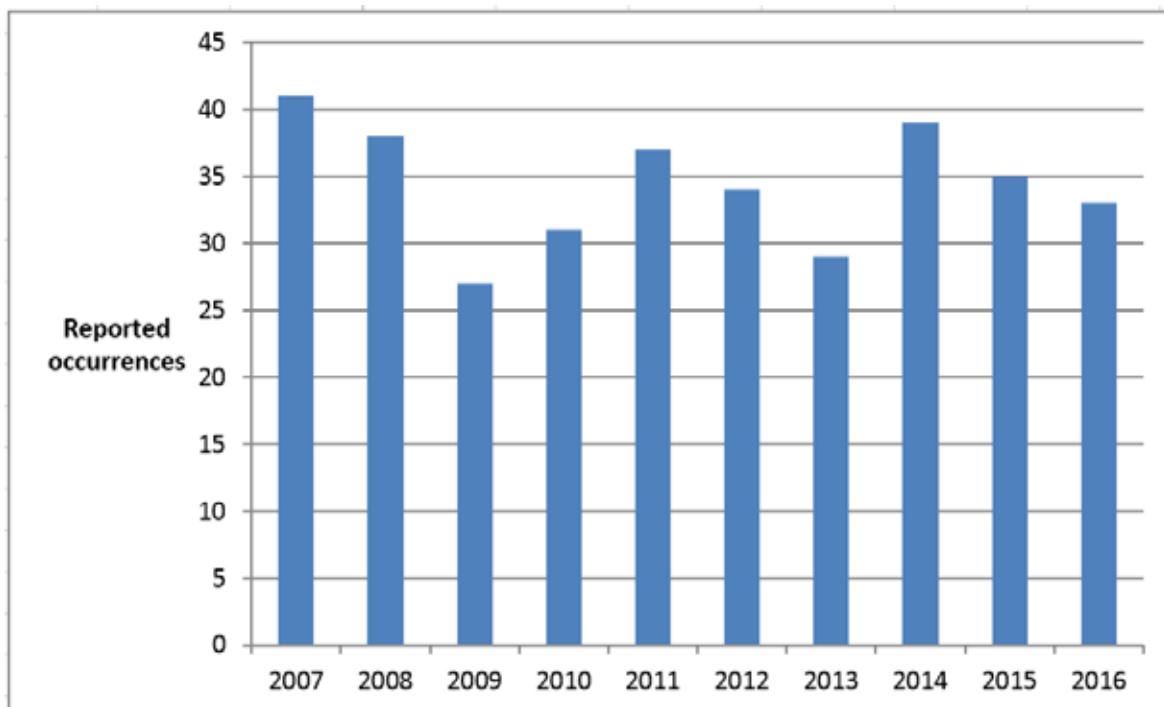
Between January 2007 and December 2016, there were 344 occurrences (Figure 5) where trains exceeded their limits of authority as a result of crews not responding appropriately to signal indications displayed in the field. Since 1998, the TSB has investigated 13 occurrences where a train exceeded its limits of authority, of which 11 resulted in a collision or a derailment (Appendix A). In each of these investigations, an operating crew member's misperception of wayside signal indications was determined to be a cause or a contributing factor.

Figure 5. Occurrences reported to the TSB from 2007 to 2016 where a train exceeded its limits of authority due to inappropriate crew response to signal indications
