RAIL TRANSPORTATION SAFETY INVESTIGATION REPORT R18D0096

MOVEMENT EXCEEDS LIMITS OF AUTHORITY

VIA Rail Canada Inc.
Passenger train P02921-31
Mile 99.1, Drummondville Subdivision
Drummondville, Quebec
31 October 2018

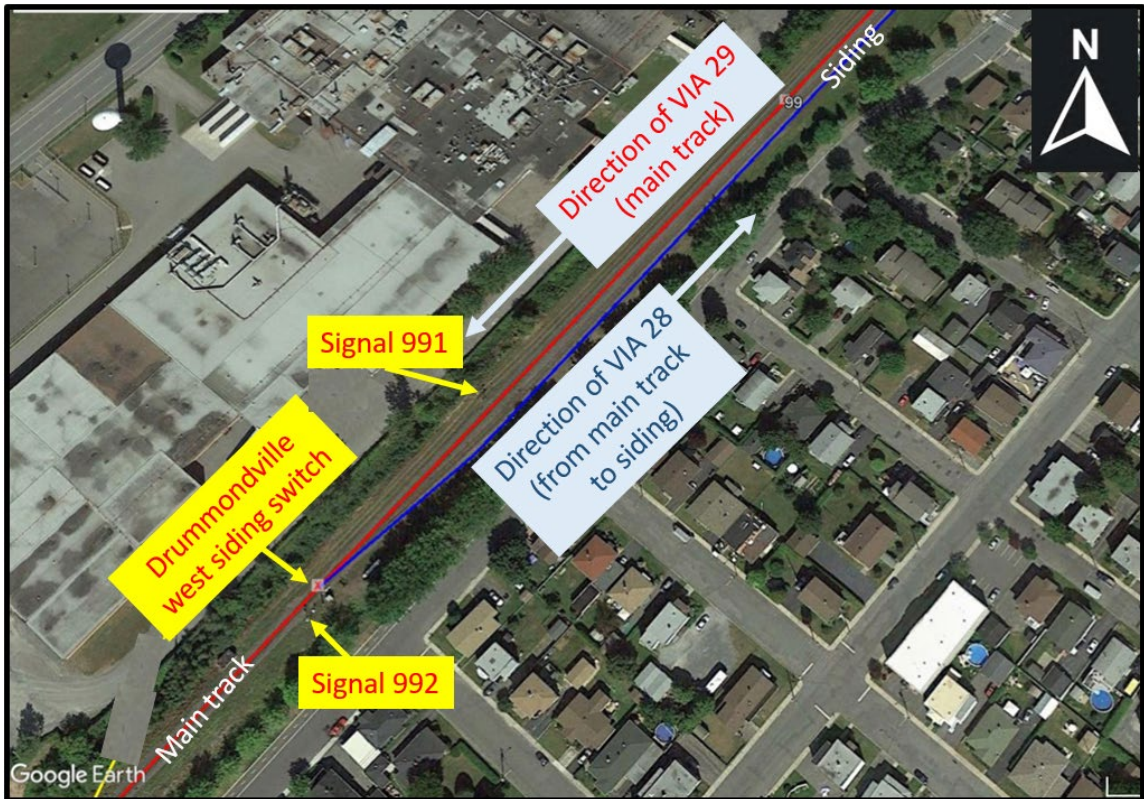
Figure 1. Occurrence area (Source: Google Earth, with TSB annotations)

VIA 29 ran through the Drummondville west siding switch and continued westward toward Montréal. VIA 29's crew members were unaware that they had passed a Stop indication or that VIA 28 had only just cleared the main track. There were no injuries.

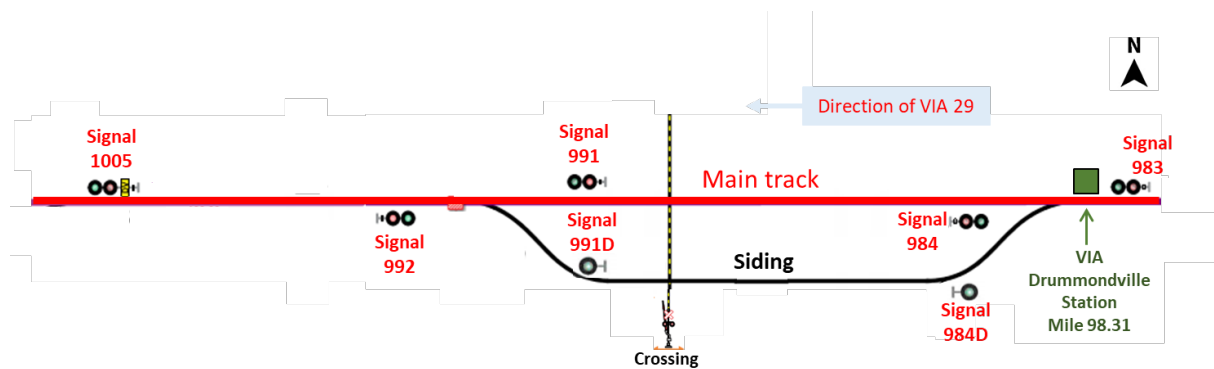
Figure 2. Location of signals (Source: TSB)

Signal 1005 is also a high-mast, double-aspect signal. It is located at Mile 100.5 of the CN Drummondville Subdivision, 1.4 miles (7392 feet) from Signal 991 (Figure 2). Because of the alignment and elevation of the signals, if Signal 1005 is illuminated, it can be seen by an operating crew before having passed Signal 991.

For a westbound movement, such as VIA 29, Signal 1005 would not normally be illuminated at the same time as Signal 991. However, because the railway signalling system is non-directional, if an eastbound train is occupying the block east of Signal 1005, that signal will automatically be illuminated. In this occurrence, when eastbound VIA 28 entered the block east of Signal 1005, that signal illuminated until the train exited the block at Signal 992.

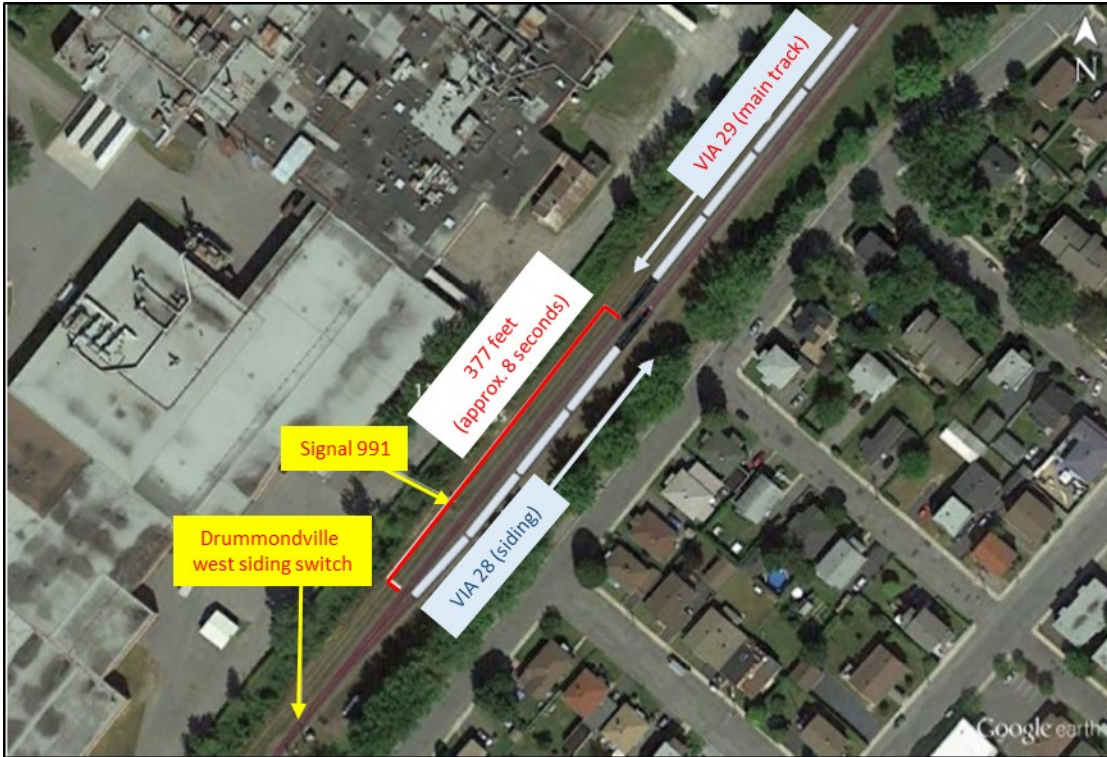
Figure 3. Distance between VIA 28 entering the siding and VIA 29 continuing on the main track
(Source: Google Earth, with TSB annotations)

- The distance between the head end of the locomotive on VIA 29 and the tail end of the last LRC passenger coach on VIA 28 was approximately 377 feet at the point when the last coach on VIA 28 was completely in the siding.
- It would have taken VIA 29 approximately 8 seconds to travel that distance at its speed.
