RAIL TRANSPORTATION SAFETY INVESTIGATION REPORT R19C0015

UNCONTROLLED MOVEMENT OF ROLLING STOCK AND MAIN-TRACK TRAIN DERAILMENT

Canadian Pacific Railway Company
Freight train 301-349
Mile 130.6, Laggan Subdivision
Yoho, British Columbia
04 February 2019

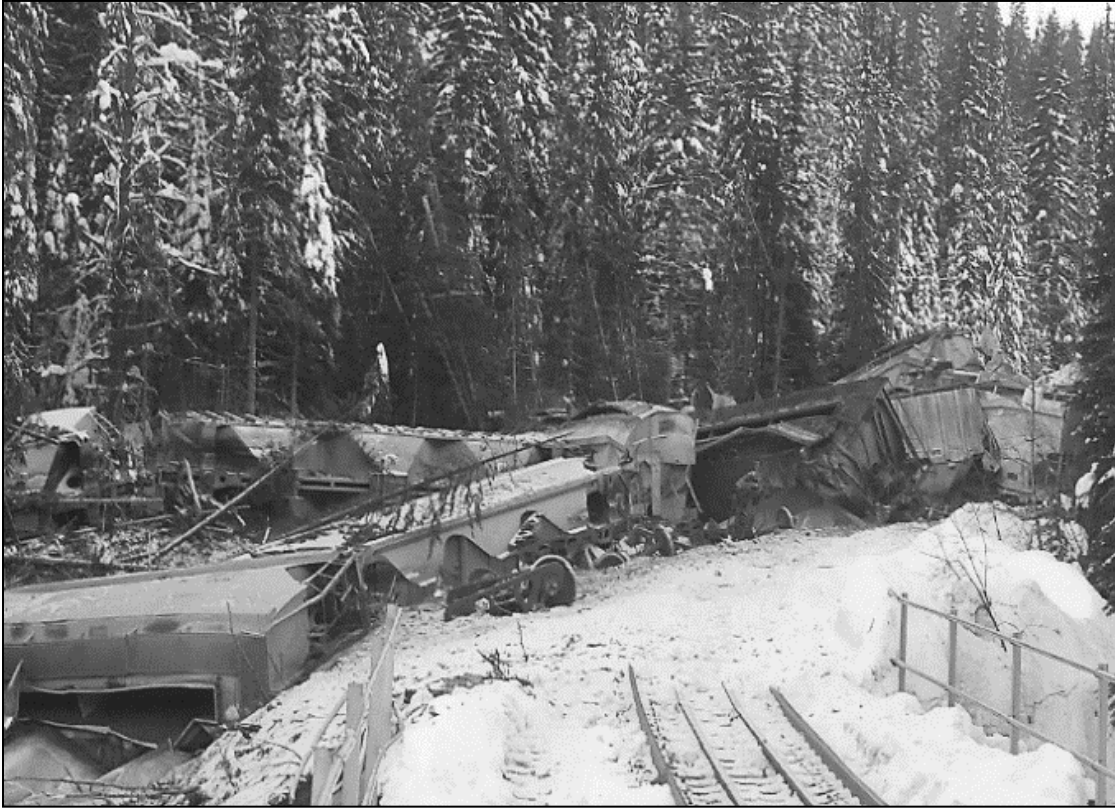
The front portion of the train, including the lead locomotive (CP 9538) and the first 35 cars, had derailed on the curve immediately before the Kicking Horse River bridge at Mile 130.6 (Figure 4).

Figure 4. Derailed head-end cars looking toward the rear of the train (Source: Canadian Pacific)

The head-end locomotive, CP 9538, was lying on its left side in the riverbed, some 35 feet below the track level. The river was quite shallow, and the surface was frozen and covered with snow. A patch of open water about 20 feet in diameter was visible underneath and adjacent to the locomotive, where the ice had broken when the locomotive fell onto the riverbed. An inspection of the underside of the locomotive showed little indication of ground contact, but the rest of the locomotive had sustained extensive damage.

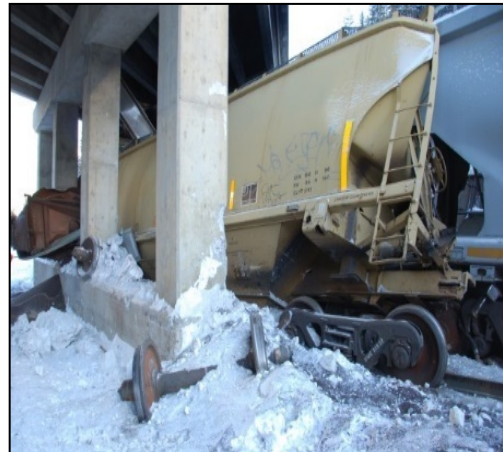
Figure 5. Cars under the Highway 1 overpass (Source: TSB)

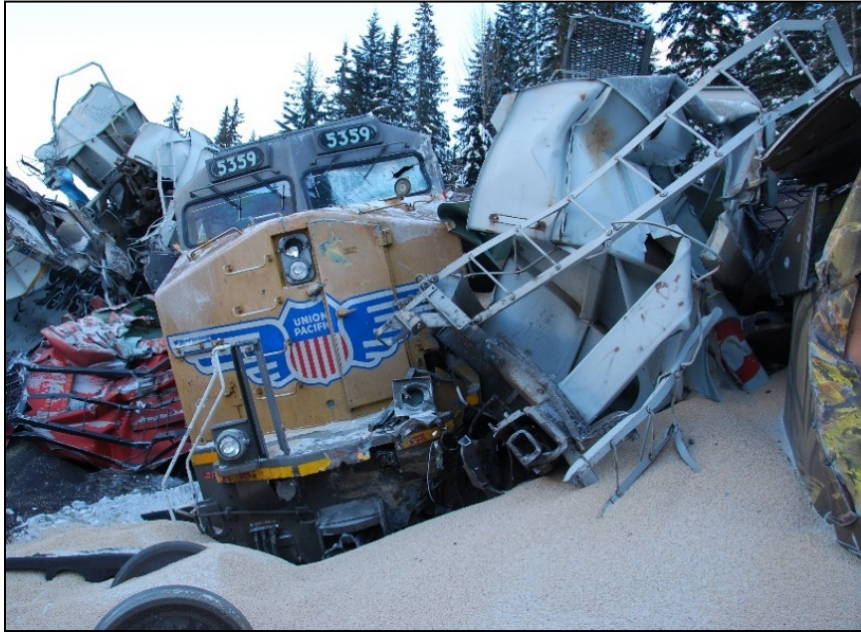
The mid-train remote locomotive, UP 5359, had derailed but stood upright among other cars stacked in a side-by-side pile-up (Figure 6).

Figure 6. Mid-train distributed power remote locomotive, UP 5359 (Source: TSB)

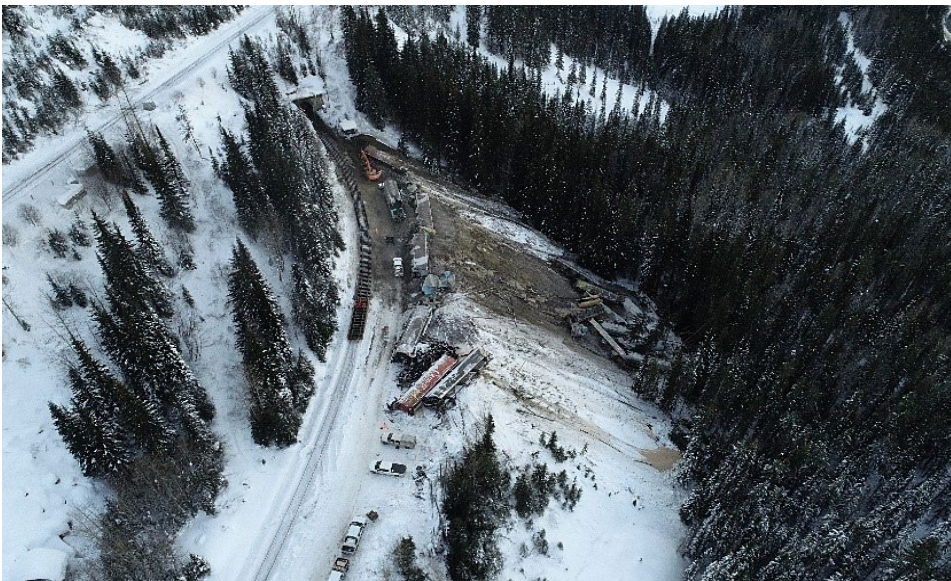
Figure 7. Tail-end cars derailed outside the Upper Spiral Tunnel (Source: Canadian Pacific)

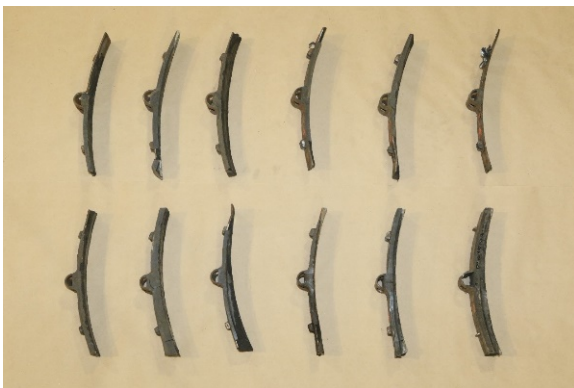
Figure 8. Twelve of the recovered locomotive brake shoes (Source: TSB)

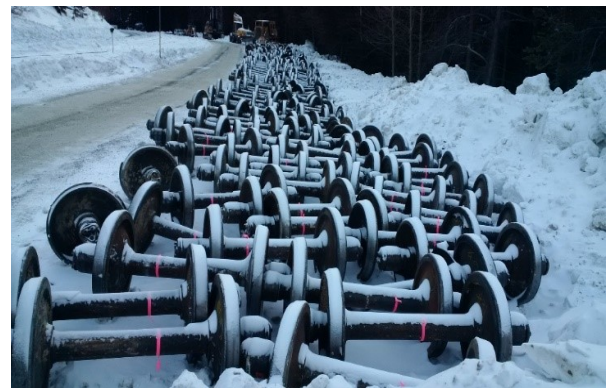
Figure 9. Recovered car wheelsets (Source: TSB)

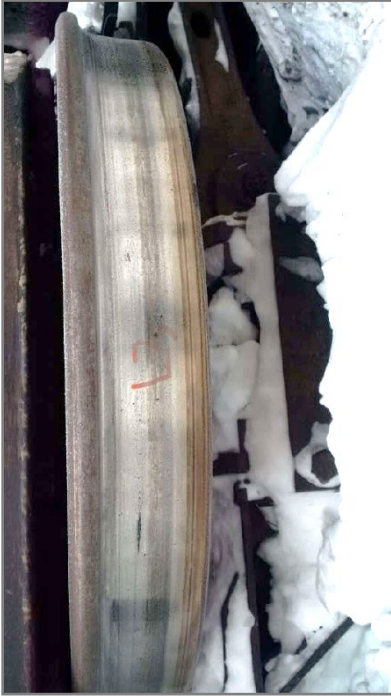
Figure 23. Wheel tread with no blueing
(Source: TSB)

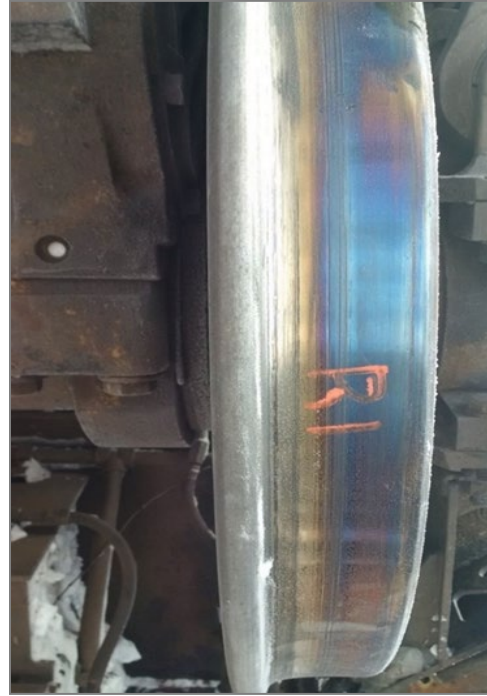
Figure 24. Wheel tread with very heavy blueing
(Source: TSB)
