# RAIL TRANSPORTATION SAFETY INVESTIGATION REPORT R19T0191

## **CROSSING ACCIDENT**

Metrolinx  
GO Transit commuter train 3919  
Mile 62.08, Guelph Subdivision  
Kitchener, Ontario  
13 November 2019

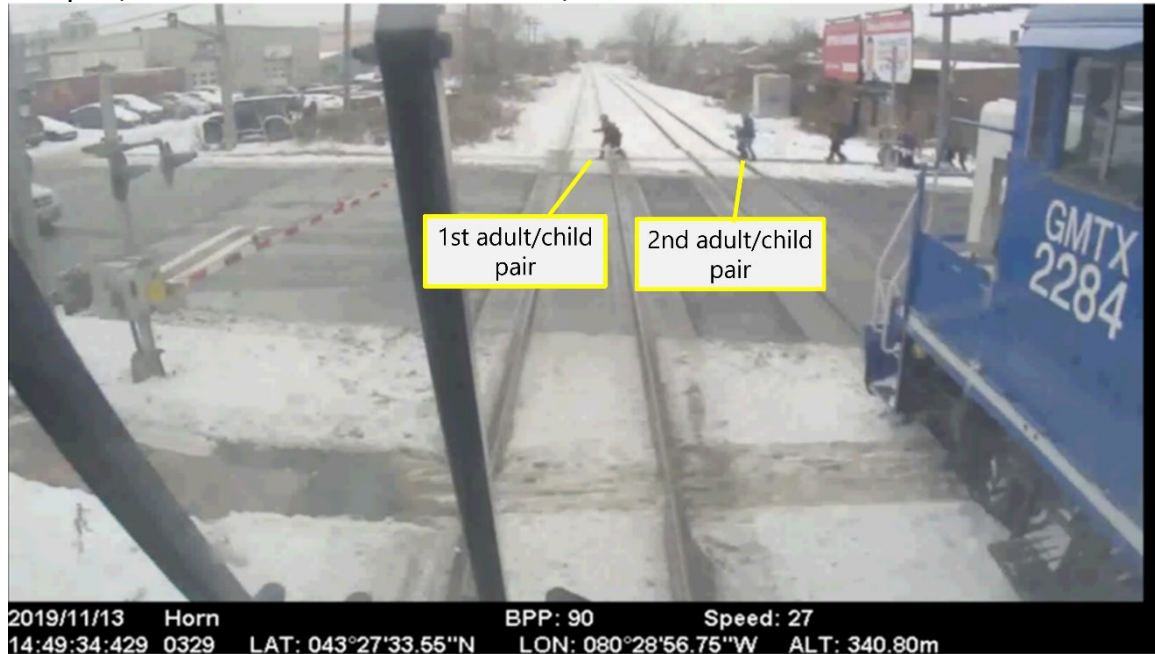
When GO 3919 was about 80 feet from the crossing, 2 pedestrians (the 1st adult and child pair) who were holding hands, appeared on the north side of the crossing from behind the CN locomotive. They ran southward onto the crossing (Figure 3), and the GO 3919 crew immediately activated the locomotive horn.

Figure 3. An image from the forward-facing video camera from GO 3919 train's cab car 329 showing the 1st adult and child pair traversing the Lancaster Street West crossing followed by the 2nd adult and child pair (Source: GO Transit with TSB annotations)

As the 1st adult and child pair cleared the crossing to the south, a 2nd adult and child pair followed immediately behind into the path of GO 3919 and were subsequently struck by the train. With the train proceeding at 27 mph, the GO 3919 crew initiated a full service brake application and the train came to rest with the tail-end locomotive occupying the crossing.

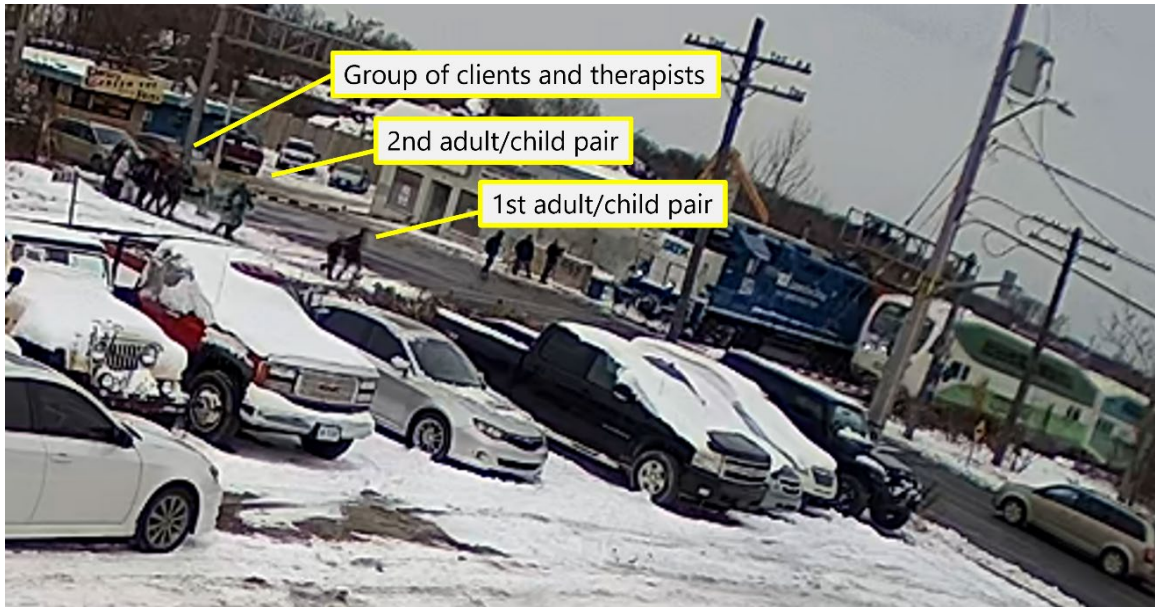
Several of the adults in the group assumed that if there was a second train, it would come from the west, which was similar to the way vehicles travel on a 2-lane roadway network.

Figure 4. Lancaster Street West crossing looking northeast (Source: Autologix video, with TSB annotations)

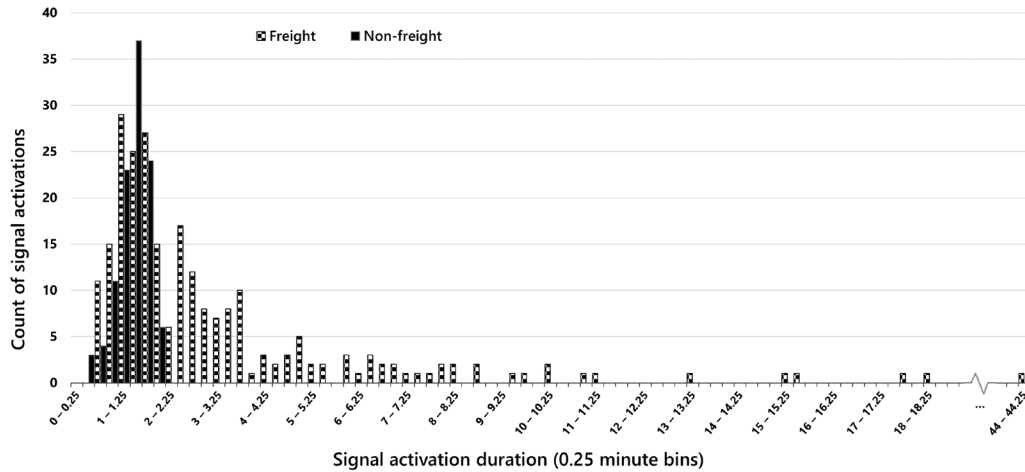
Figure 8. Number and duration of signal activations (in increments or bins of 0.25 minutes) at the Lancaster Street West station for freight and non-freight trains, from 20 June to 29 June 2020 (Source: TSB)

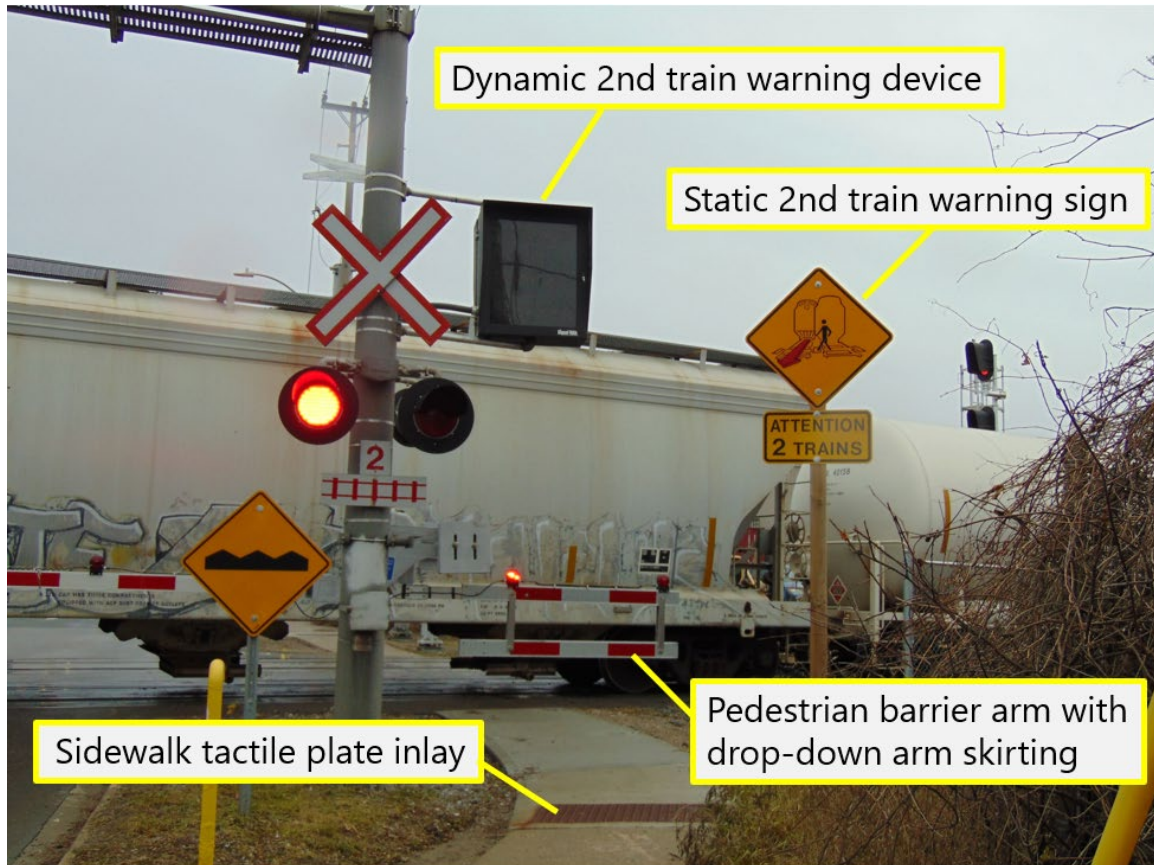
Figure 11. Lancaster Street West crossing safety improvements (Source: TSB)

Metrolinx has installed

- dedicated sidewalk pedestrian barrier arms with drop-down arm skirting on all 4 quadrants;
- sidewalk tactile plate inlays on all 4 crossing quadrants to identify the crossing approach to visually challenged pedestrians and to delineate a safe stopping point for them to wait for passing movements;
- dynamic LED signs displaying “Danger – Multiple Trains Expected” that are activated when a second train enters the crossing circuit; and
- static second-train event signage in all 4 quadrants of the road approach.
