RAIL TRANSPORTATION SAFETY INVESTIGATION REPORT R20V0230

NON-MAIN-TRACK UNCONTROLLED MOVEMENT

Canadian National Railway Company
Remote control locomotive system
Yard assignment 1500 North end
Mile 462.4, Chetwynd Subdivision
Prince George Terminal, South Yard
Prince George, British Columbia
13 November 2020

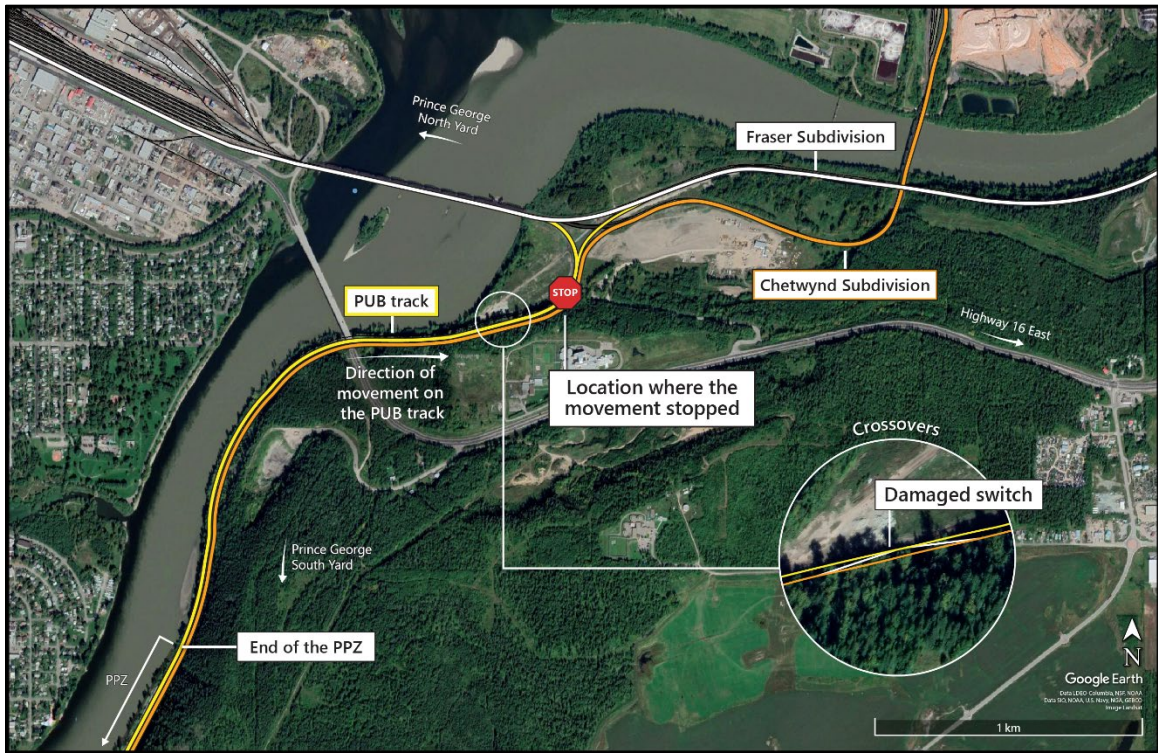
assignment) northward within the limits of a point protection zone (PPZ)¹ on the PUB track² when he lost control of the movement. The uncontrolled movement accelerated to approximately 17 mph, ran through a crossover switch that was lined against the movement's direction of travel, damaging the switch, and subsequently came to a stop about 7200 feet outside the limits of the PPZ and about 1250 feet before the entrance of the main track of the Fraser Subdivision (Figure 2). No dangerous goods were involved, and the movement did not derail. No one was injured.

Figure 2. Map showing the location of the PUB track, the direction of movement, and the approximate location where the movement stopped (Source: Google Earth, with TSB annotations)

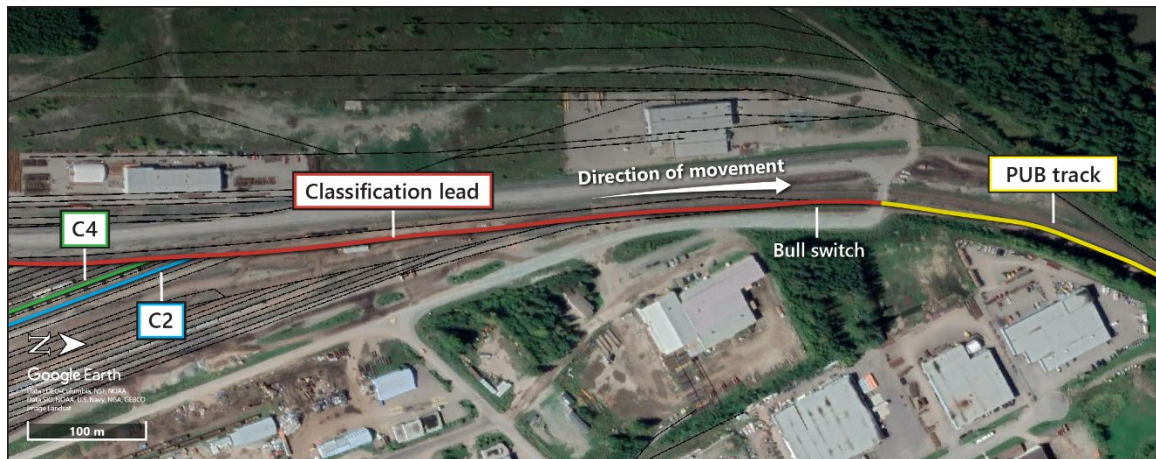
The crew was working in the classification yard at the north end of the South Yard. They had been instructed to double over³ 54 cars (52 loaded cars and 2 empty cars) from track C4 to a cut of cars on track C2. The move required the assignment to proceed past the bull switch⁴ and onto the PUB track (Figure 3). The PUB track is on a hill; the grade varies between 0.49 and 1.13%, with an average descending grade of 0.70%. The grade levels off between the Highway 16 overpass and the end of the PUB track, just before it connects with the main track of the Fraser Subdivision.

Figure 3. North end of the Canadian National Railway Company Prince George Terminal South Yard
(Source: Google Earth, with TSB annotations)
