# RAIL TRANSPORTATION SAFETY INVESTIGATION REPORT R23D0011

## CROSSING COLLISION

Réseau de transport métropolitain  
Commuter train EXO 816  
Mile 62.18, Canadian National Railway Company  
St-Hyacinthe Subdivision  
Saint-Bruno-de-Montarville, Quebec  
27 January 2023

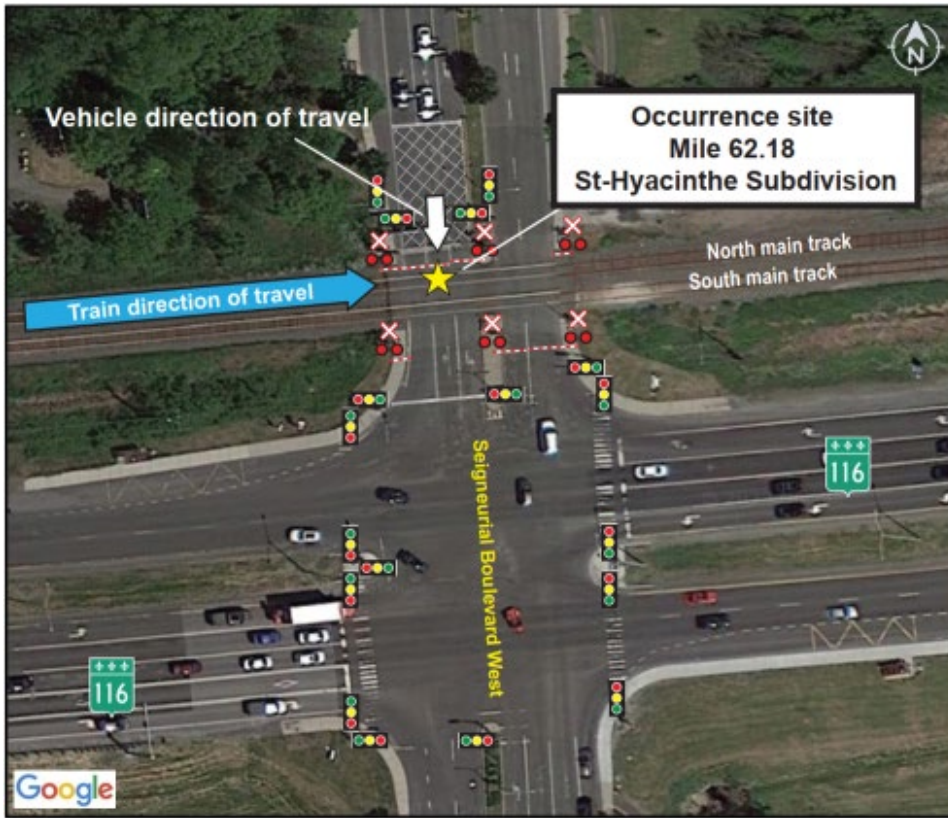
Figure 2. Collision site (Source: Google Maps, with TSB annotations)

The collision occurred at a public crossing equipped with automatic warning devices (flashing lights, bells, and gates) that were activated. Although the road was partly snow-covered at the time of the occurrence, it was in good condition. The vehicle was struck at the front right wheel and pushed approximately 20 m toward the northeast side of the grade crossing. The train remained on the rails and the locomotive sustained only minor damage. No fuel was spilled (Figure 2).

The track appeared to be undamaged. The automatic warning devices on the median north of the grade crossing were torn off when the vehicle was pushed by the impact.

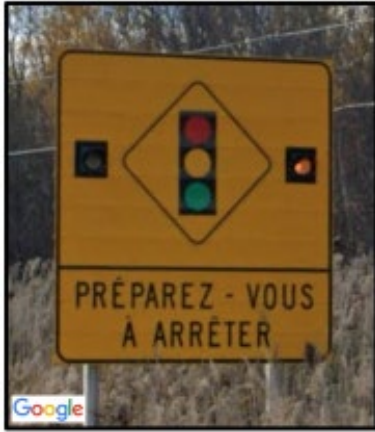
Figure 4. Advance sign installed on Route 116 (Source: Google Maps)

The traffic lights at this intersection are interconnected with the detection systems installed on the track. As a result, trains approaching the grade crossing are detected at least 25 seconds before the grade crossing's automatic warning devices are activated. The traffic lights then go into advance pre-emption mode in a specific sequence to clear traffic before the grade crossing warning system is activated. One of the features of this system is that it activates the flashing yellow lights of the advance signs warning motorists on Route 116 to prepare to stop. These signs are located approximately 250 m on either side of the intersection with Seigneurial Boulevard West (Figure 4).
