RAILWAY INVESTIGATION REPORT

R97D0253

TANK CAR FAILURE

CANADIAN NATIONAL

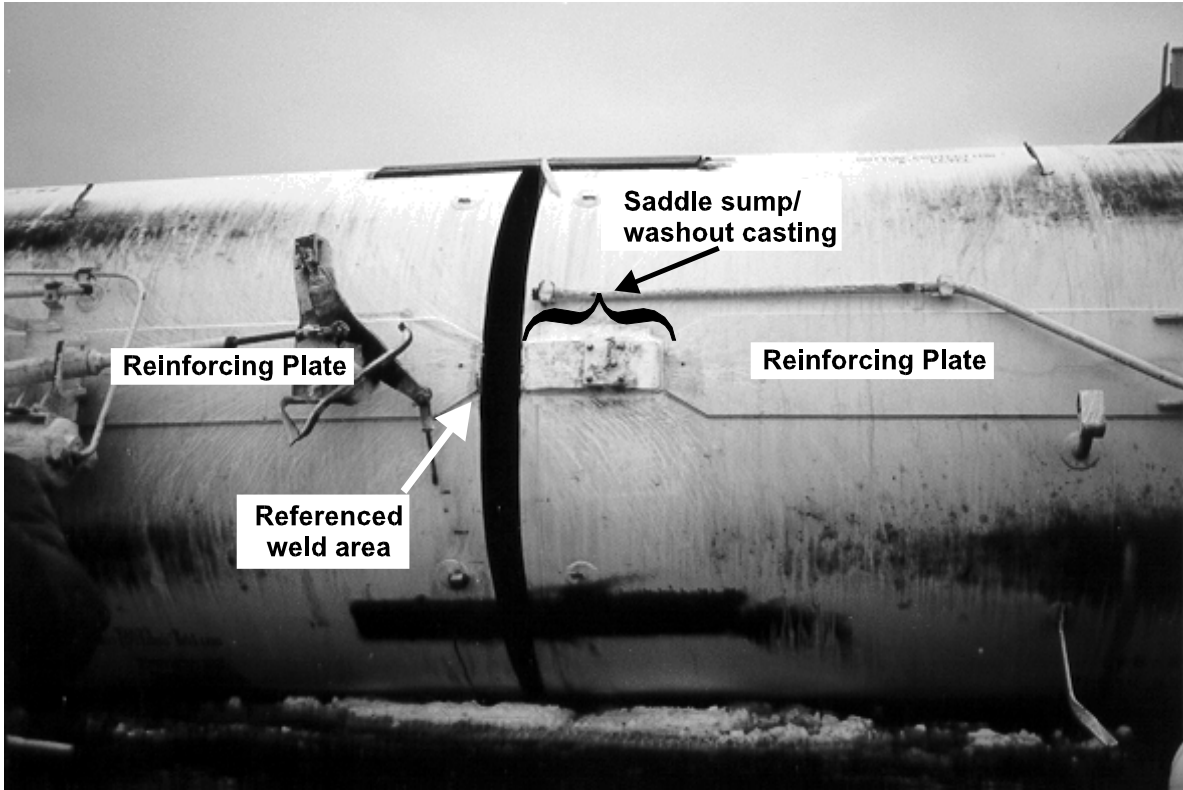
- 1) There was a space of approximately 25 mm between the reinforcing plate and the saddle sump/washout casting at the "B" end of the sump casting.
- 2) The longitudinal weld securing the reinforcing plate did not appear to be equal in thickness along the entire length of the weld.
- 3) A rust-coloured stain was evident on the bottom of the car from the BL corner of the sill reinforcing plate near the washout casting towards the "B" end of the car for approximately 1 m.
- 4) The weld on the corner of the reinforcing plate near the washout casting appeared to have porosity and heavy rust discolouration.
- 5) The root of the weld did not appear to have good penetration into the parent metal of the reinforcing plate.
- 6) The fracture appeared to run parallel with the weld and continued in this manner beyond the weld and circumferentially up both sides of the tank shell to the manway.

- 1) The tank car failed when an existing fatigue pre-crack reached a critical size, causing failure under normal operating conditions.
- 2) The fracture occurred in the weld heat-affected zone at the junction of two weld beads, an area of inherently poor physical conditions due to changing micro-structure.

- 3) The pre-crack existed for some years.
- 4) The fatigue pre-crack initiated at a location of high stress in the toe of the weld. The high stress was brought about by the sharp weld geometry.

- 7) The gap between the reinforcing plate and the washout casting was 10 mm greater in size at the failed end when compared to the non-failed end.
- 8) Filling the gap with a weld bead may have prevented the failure.

The 25 mm gap between the reinforcing plate and the washout casting constituted an alteration to or variance with the approved drawings and created a stress concentration effect. It would be expected that an AAR-certified plant would be aware that such a variance with the design specification was unacceptable, and that its quality assurance program would detect such a construction error. It would also be expected that the sharp weld geometry would be detected by quality assurance measures. Since the manufacturer is no longer in business, the cause of these shortcomings could not be explored. However, a post-accident inspection of the other cars built to the certificate by Riley-Beaird led to the identification of two cars with deficient welds in the subject area (as outlined in the Safety Action section), but no other cars had been manufactured with a gap and missing butt weld in the reinforcing plate-to-washout casting area. It is concluded, therefore, that the construction to a variance with the design requirements and subsequent lapse in quality assurance was an extraordinary event at that facility.

3. The fatigue crack initiated at a location of high stress brought about by sharp weld geometry.
4. The failure is attributable to the excessive gap and missing butt weld between the reinforcing plate and the washout casting.

During periodic qualification of tank cars in their fleets, the Union Tank Car Company and Procor now require a focused visual inspection in areas of transverse welds at bottom reinforcing plates.
