RAILWAY OCCURRENCE REPORT

R97T0299

COLLISION

GO Transit
Commuter Train No. 831 and
Commuter Train No. 841
Toronto Terminals Railway
Toronto, Ontario
19 November 1997

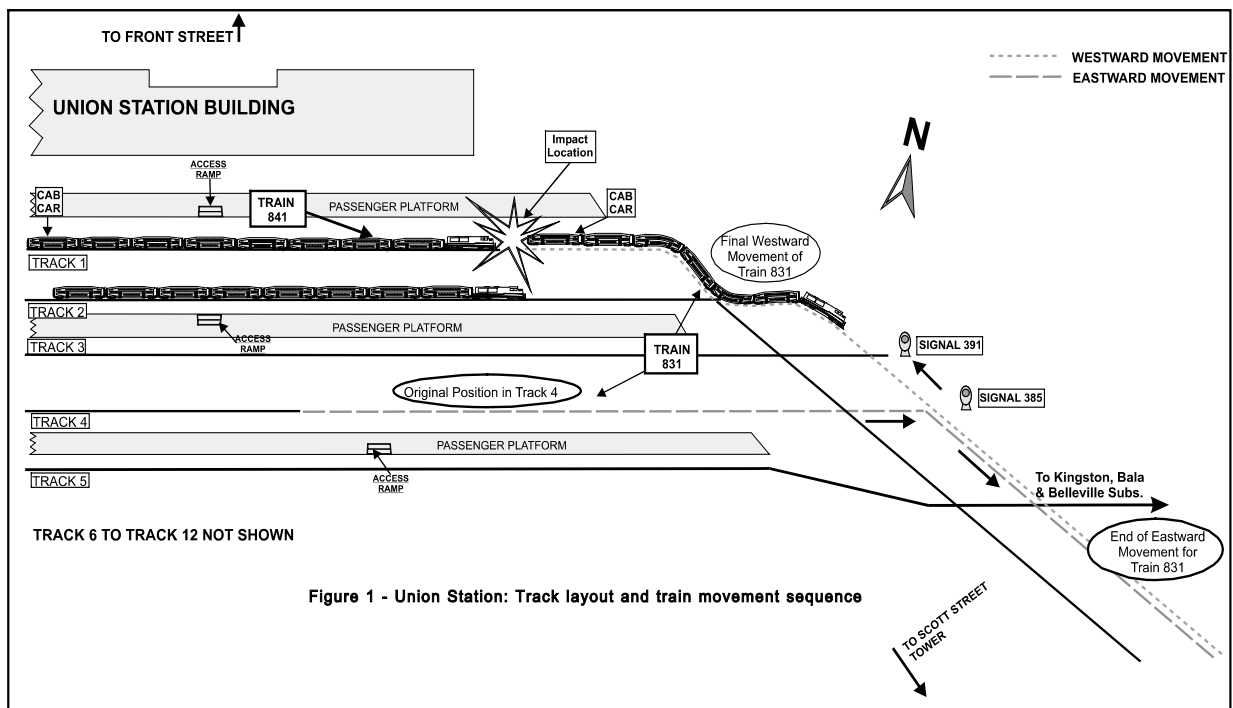
Figure 1 - Union Station: Track layout and train movement sequence

Commuter train No. 831 (train 831), scheduled to arrive in track No. 1 at 1616 at Union Station, had no passengers and was stopped in track No. 4. At approximately 1610, train 831 pulled eastward out of track No. 4 and stopped clear of signal No. 391 and signal No. 385 (see Figure 1). The train waited several minutes at this location for the Scott Street tower train movement director (TMD) to line the switches for the intended westward movement into track No. 1. When the signals changed from red to yellow, the conductor, who was controlling the movement while positioned in the leading car, noted that track No. 1 appeared to be clear. At approximately 1614, the conductor relayed to the first locomotive engineer, via intercom, that the signal lights had changed and that it was now permissible to reverse the movement into track No. 1. The signal aspect and the distance to reverse were not discussed between the two crew members. The first locomotive engineer then began to reverse the train into track No. 1. As the train was moving slowly along the track, the first locomotive engineer contacted the conductor, via intercom, and they had a brief discussion about the specific location to spot the train in track No. 1. The conductor stated that, during the westward movement towards track No. 1, he had taken his coat off, sat down in the cab car², turned on the bell and dimmed the lights. Nearing the platform area, he realized that there was a train standing in track No. 1, approximately 200 feet away.

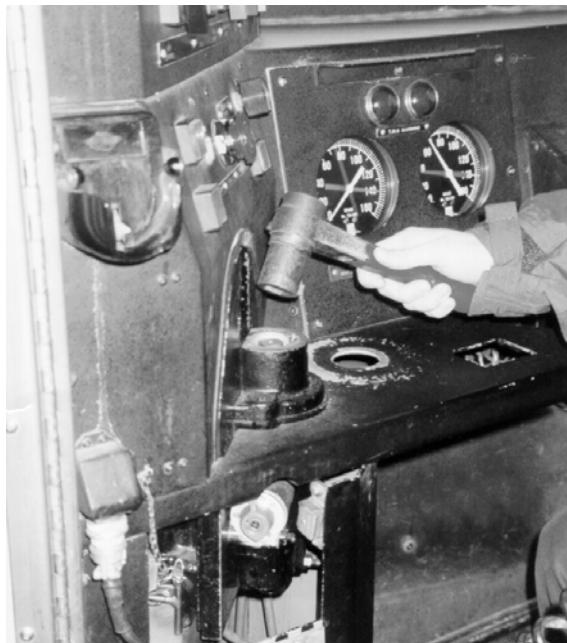
Figure 2 - Interior view of cab control station (automatic brake valve and handle storage location indicated by arrows)

The Board determined that the collision occurred because the crew reversed train No. 831 without the exchange of critical information necessary to perform the movement safely. Contributing factors include the limited visibility of track No. 1, the inability of the crew to establish intercom communication, and the limited accessibility to the two 'emergency' brake valves closest to the cab control station.

The cab control station is a small operating compartment located in one end of the cab car which is positioned at the tail end of the train. It is equipped with a console from where a crew member can control the train. An automatic brake valve is located within the cab control station. Local operating instructions require that the brake valve handle be removed and stored on the console when changing train control from the cab car to the locomotive (see Figure 2).

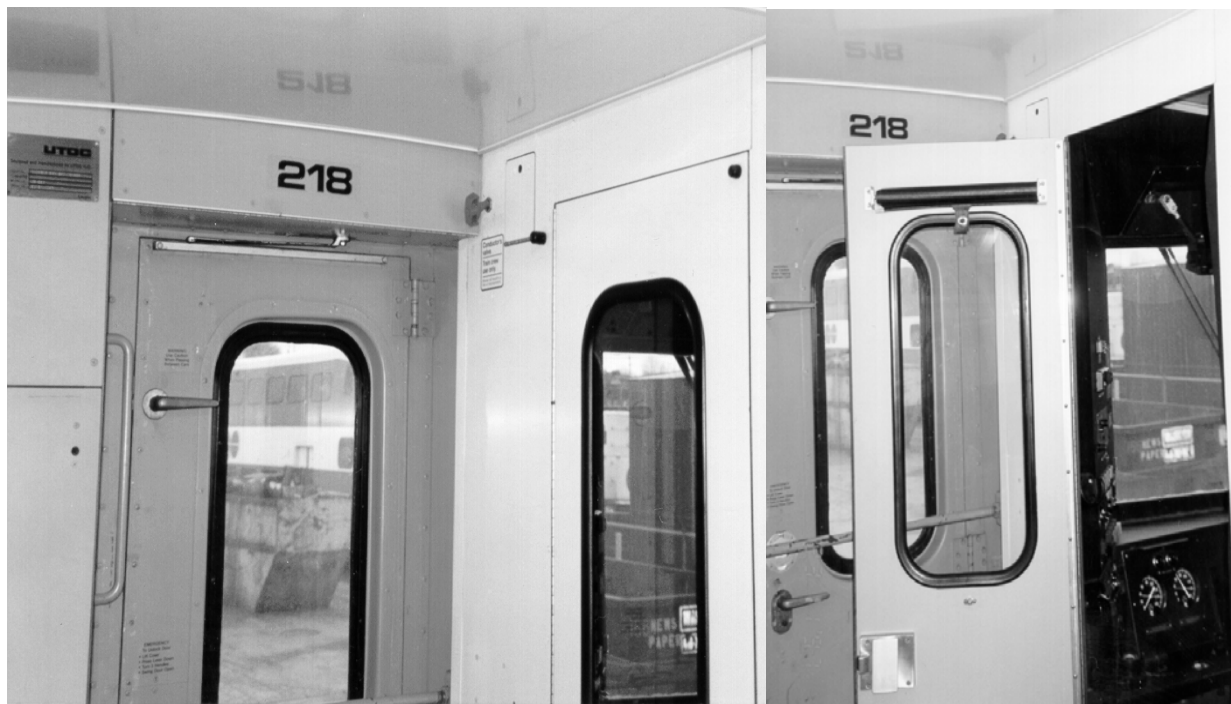
The door of the cab control station was secured in the 'open' position. The conductor indicated that he did not attempt to pull the conductor's emergency valve which was located in the aisle behind the door. When the locomotive of stationary train 841 was immediately in front of him, he dove out the doorway of the cab control station onto the seats across the aisle to better protect himself from the force of the anticipated impact. At approximately 1616, train 831 struck train 841. As a result of the collision, the cab car and one of the bi-level coach cars (coach) on train 831 derailed, and train 841 was pushed approximately 35 feet westward before coming to a stop.

Each of the 329 coaches is equipped with four conductor's emergency valves, which are used for initiating an emergency brake application. In each cab car, there is an additional conductor's emergency valve located in the aisle adjacent to the cab control station. Access to the conductor's emergency valve is obstructed when the door to the cab control station is left in the open position (see Figure 3).

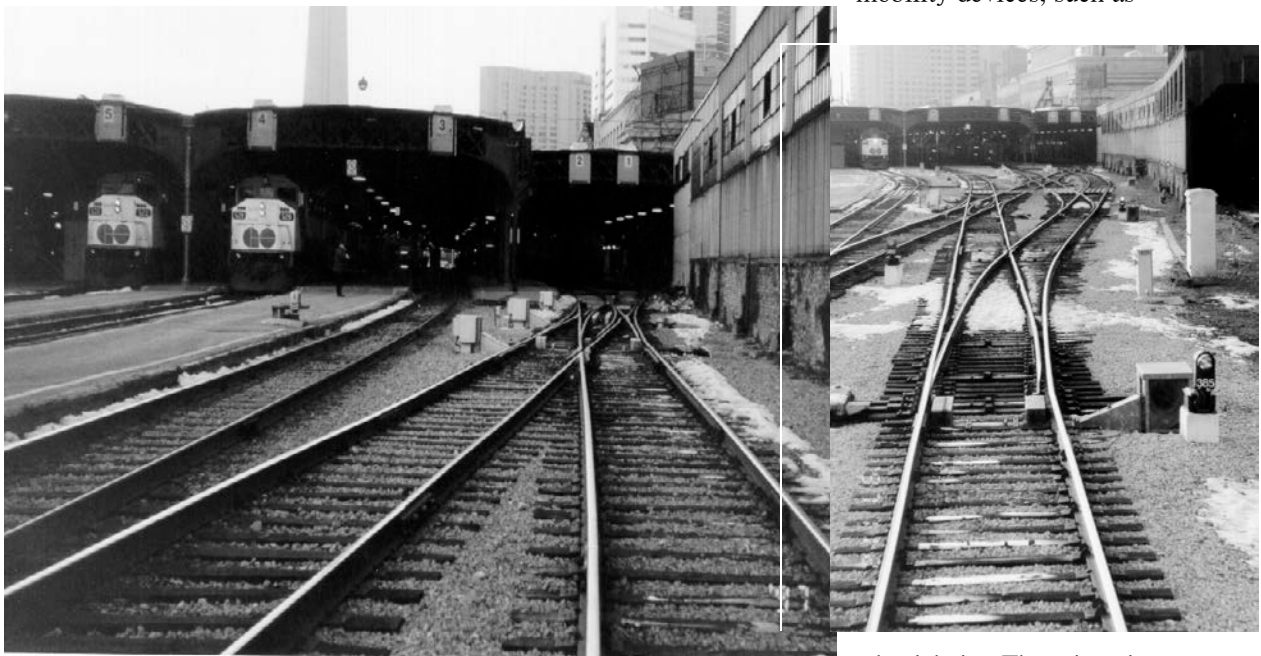
On tracks No. 1 and No. 2, the trains are positioned for boarding further to the west (see Figures 4a and 4b). The front of a locomotive positioned standing in track No. 1 or track No. 2 is recessed 160 feet in comparison with the east end of trains on the other tracks, 100 feet of which is inside the train shed. During daylight hours, trains in tracks No. 1 and No. 2 are not as easy to see as trains located in the other tracks, where the fronts of the GO Transit locomotives are plainly visible.

⁷ A dwarf signal is a fixed low signal located at the entrance of a route or block used to govern trains entering and using that route or block. Figure 4b shows single dwarf signals Nos. 385 and 391.

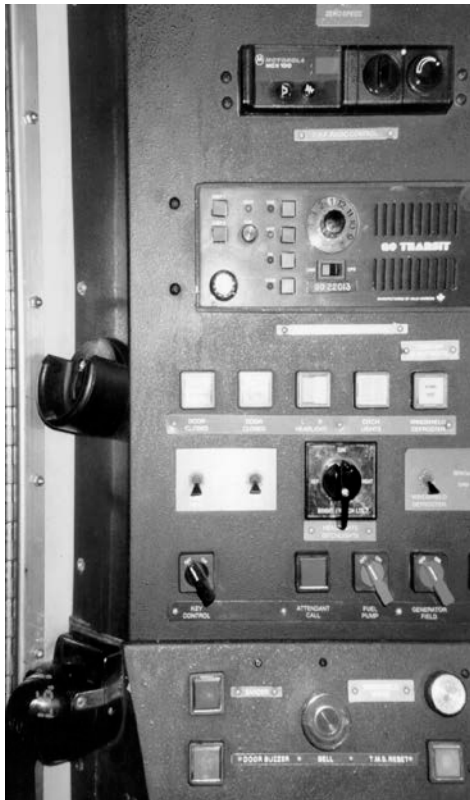
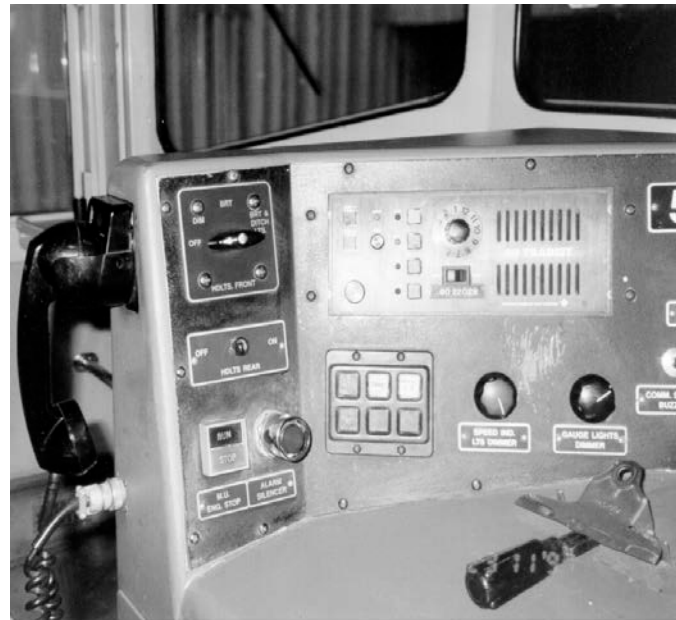
To select a communication system, one of the four push buttons (see Figures 5a and 5b) must be depressed. The corresponding LED indicator will illuminate, showing which communication system is activated and being controlled by the ICCU.

8. The use of the intercom system between crew members necessitated that the intent to communicate be established prior to actual communication.
9. The deselect feature of the ICCU disconnects the operator from the chosen communication channel each time the handset is replaced in the cradle, activating the radio hang-up switch.
