RAILWAY INVESTIGATION REPORT

R99T0256

DERAILMENT

CANADIAN NATIONAL
FREIGHT TRAIN NO. M304-41-21
MILE 202.98, BALA SUBDIVISION
NEAR BRITT, ONTARIO
23 SEPTEMBER 1999

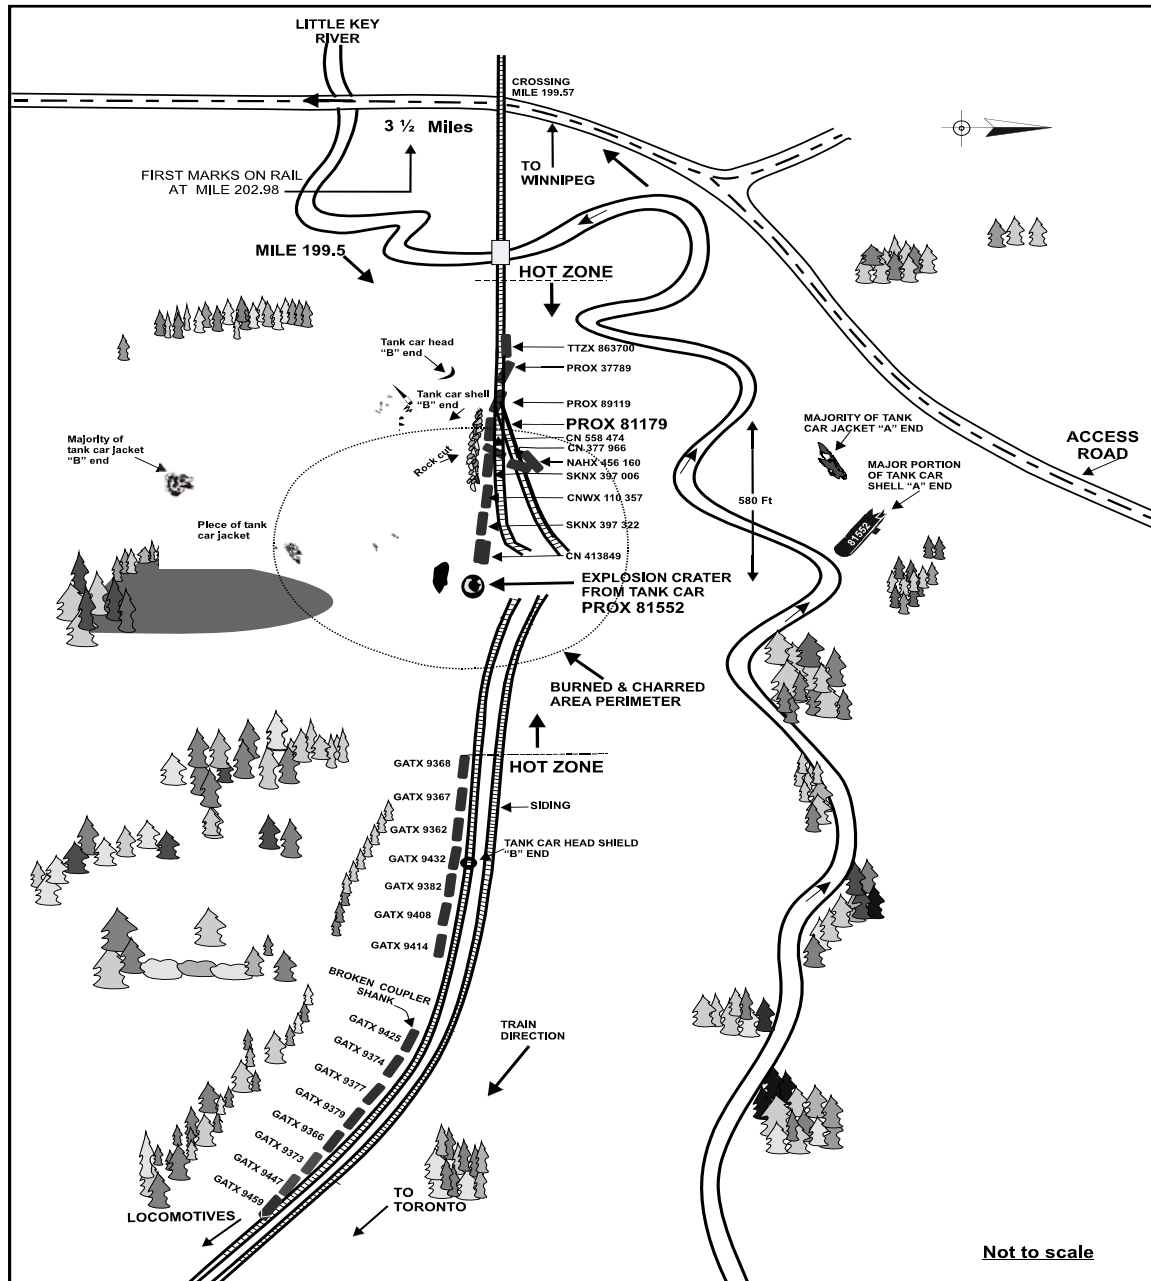
The conductor and a maintenance-of-way employee (who was with a work gang whose boarding cars were located in a back track off the siding at Mowat) travelled by truck on an adjacent access road to the rear of the train where they saw fire and smoke. Approximately one-half hour after the derailment, they heard a loud explosion and, at the same time, the RTC in Toronto experienced a loss of the Centralized Traffic Control System signal from Ardbeg, Ontario, north to Capreol, Ontario. An OPP officer on the scene recorded the time of the explosion as 1348. Another CN maintenance-of-way employee recalled hearing two explosions, at around 1320 and 1345. Detailed examination after the accident revealed that the tank car loaded with LPG (PROX 81552) had exploded. Pieces of the tank shell and jacket were projected in all directions. The larger pieces of tank car wreckage are identified on the derailment schematic in Figure 2.

Car PROX 81552 exploded into six main pieces surrounding the crater left by the explosion. (Figure 2 shows the location where the major pieces of the ruptured LPG car were found, and Appendix A shows the identified tank car fractures.) A major portion of the car struck box car CN 413849 as indicated by the impact damage to that car (see Figure 10). It then careened through the woods knocking down small trees and brush. It traversed a brook and struck a vertical rock face where the spent pressure vessel came to rest in several pieces, approximately 300 feet (91 m) from the point of detonation. The open end of the vessel showed fire damage as

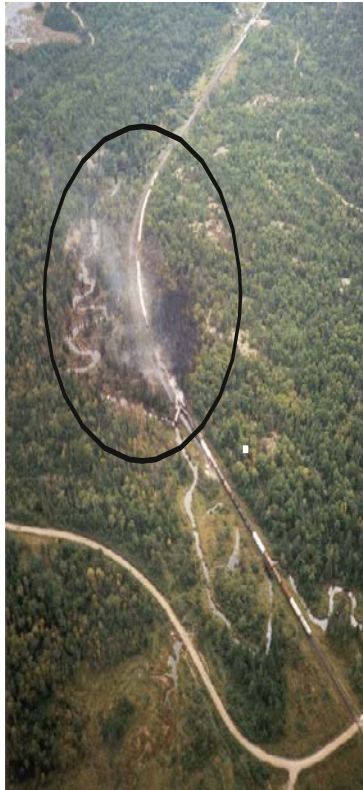
A crater in the right-of-way measuring approximately 2 m deep, 3 m wide and 15 m long was created by the LPG fire and subsequent violent rupture of the tank, which destroyed the roadbed and altered the physical state of the soils and other materials in the area. A box car immediately west of the LPG tank was crushed and bent 90 degrees. The main track and adjacent siding track were moved laterally and destroyed. Debris of demolished rail cars was strewn about the derailment. The adjacent trees and earth were scorched black for a radius of approximately 200 feet. Aerial photographs show the effect that the ensuing fireball and chemical release had on the vegetation surrounding the derailment location (see Figure 3).

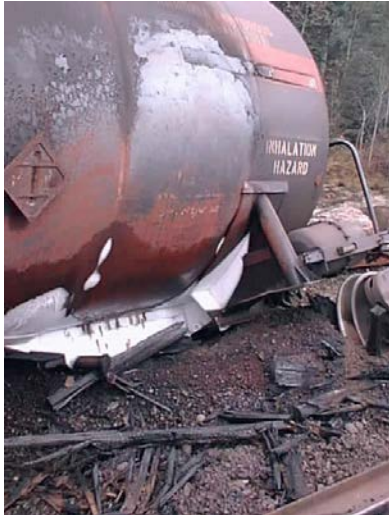
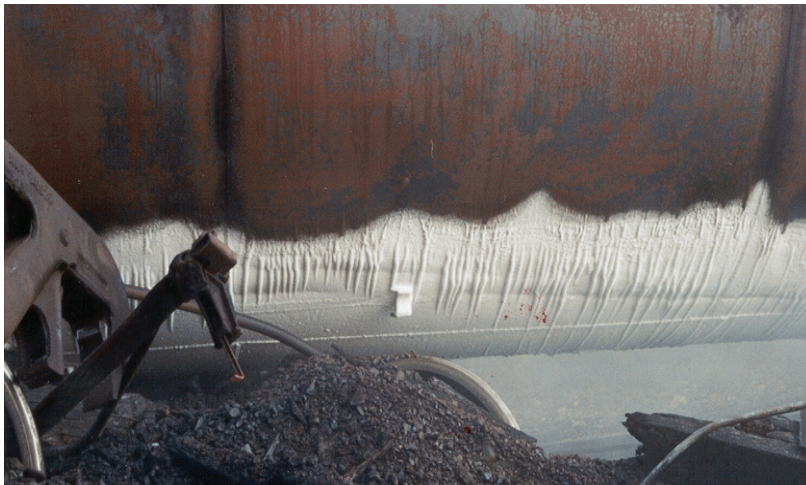
The jacket of ammonia car PROX 81179 was badly scorched due to fire. Except for a residual amount (heel) of refrigerated product remaining in the car, the car lost most of its contents within eight hours of the derailment. The majority of the ammonia burned off rather than forming a gas cloud. Figures 4, 5 and 6 show some of the fire damage on the exterior of the tank and the frosting due to the refrigerated heel. Twelve hours after the derailment, there were about 10 inches of product left in the tank car as indicated by the frost line. In the bolster areas of the car, the frosting peaked at higher levels due to higher thermal conductivity in that zone.

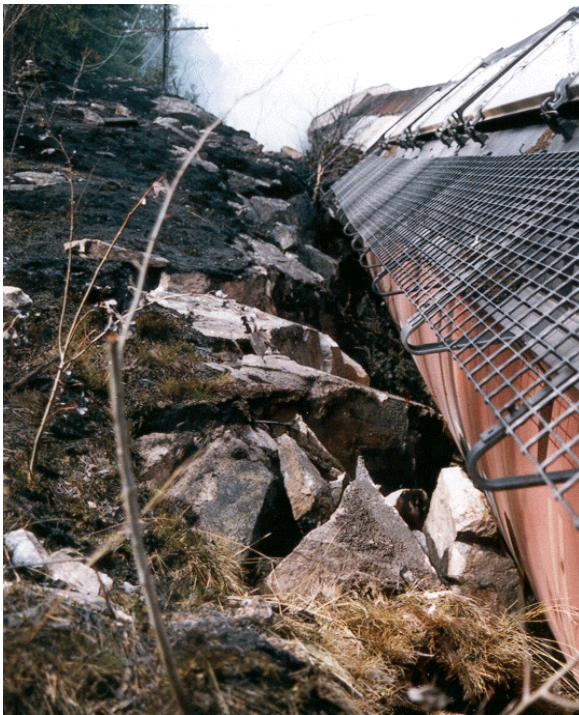
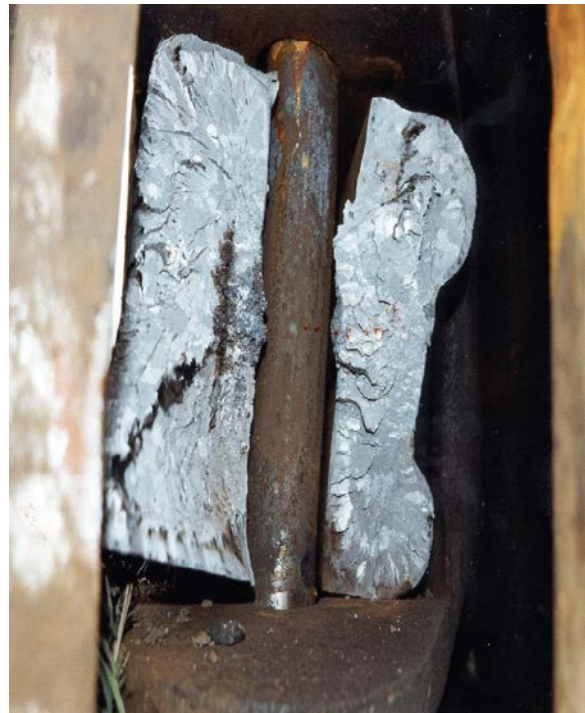
Another fire burned at car PROX 81552, containing LPG, at a location eight cars forward of car PROX 81179. Car PROX 81552 was next to the empty (purged and cleaned) tank car, car GATX 9368. The latter rolled over during the derailment, as did car PROX 81552. Both cars then scraped against a jagged rock cut alongside the right-of-way (see Figure 8). Gouges and scrape marks were observed on the right side of car GATX 9368. Longitudinal marks indicate that the train was still going forward while car GATX 9368 and car PROX 81552 got caught in the rock cut. Extreme longitudinal forces in the train lifted and derailed the 15 empty tank cars immediately ahead of the rock cut (derailing them to the inside of the curve, a phenomenon known as stringlining) and broke a coupler shank on car GATX 9425, located eight cars ahead of car PROX 81552 (see Figure 9).

Car PROX 81552 eventually exploded. Two of the cars between car PROX 81552 (the load of LPG) and the other fire at car PROX 81179 (the load of anhydrous ammonia) were undamaged by fire, indicating that there were two separate fires.

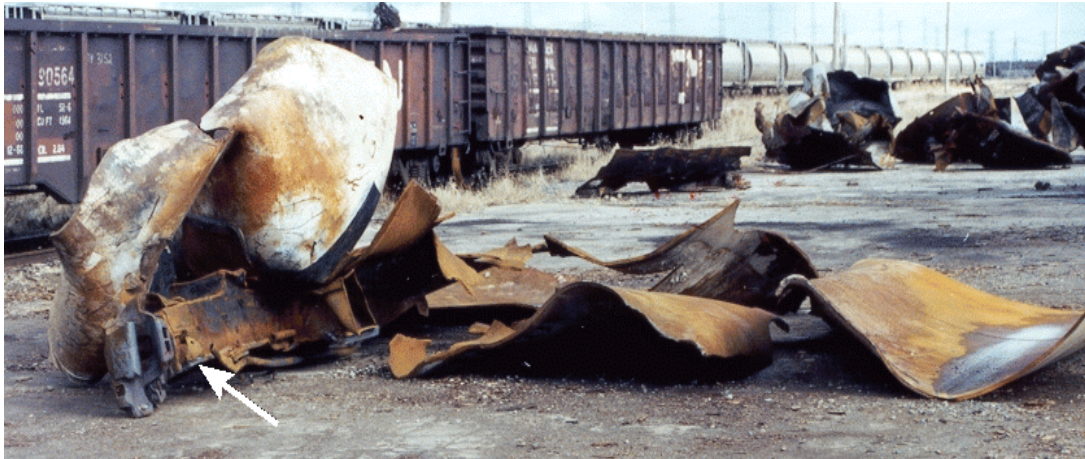
The main part of the “B” end of the car, including the head and a portion of approximately 16.5 feet (5 m) of the tank shell, was found on the opposite side of the railway right-of-way. Trees 60 feet (18 m) tall surrounding this location were not disturbed by the falling tank indicating that it dropped to this location from a much higher altitude. This section of the tank was facing east at the time of detonation, but was found about 340 feet (104 m) southwest of its origin. The piece was approximately 50 feet (15 m) from the right-of-way and about 92 feet (28 m) from the closest rail. The cylindrical portion of the tank was bent back on itself, a characteristic feature of a BLEVE (see Figure 11). This fact indicates that the initial failure of the tank was longitudinal, followed by a circumferential failure. The other half of the “B” end head was on the right-of-way next to a fibre-optic cable bungalow about 335 feet (102 m) west of the point of detonation.

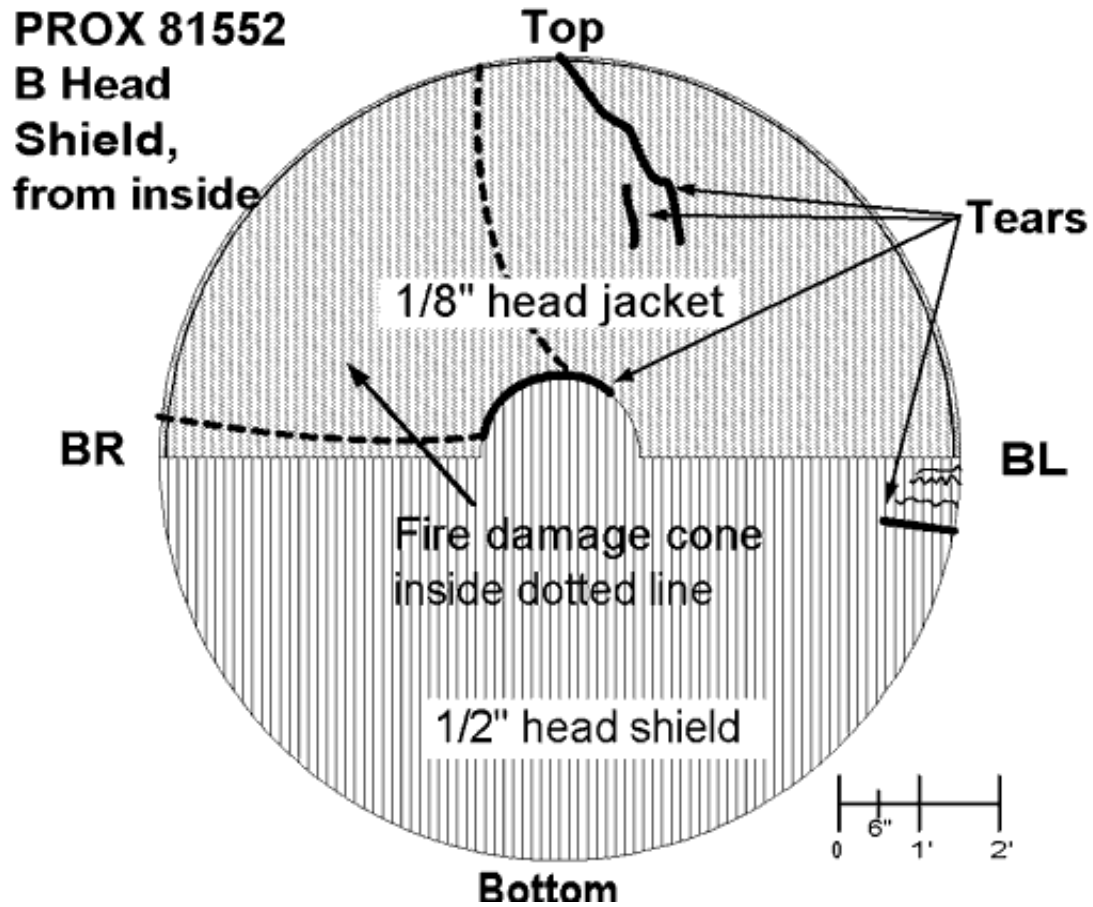
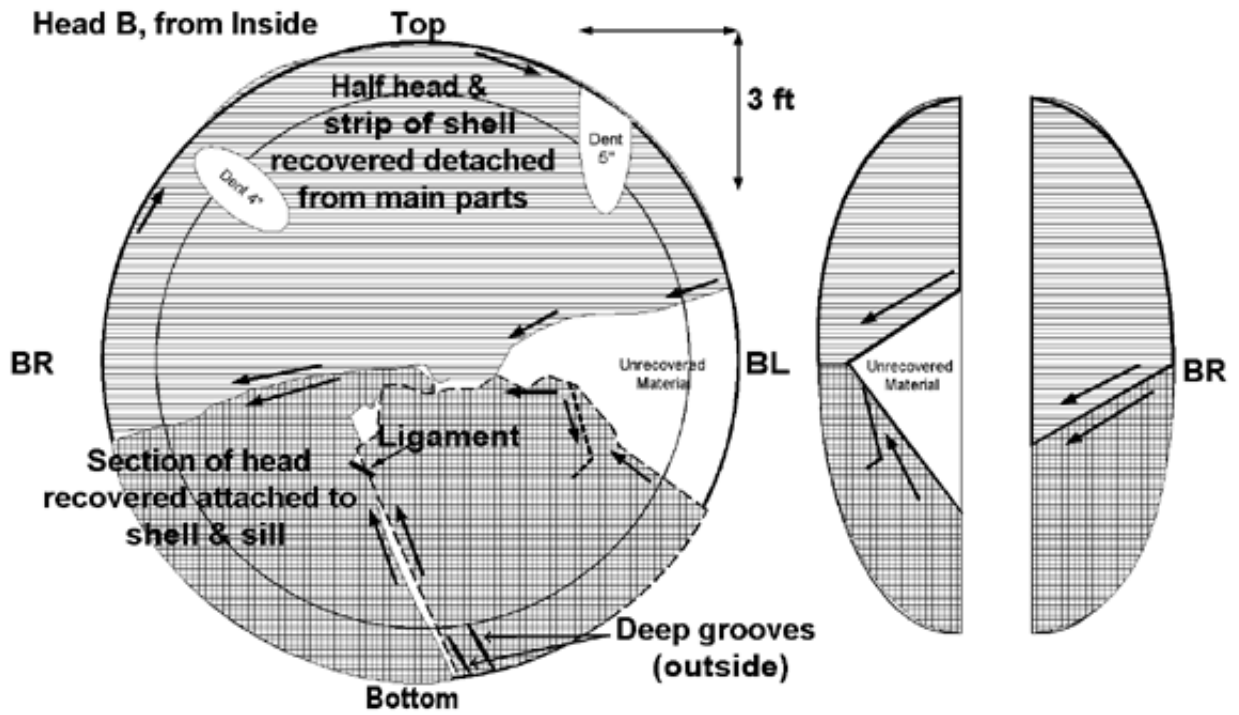
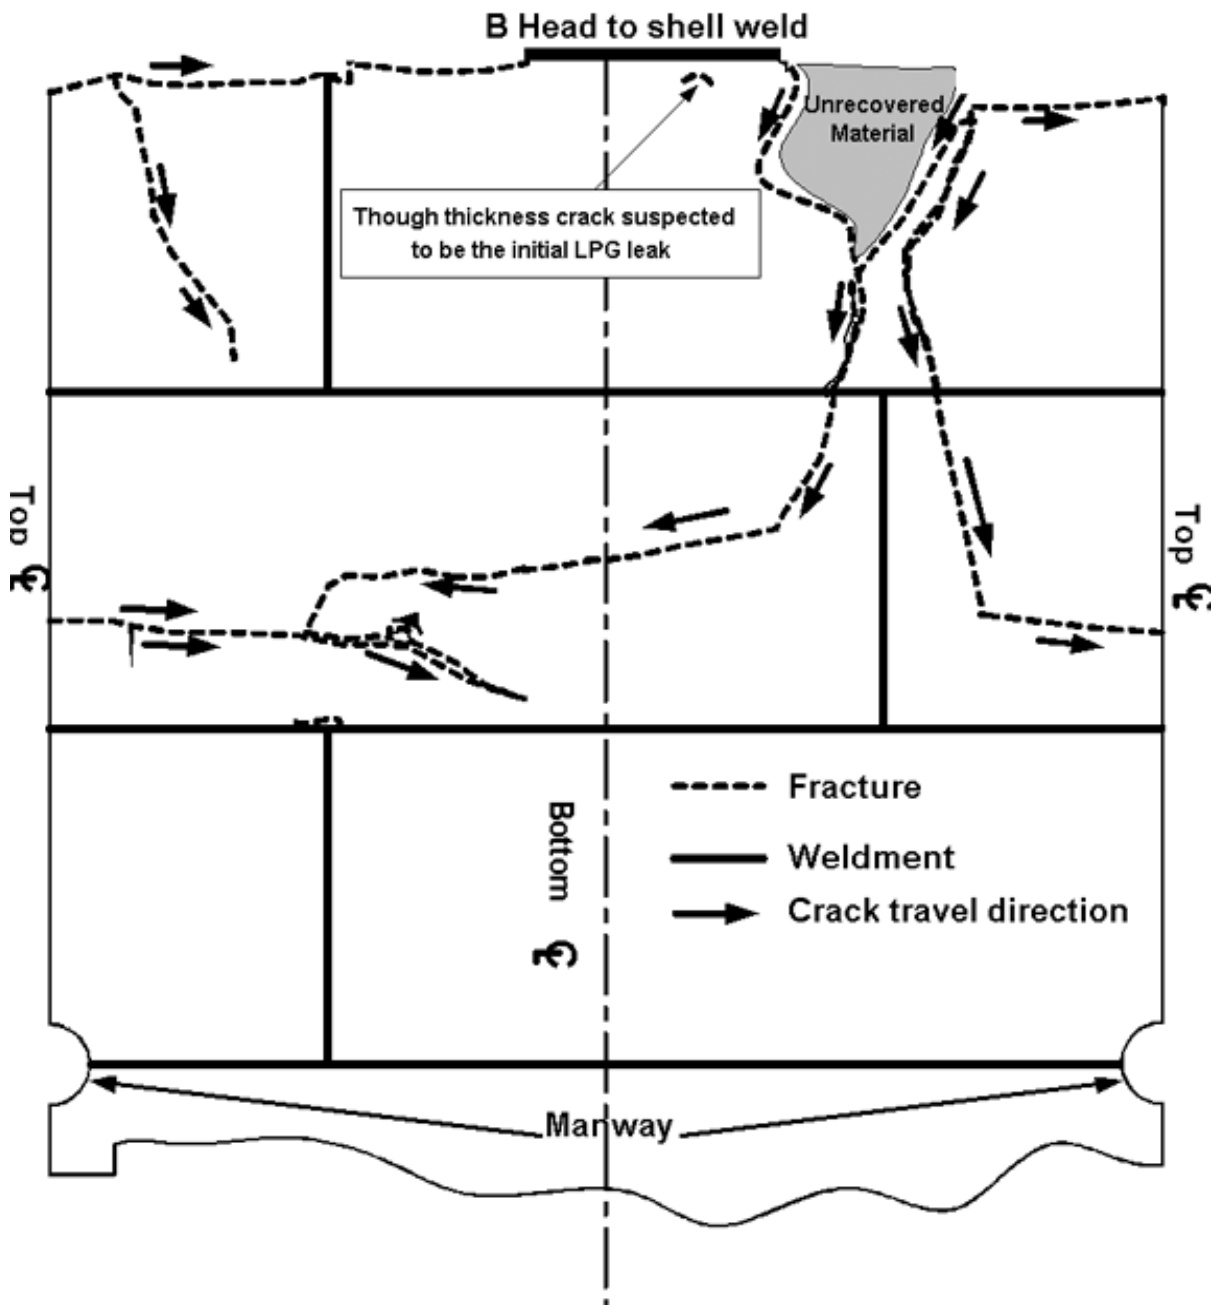
Appendix A—Schematics of Major Fracture Locations on Tank

- Car PROX 81552, the LPG car, failed from a Boiling Liquid Expanding Vapour Explosion known as a BLEVE. A small section of the tank car shell where the BLEVE initiated was not recovered.

- The BLEVE occurred within 37 minutes after the application of the emergency brake. The derailment damage to the tank car and to the “B” end jacket and head shield weakened the tank and reduced the effectiveness of the thermal protection system. The regulations with regards to thermal protection systems require that the tank car not fail for 100 minutes in a pool fire and 30 minutes in a torch fire. However, this applies to a tank car meeting both the tank integrity requirements and the thermal protection system requirements and could not be expected for the subject car which was breached during the derailment.

- The requirement to construct the sill-to-pad weld such that it is weaker than the pad-to-tank weld came into effect in 1971.¹⁷ Therefore, it was not in place when the subject car was built in 1966. In the subject car, the failure of the sill-to-pad weld to fracture cleanly likely resulted in the crack in the bottom shell at the “B” end. This crack allowed product to escape, leading to the fire and subsequent BLEVE.
