RAILWAY INVESTIGATION REPORT

R99T0298

CROSSING ACCIDENT AND DERAILMENT

BOWMANVILLE, ONTARIO

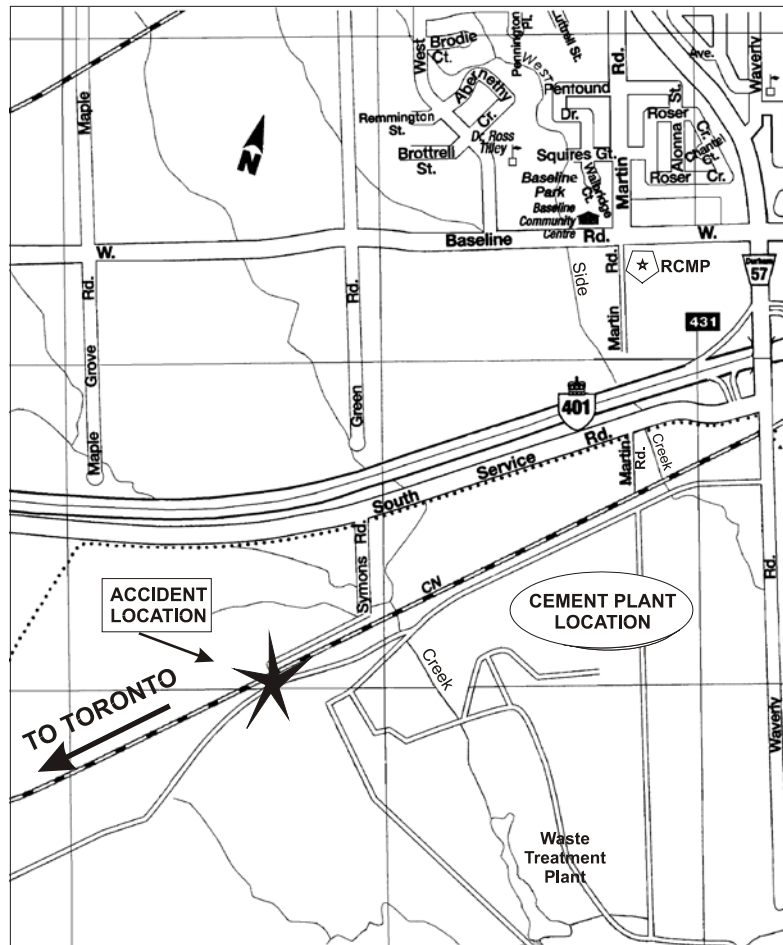
Halfway between Holt Road and Waverly Road, he arrived at an intersection where Symons Road led southward off the South Service Road. Figure 1 shows a map of the area and the accident location. Symons Road was an unpaved gravel road, approximately 4.6 m wide and in good condition. There was a “No Exit” sign at the south-east side of the intersection facing traffic turning from the South Service Road. The driver turned onto Symons Road, and drove southward for approximately 350 m, where the road turned westward at the railway embankment. The driver proceeded westward on the laneway for another 370 m, where the laneway ascended, at a six per cent grade, and made a tight turn to the south, immediately crossing over the double main tracks of the CN Kingston Subdivision. The driver realized that he had taken the wrong route, but believed he could pull onto the crossing, back the trailer into a farm field on the north side of the crossing and turn around. There was an access gate to the cement plant 17.5 m beyond the south rail of the south track.
