# AIR TRANSPORTATION SAFETY INVESTIGATION REPORT A24A0019

## **COLLISION WITH TERRAIN**

Custom Helicopters Ltd. Bell 206L (helicopter), C-FYHN Goose Bay Airport (CYYR), Newfoundland and Labrador, 75 NM N 02 May 2024

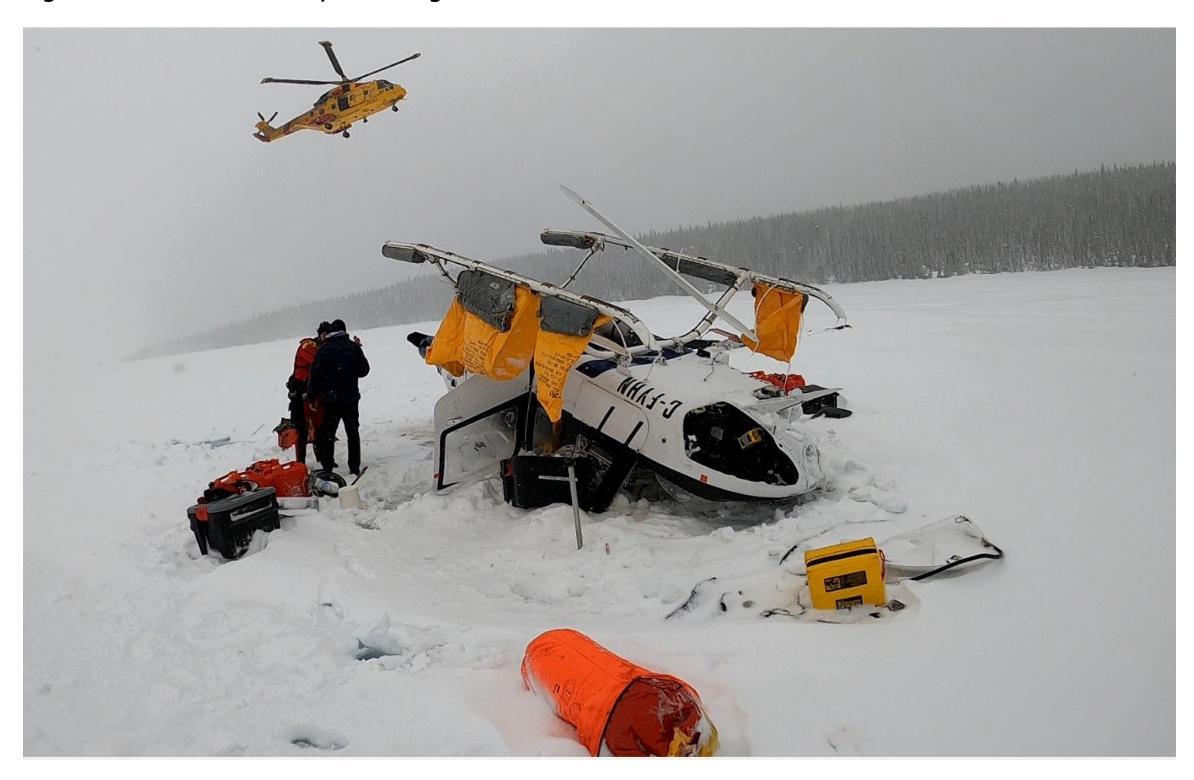
The helicopter sustained substantial damage when it struck the frozen lake and rolled to an inverted position; the main landing gear skids bent, the main rotor assembly and tail boom separated from the helicopter, and both front windscreens and chin bubbles shattered.

Figure 2. Occurrence helicopter during the rescue (Source: Halifax Joint Rescue Coordination Centre)
