# Marine Transportation Safety Investigation Report M20P0110

## STRIKING

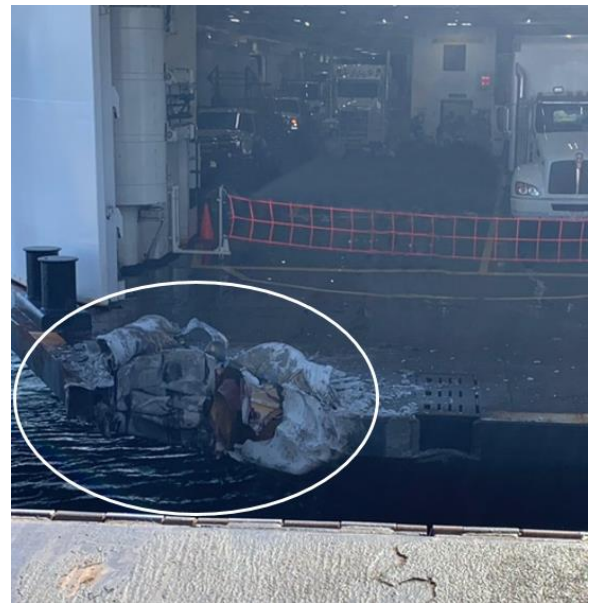
- <sup>7</sup> The set is the difference between the course made good and the course steered due to external forces such as wind and current on the vessel.

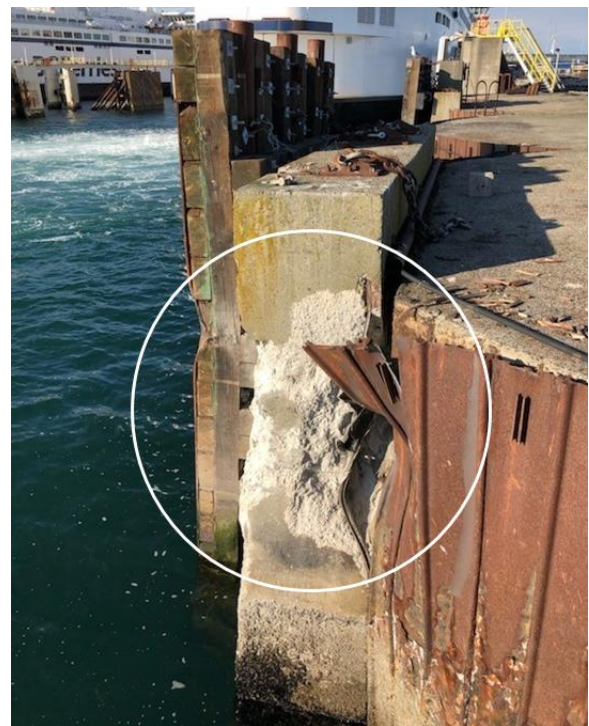
<sup>12</sup> After the occurrence, it was determined that the port anchor had released approximately 6 inches.

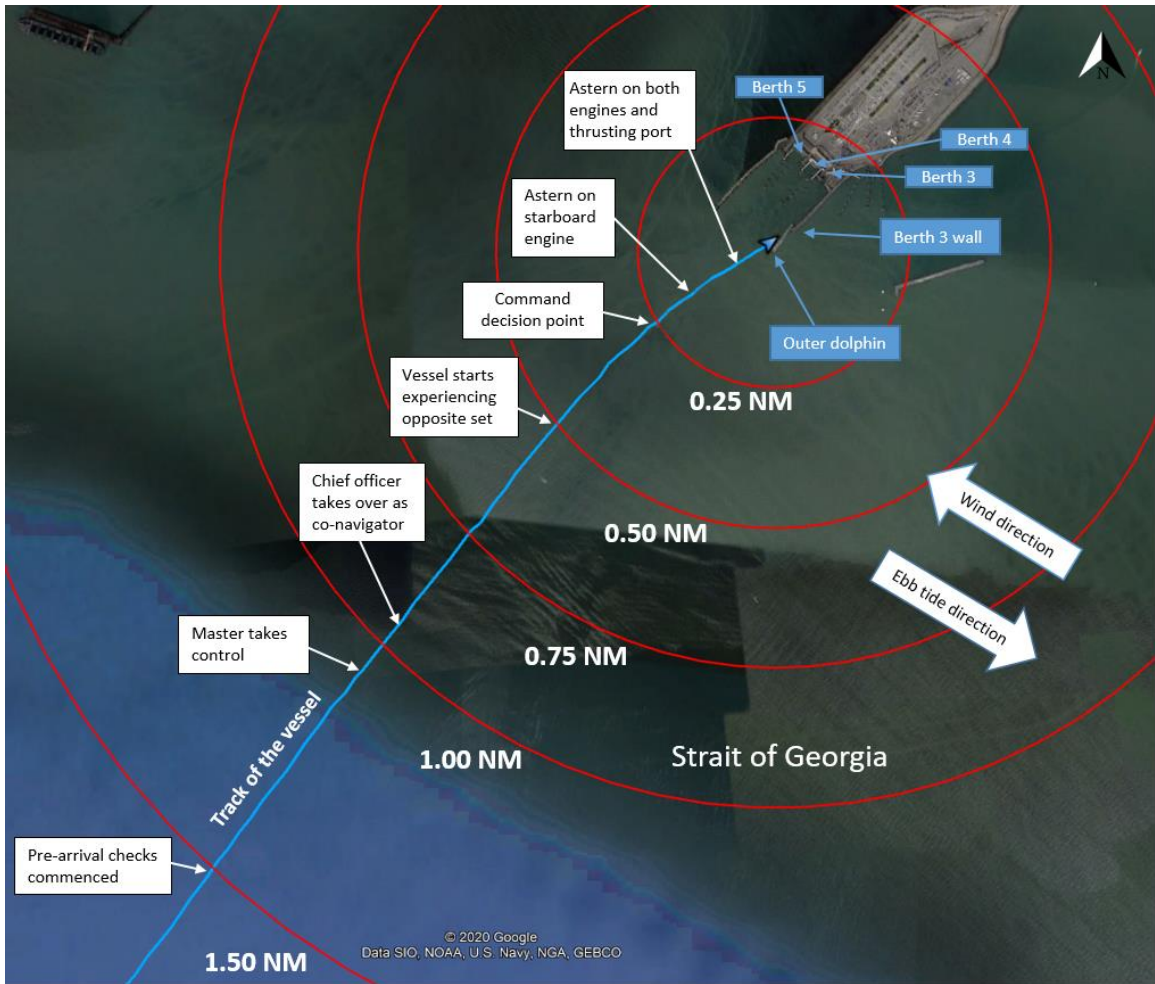
Distance off	Recommended speed (knots)	Recommended pitch	Actual speed (knots)	Actual pitch
1.5 NM	N/A	80%	20.6	90%
1.0 NM	N/A	40%	20.4	90%
0.75 NM	15.0	N/A	19.9	85%
0.5 NM	12.0	20%	18.0	62%
0.25 NM	9.0	Astern	13.8	40%
Outer dolphin	N/A	N/A	6.2	Full astern
